THE SHELL PETROLEUM DEVELOPMENT COMPANY OF NIGERIA LIMITED

JOINT INVESTIGATION REPORT FOR INCIDENT NO: -

THE SHELL PETROLEUM DEVELOPMENT COMPANY OF NIGERIA LIMITED JOINT INVESTIGATION REPORT FOR INCIDENT NO: 677398

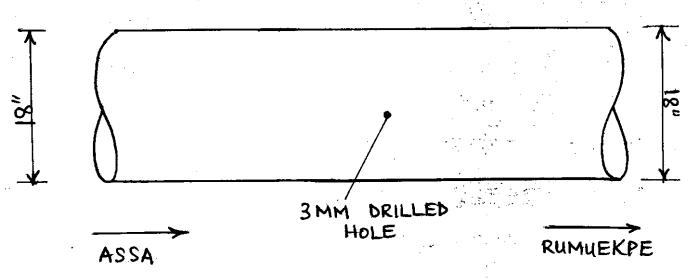
E. GRAPHIC DESCRIPTION OF LEAK POINT (Details should be contained in leak repair report)

PLAN SECTION OF 18" ASSA - RUMUEKPE PIPELINE AT AWARA SHOWING LOCATION OF DRILLED HOLE AT 1 0' CLOCK POSITION.
