JOINT INVESTIGATION REPORT FOR INCIDENT NO:	0128 725931

A. GENERAL INFORMATION:		
1. Spill incident Number: 72593	2.Type o	f incident* OIL SPILL
3. Name of Location <u>CAWTHOR</u>	WE CHANNEL	IT WELL SIT FLOWLINE

E. GRAPHIC DESCRIPTION OF LEAK POINT (Overview sketch of the site should be added as an appendix 1)

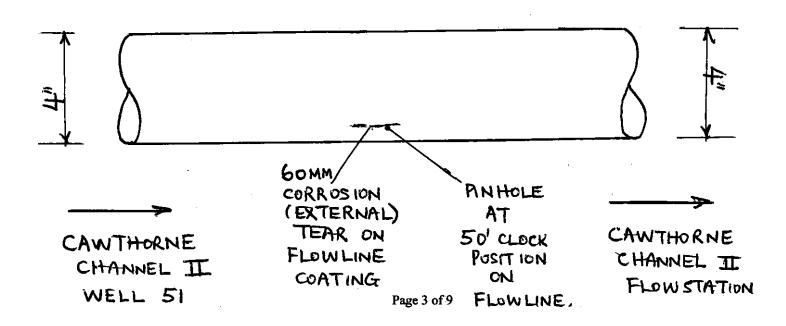
9. Details of incident  a. Date of incident: 1174  b. Date/Period of investigation: 17	OCTOBER 20 TH OCTOBER	•
c: Description of spill point environm	ent	
☐ Firmed soil	<b>∠</b> Loose soil	☐ Previously excavated area
☐ Under water	<b>✓</b> Swampy	☐ Exposed pipe surface
☐ Well Platform (on Water)  d. Description of leak point (tick as approximately)	mlicable):	□ Rig
□ Drilled hole	☐ Hack saw cut	□ Explosive tear,
□ Complete Rupture	☐ Inward dent,	☐ Well head tampering
☐ Failed Weld-on illegal hot tap vo	•	☐ Missing Pipeline/Flowline)
☐ Crude oil theft (illegal bunkering		☐ Third party tampering with Clamp
☐ Third party tampering with valv	• •	☐ Third party tampering with flange,
✓External Corrosion	<i>3,</i>	□ Internal Corrosion
☐ Saver-pit over flow,	☐ Surge vessel overflow,	
☐ Flare System/Bund wall Failure		□ com unit failure
□ Cold vent	☐ Relief valve failure	Others (specify) PIN HOLE

SECTION OF CAWTHORNE CHANNEL II WELL SIT FLOWLINE AT MBIAMA SHOWING POSITION OF PINHOLE DUE TO CORROSION.
