THE SHELL PETROLEUM DEVELOPMENT COMPANY OF NIGERIA LIMITED

JOINT INVESTIGATION REPORT FOR INCIDENT NO: 0112 721661

1. Spill incident Number: 721661 2. Type of incident* CONDENSATE SPILL
 3. Name of Location 6" OBIGBO NORTH PIPELINE
 4. Name of nearest community OGALE 5. State: RIVERS 6. LGA ELEME
 7. Type of Production facility/Installation CONDENSATE PIPELINE 8. Asset owner/District NESP/PH I

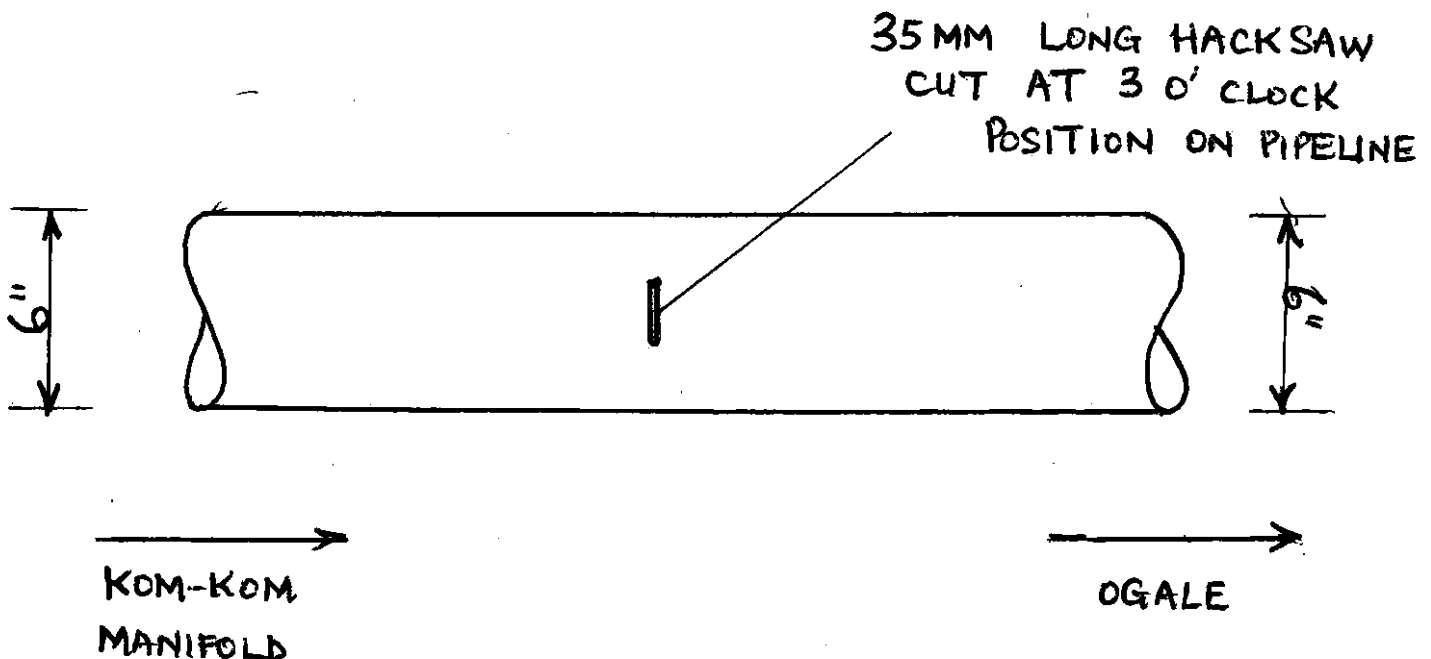
SECTION OF 6" OBIGBO-NORTH PIPELINE AT OGALE
SHOWING POSITION OF HACKSAW CUT.
