THE SHELL PETROLEUM DEVELOPMENT COMPANY OF NIGERIA LIMITED

JOINT INVESTIGATION REPORT FOR INCIDENT NO: 0403 857258

1. Spill incident Number: 857258 2. Type of incident * Oil Spill
 3. Name of Location BUKUMA WELL 8 WELL HEAD
 4. Name of nearest community BUKUMA 5. State: RIVERS 6. LGA DEGEMA
 7. Type of Production facility/Installation WELL HEAD 8. Asset owner/ District NESI/SURMP 1

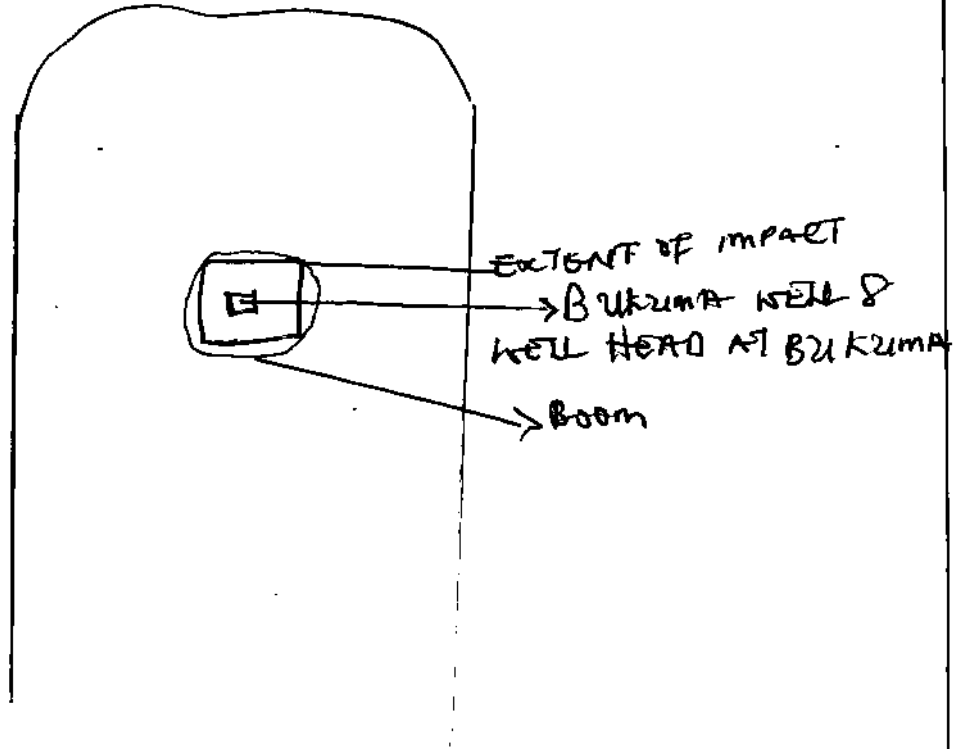
27. Appendix 1: Overview sketch of the site

Location: BUKUMA WELL & WELL HEAD AT BUKUMA
