ANT OF MIGERIA LIMITED
JOINT INVESTIGATION REP	ORT FOR INCIDENT N	10: 0103779129
(Note: As practicable as possible the JIT	report is to be signed in th

A. GENERAL INFORMATION:	_	5 of the participating partiesy
1. Spill incident Number: 77912	9 2.Tvn	e of incident* All QPIII
3. Name of Location 18" ASS7	Y-Rumuel	CPE DIPELINE

JOINT INVESTIGATION REPORT FOR INCIDENT NO: 0103 77 9129

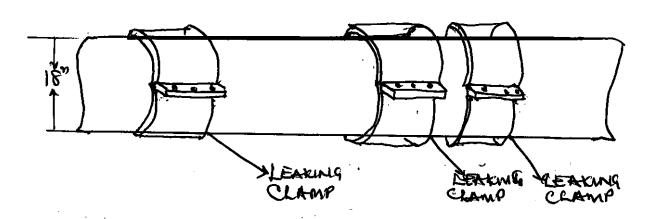
E. GRAPHIC DESCRIPTION OF LEAK POINT (Overview sketch of the site should be added as an appendix 1)

d. Description of leak point (tick as	applicable);	□ Rig
☐ Drilled hole	☐ Hack saw cut	☐ Explosive tear,
☐ Complete Rupture	☐ Inward dent,	☐ Well head tampering
□ Failed Weld-on illegal hot tap		☐ Missing Pipeline/Flowline)
☐ Crude oil theft (illegal bunkeri		☐ Third party tampering with Clamp
☐ Third party tampering with val	ve setting,	☐ Third party tampering with flange,
☐ External Corrosion		☐ Internal Corrosion
☐ Saver-pit over flow,	☐ Surge vessel overflow	
☐ Flare System/Bund wall Failur		C com unit failure
□ Cold vent	☐ Relief valve failure	Others (specify) CLAMP FAILUR

A SECTION OF 12" ASSA - RUMUEKPE PLPELINE AT

AWARA SHOWING THREE CLAMPS LEAKING AT 6 0" CLUCK
POSITION
