(Note: 710 produced do produced mile environmental mental mile environmental mental me					
A. GENERAL INFORMATION:					
1. Spill incident Number: 84311		fincident* OIL SPILL

3. Name of Location 12" MOR	IVERITE OGA	IF PIPELINE			
4. Name of nearest community OWA					
7. Type of Production facility/Installation	IL PIPELINES. A	sset owner/ District NPF / PH 2

JOINT INVESTIGATION REPORT FOR INCIDENT NO: 0384 843118

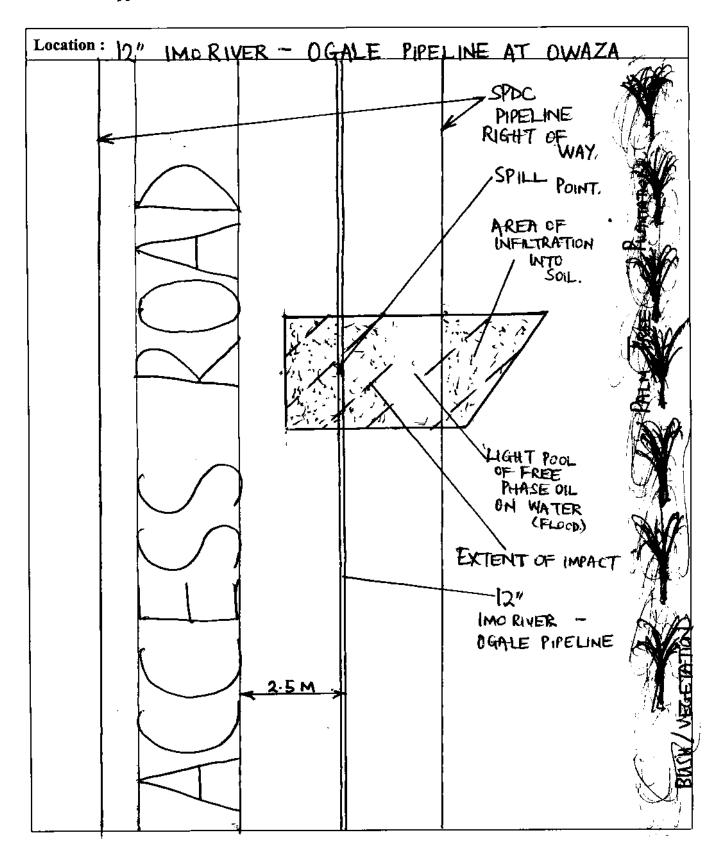
27. Appendix 1: Overview sketch of the site

E. GRAPHIC DESCRIPTION OF LEAK POINT While detail report of the leak point should be contained in the Leak report, overview sketch of the site should be added as an appendix 1) CONNECTING SECTION I" PIPE 12" IMO RIVER OGALE PIPELINE AT DWAZA SHOWING POSITION CRUBE OIL THEFT FITTING. BALL VALVES PIPE DRILL AT ILLEGAL FITTING IMO RIVER I Page 3 of 9
