THE SHELL PETROLEUM DEVELOPMENT COMPANY OF NIGERIA LIMITED JOINT INVESTIGATION REPORT FOR INCIDENT NO: 0206841

1. Spill incident Number:	A. GENERAL INFORMATION:				
3. Name of Location	^				
4. Name of nearest community	1. Spill incident Number: 8715	2.Type	of incident* UIL SPIEL

E. GRAPHIC DESCRIPTION OF LEAK POINT While detail report of the leak point should be contained in the Leak report, overview sketch of the site should be added as an appendix 1)

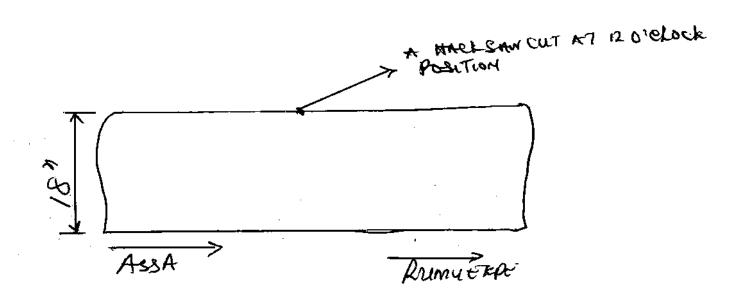
SHOWING HACK SAW CUT AT 12 0' Chock POSITION.
