| JOINT INVESTIGATION REPO | ORT FOR INCIDENT NO | 0311 |
| 3. Name of Location 16 INCH U | ZERE - ERIE | MUTRUNKLING |
| 7. Type of Production facility/Installation | RUNKLINE 8. AS | sset owner/ District PIPELINE |

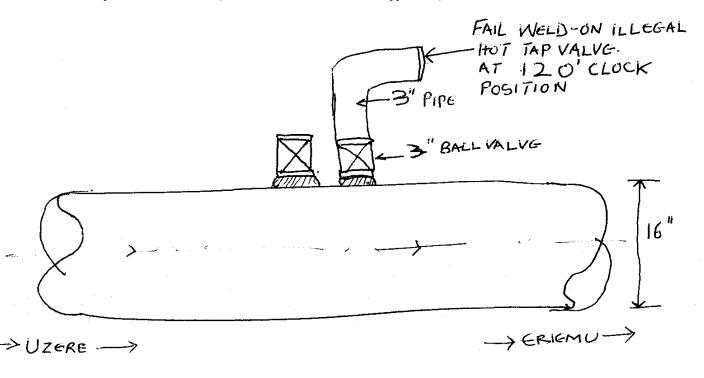
E. GRAPHIC DESCRIPTION OF LEAK POINT While detail report of the leak point should be contained in the Leak report, overview sketch of the site should be added as an appendix 1)

| JOINT INVESTIGATION REPO | ORT FOR INCIDENT NO | 0311 |
|---|--|---|
| 9. Details of incident a. Date of incident: 3\07\20 b. Start date/time of investigation: 5 c. Investigation End date: 5 d. Description of spill point environm Firmed soil Under water Well Plateform (on Water) e. Description of leak point (tick as a Drilled hole Complete Rupture Failed Weld-on illegal hot tap water Third party tampering with val Corrosion Outward dent Valve Failure Relief valve failure | pplicable); Hack saw cut Inward dent, valve, ing) point, | ☐ Exposed pipe surface ☐ Rig ☐ Explosive tear, ☐ Well head tampering ☐ Missing Pipeline/Flowline) ☐ Third party tampering with Clamp ☐ Third party tampering with flange, ☐ Surge vessel overflow |
| f. Incident caused by: Third party interference | □Operational | □ _{Mystery} |
