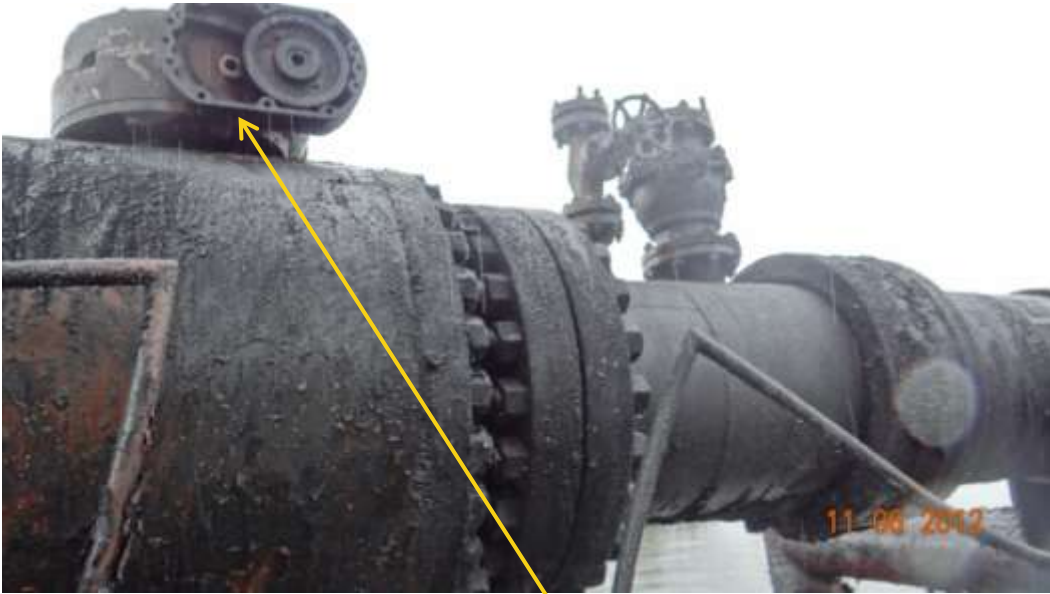
Close up: Spill and resulting fire caused by tampering of the isolation valve control system by unknown persons. Previous location of missing isolation valve control system on 24" Cawthorne Channel-Bonny Ball Valve Station at Kalibiana.
