THE SHELL PETROLEUM DEVELOPMENT COMPANY OF NIGERIA LIMITED

JOINT INVESTIGATION REPORT FOR INCIDENT NO: 820273<sup>0236</sup>

1. Spill incident Number: 820273 2. Type of incident \* OIL SPILL  
 3. Name of Location AGRADA WELL 34 S FLOWLINE  
 4. Name of nearest community OMUOHIA/OMUEKE 5. State: RIVERS 6. LGA IKWERRE  
 7. Type of Production facility/Installation OIL FLOWLINE 8. Asset owner/ District NELL/PH 1

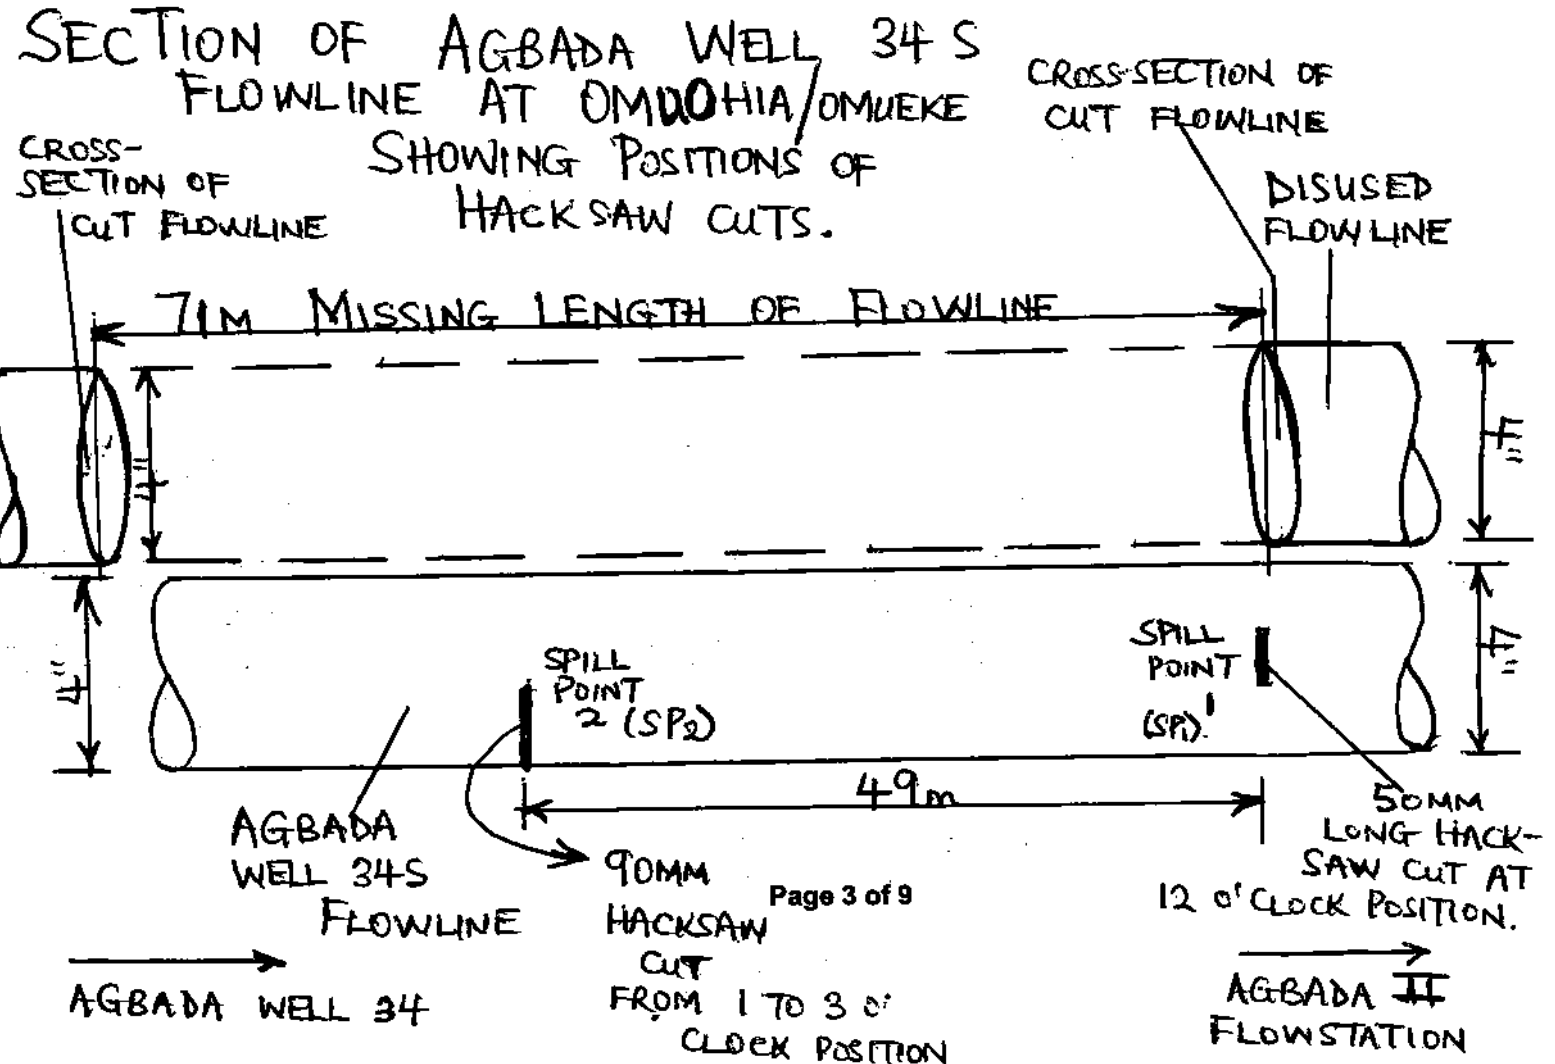
E. GRAPHIC DESCRIPTION OF LEAK POINT While detail report of the leak point should be contained in the Leak report, overview sketch of the site should be added as an appendix 1)

e. Description of leak point (tick as applicable);  
 Drilled hole  Hack saw cut  Explosive tear,  
 Complete Rupture  Inward dent,  Well head tampering  
 Failed Weld-on illegal hot tap valve,  Missing Pipeline/Flowline)  
 Crude oil theft (illegal) bunkering) point,  Third party tampering with Clamp  
 Third party tampering with valve setting,  Third party tampering with flange,  
 Corrosion  Saver-pit over flow,  Surge vessel overflow  
 Outward dent  Flare System/Bund wall failure  
 Valve Failure  com unit failure  Cold vent  
 Relief valve failure  Others (specify) \_\_\_\_\_

f. Incident caused by:  
 Third party interference  Operational  Mystery \_\_\_\_\_

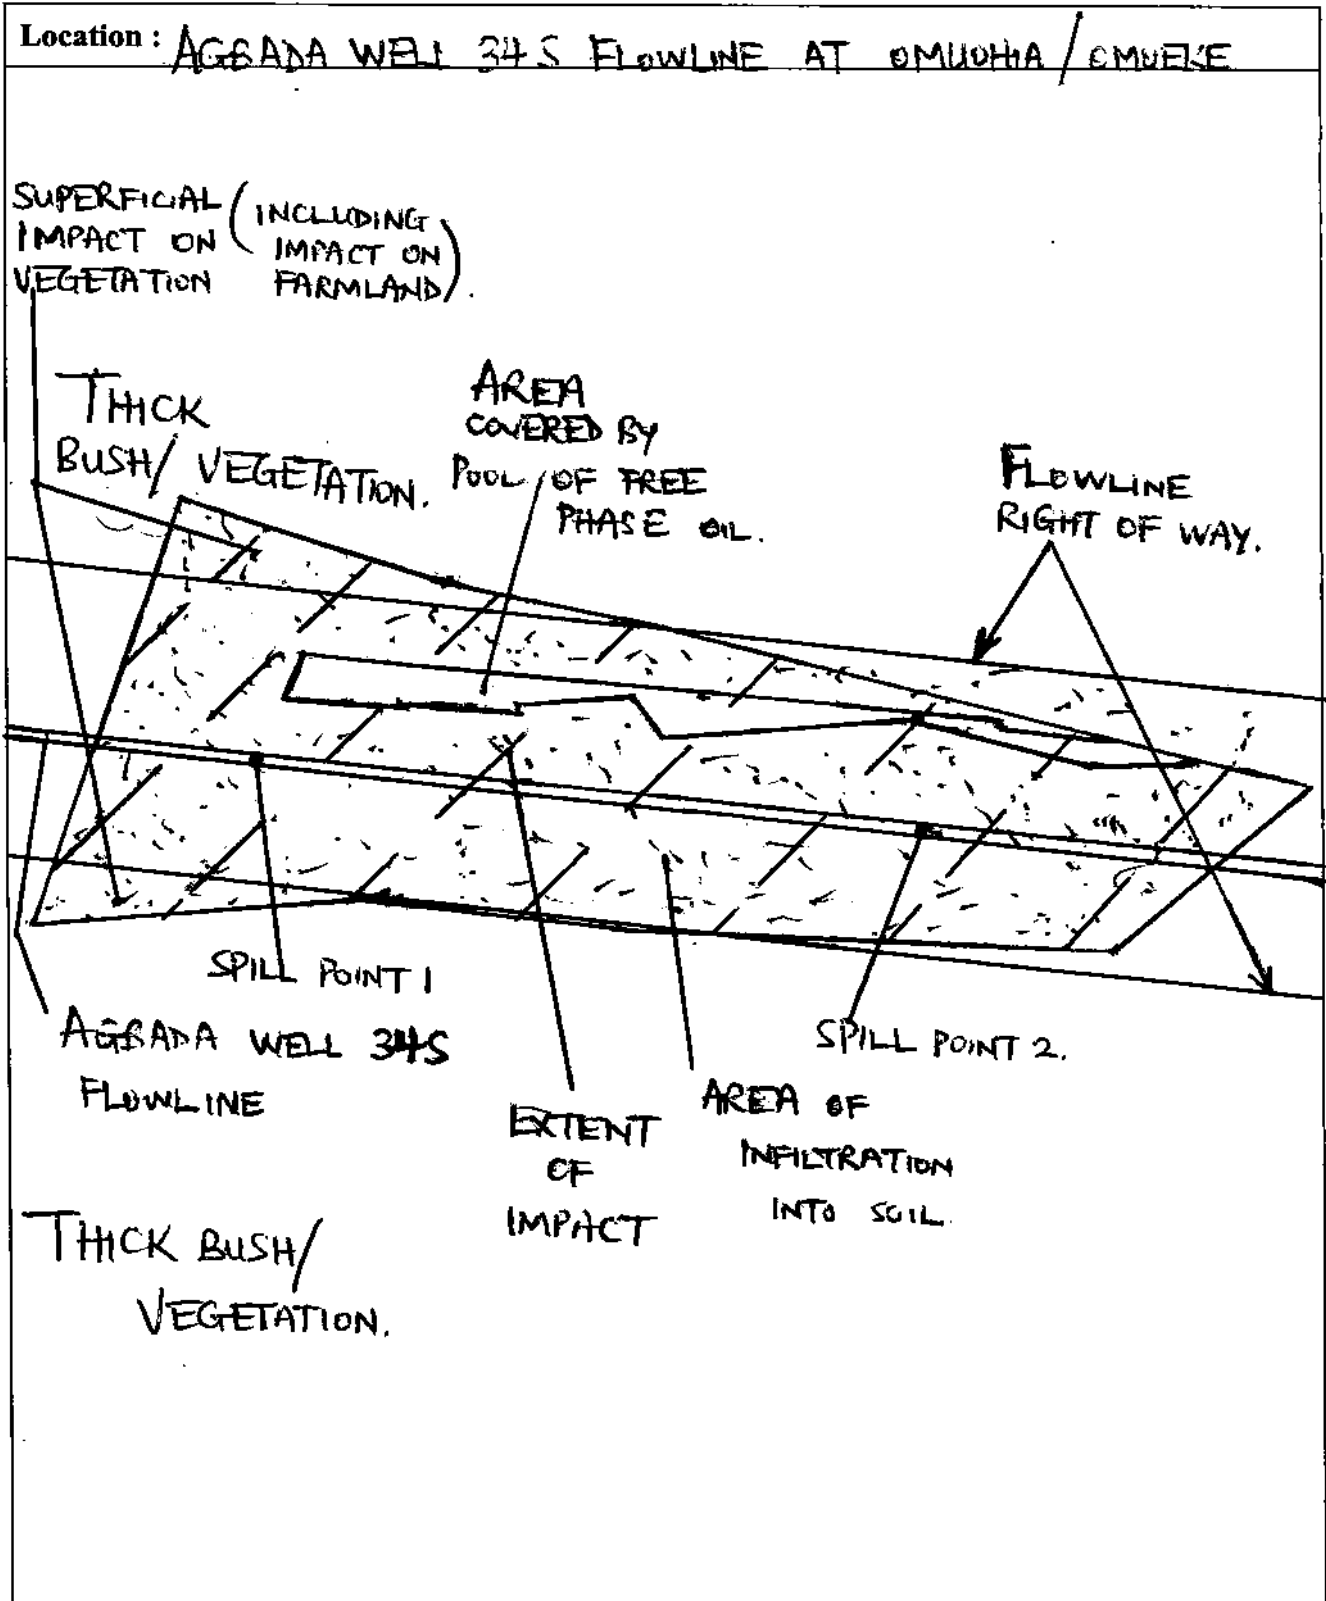
27. Appendix 1: Overview sketch of the site

- Total calculated area of impact 0.21 Ha
- Impact within SPDC R.O.W \_\_\_\_\_
- Impact outside R.O.W \_\_\_\_\_

- a. Computation of volume of pool of free phase oil (on land or confined water body).
- Area ( $m^2$ ) occupied by pool of free phase oil 200
  - Average Depth (m) of pool of free phase oil 0.001

i Area \*(m<sup>2</sup>) covered by the oil: 1,900
