THE SHELL PETROLEUM D	EVELOPMENT COM	PANY OF NIGERIA LIMITED
JOINT INVESTIGATION REPO	RT FOR INCIDENT NO:	: 0459 B88097
Note: As practicable as possible the JIT re	port is to be signed in the	field by all the participating parties)

A. GENERAL INFORMATION:		
. Spill incident Number: 88809		fincident* OIL SYILL
. Name of Location 24" Ofart	E - BONNY P	IPELINE
Name of nearest community	5. State: RIV	HERS 6. LGA TAI

7. Type of Production facility/Installation)IL PIPELINE 8. As	sset owner/ District U1 G / Y /MES?
B. INCIDENT INFORMATION:		
a. Date of incident: 2 NOVE

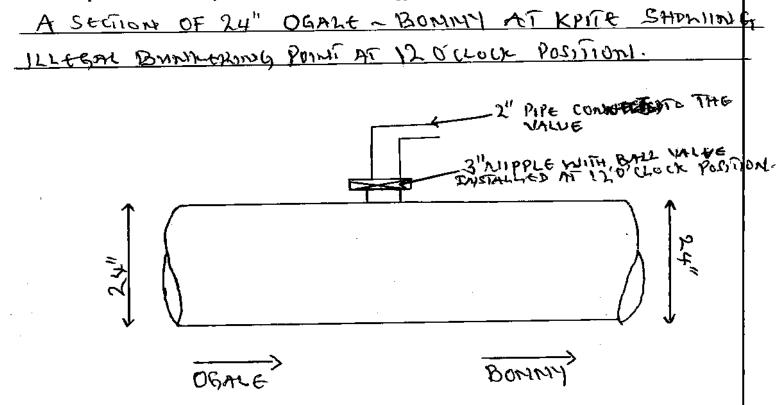
E. GRAPHIC DESCRIPTION OF LEAK POINT While detail report of the leak point should be contained in the Leak report, overview sketch of the site should be added as an appendix 1)

e. Description of leak point (tick as ap	_	-
Drilled hole	∐Hack saw cut	☐Explosive tear,
☐Complete Rupture	☐ Inward dent,	☐ Well head tampering
Failed Weld-on illegal hot tap v		☐ Missing Pipeline/Flowline)
Crude oil theft (illegal) bunkeri		☐ Third party tampering with Clamp
☐Third party tampering with valv	-	☐ Third party tampering with flange,
Corrosion	☐ Saver-pit over flow,	☐ Surge vessel overflow
Outward dent	☐Flare System/Bund wa	_
□Valwe Failure	_	☐ Cold vent
Relief valve failure	Others (specify)

f. Incident caused by:		
Third party interference	Operational	Mystery
g. Spill point coordinates Measuring unit (1)	MINNA MID-	-BELT
Northing:	r	Easting:
78618	83	
78618	3.53	535311.83
