3. Name of Location 20 INCH CTU	MARA-ESCRA	WOS PIPELINE AT ESCRAVOS
4. Name of nearest community AJUDA	<u>PO</u> 5. State: <u>DFI</u>	TA 6. LGA WARRI-SOUTH WEST

# THE SHELL PETROLEUM DEVELOPMENT COMPANY OF NIGERIA LIMITED JOINT INVESTIGATION REPORT FOR INCIDENT NO: 0514895959 RISK ASSESSMENT

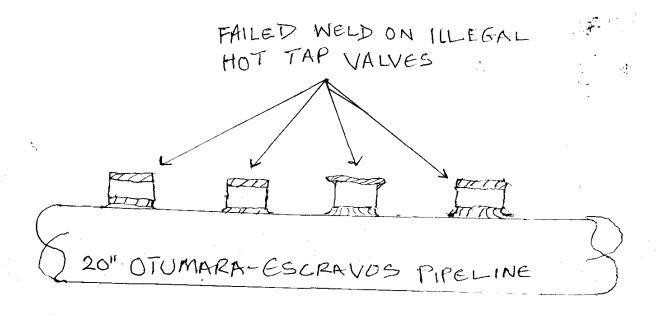
E. GRAPHIC DESCRIPTION OF LEAK POINT While detail report of the leak point should be contained in the Leak report, overview sketch of the site should be added as an appendix 1)

7. Type of Production facility/Installation 1	RUNKLINE 8. A	Asset owner/ District_PIPELINE
B. INCIDENT INFORMATION:		
9. Details of incident  a. Date of incident: 23 II 2  b. Start date/time of investigation: 2  c. Investigation End date: 24 II  d. Description of spill point environm	4 11/2012 A 1/2012	T 1308 HRS
☐Firmed soil	Loose soil	☐ Previously excavated area
☐Under water	Swampy	Exposed pipe surface
Well Plateform (on Water) e. Description of leak point (tick as a	pplicable);	$\square_{\mathrm{Rig}}$
Drilled hole	□Hack saw cut	☐Explosive tear,
Complete Rupture	☐ Inward dent,	☐ Well head tampering
Failed Weld-on illegal hot tap	valve,	☐ Missing Pipeline/Flowline)
Crude oil theft (illegal) bunker	ing) point,	☐ Third party tampering with Clamp
Third party tampering with val	ve setting,	☐ Third party tampering with flange,
$\square_{Corrosion}$	☐Saver-pit over flow,	☐ Surge vessel overflow
Outward dent	☐Flare System/Bund v	vall failure

□Val <b>v</b> e Failure	com unit failure	☐ Cold vent
Relief valve failure	Others (specify)	
f. Incident caused by:  Third party interference	☐Operational	□Mystery

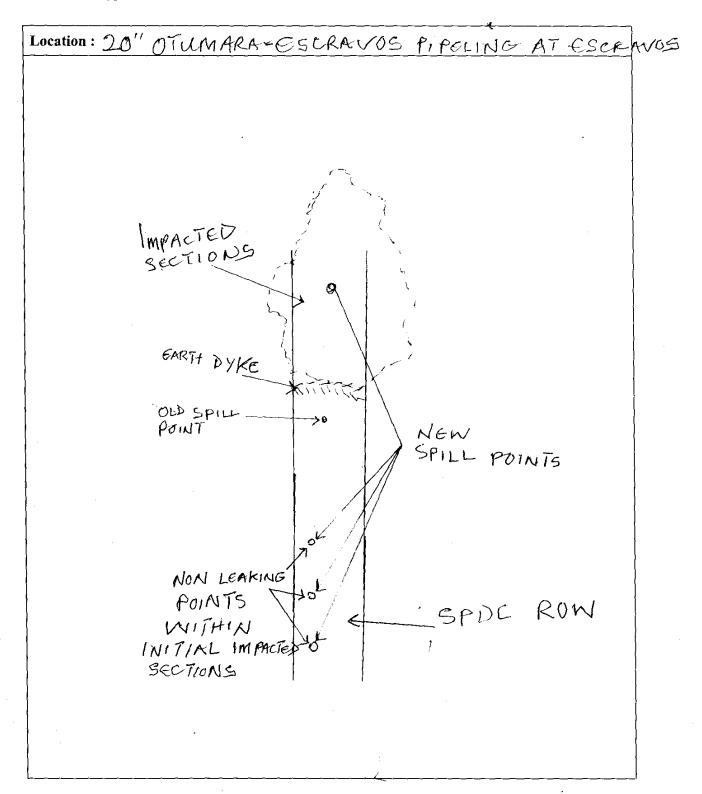
#### 27. Appendix 1: Overview sketch of the site

/N	Northing	Easting
•••		
	CIDENT INFORMATION:	
20	. Impacted Area Details	
	Total calculated area of impact	3437m2
	Impact within SPDC R.O.W	1319 m2
	Impact outside R.O.W	2118 m2
21	Volume of oil recovered before completion	of JIV (V <sub>rec</sub> J):
٠	Recovered	oil V <sub>t∞</sub> r
20	. Computation of the residual volume on site	
a.	Computation of volume of pool of free phase o  i. Area (m²) occupied by pool of fre	il (on land or confined water body). 3437 m <sup>2</sup>
	ii. Average Depth (m) of pool of fre	$\wedge$ $\wedge$ $\wedge$
