THE SHELL PETROLEUM DEVELOPMENT COMPANY OF NIGERIA LIMITED

JOINT INVESTIGATION REPORT FOR INCIDENT NO: 0506

1. Spill incident Number: 882480 2. Type of incident * OIL SPILL
 3. Name of Location 12 INCH AFIESERE - ERIEMU DELIVERY LINE - AT ERIEMU MANIFOLD
 4. Name of nearest community GANA 5. State: DELTA 6. LGA UGHELLI - NORTH
 7. Type of Production facility/Installation DELIVERY LINE 8. Asset owner/ District PIPELINE

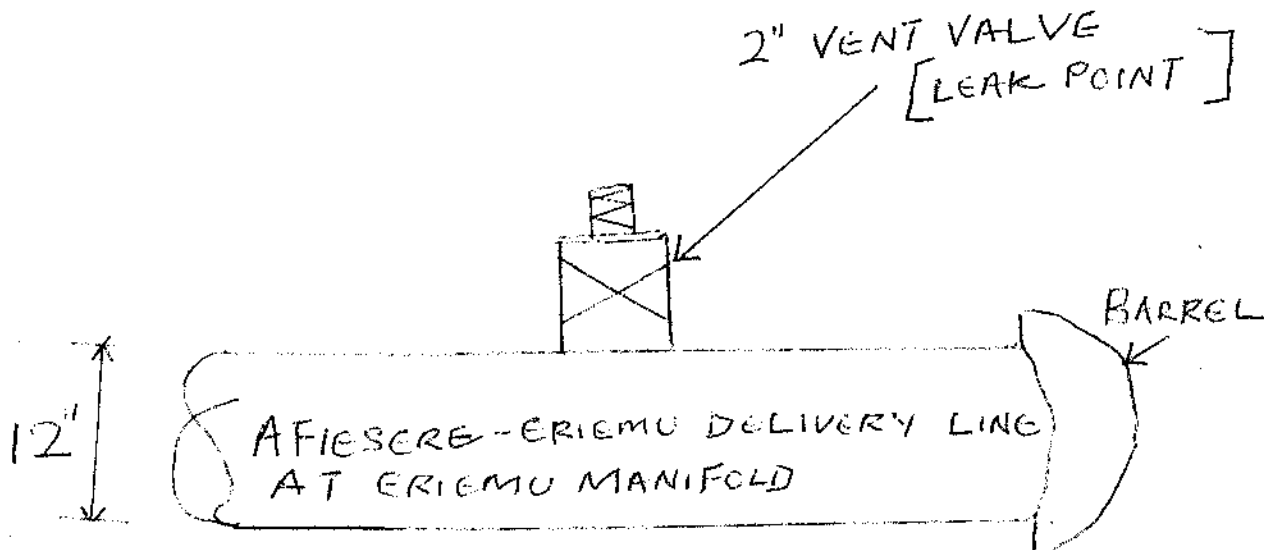
E. GRAPHIC DESCRIPTION OF LEAK POINT *While detail report of the leak point should be contained in the Leak report, overview sketch of the site should be added as an appendix 1)*

e. Description of leak point (tick as applicable);
 Drilled hole Hack saw cut Explosive tear,
 Complete Rupture Inward dent, Well head tampering
 Failed Weld-on illegal hot tap valve, Missing Pipeline/Flowline)
 Crude oil theft (illegal) bunkering) point, Third party tampering with Clamp
 Third party tampering with valve setting, Third party tampering with flange,
 Corrosion Saver-pit over flow, Surge vessel overflow
 Outward dent Flare System/Bund wall failure
 Valve Failure com unit failure Cold vent
 Relief valve failure Others (specify) LEAK FROM VENT VALVE

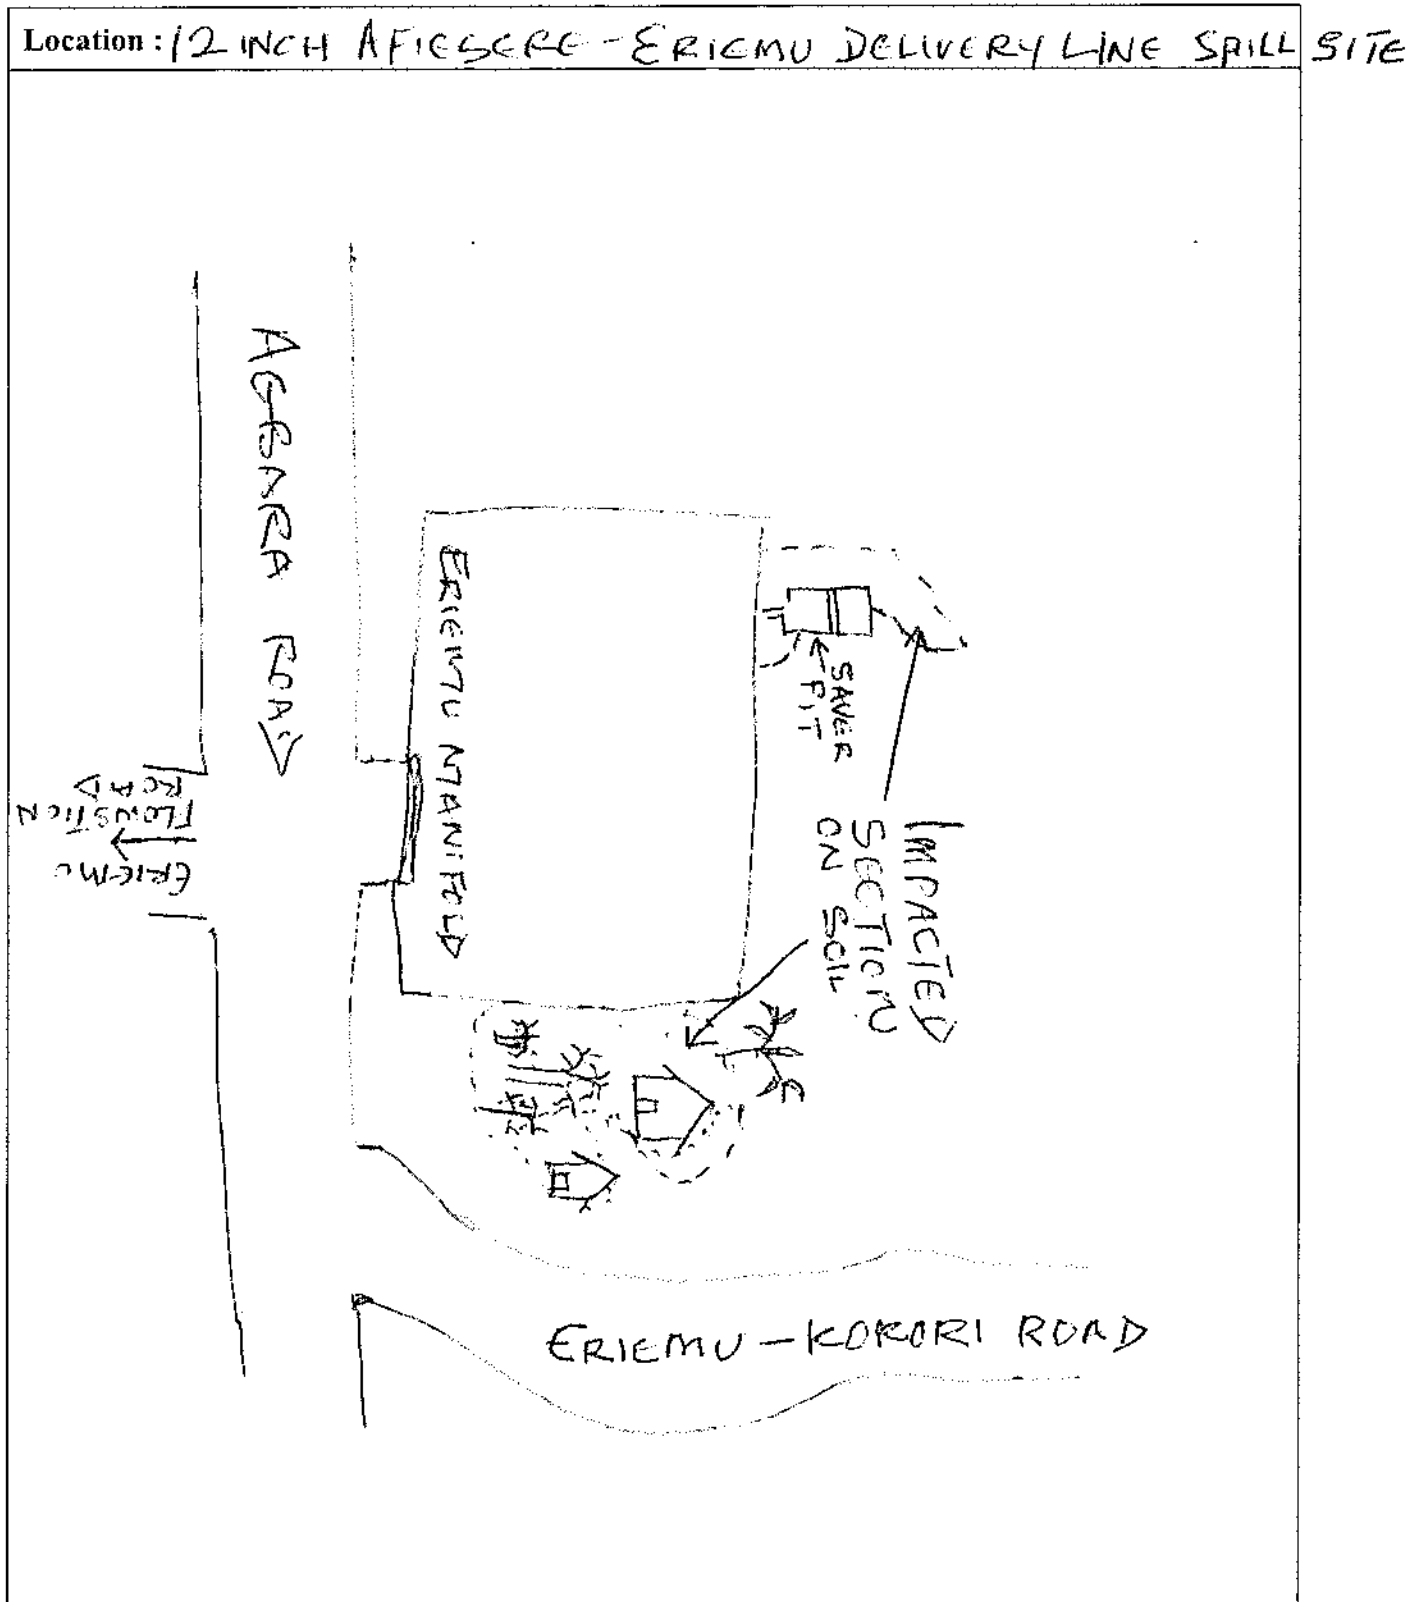
27. Appendix 1: Overview sketch of the site

- Total calculated area of impact 518.5m²
- Impact within SPDC R.O.W 366.5m²
- Impact outside R.O.W 151.96
