THE SHELL PETROLEUM DEVELOPMENT COMPANY OF NIGERIA LIMITED

JOINT INVESTIGATION REPORT FOR INCIDENT NO: 0505

- 1. Spill incident Number: 862595      2. Type of incident \* OIL SPILL
- 3. Name of Location 10 INCH KOKORI DELIVERY LINE
- 4. Name of nearest community AWIRHE      5. State: DELTA      6. LGA UGHELLI NORTH
- 7. Type of Production facility/Installation DELIVERY LINE      8. Asset owner/ District PIPELINE

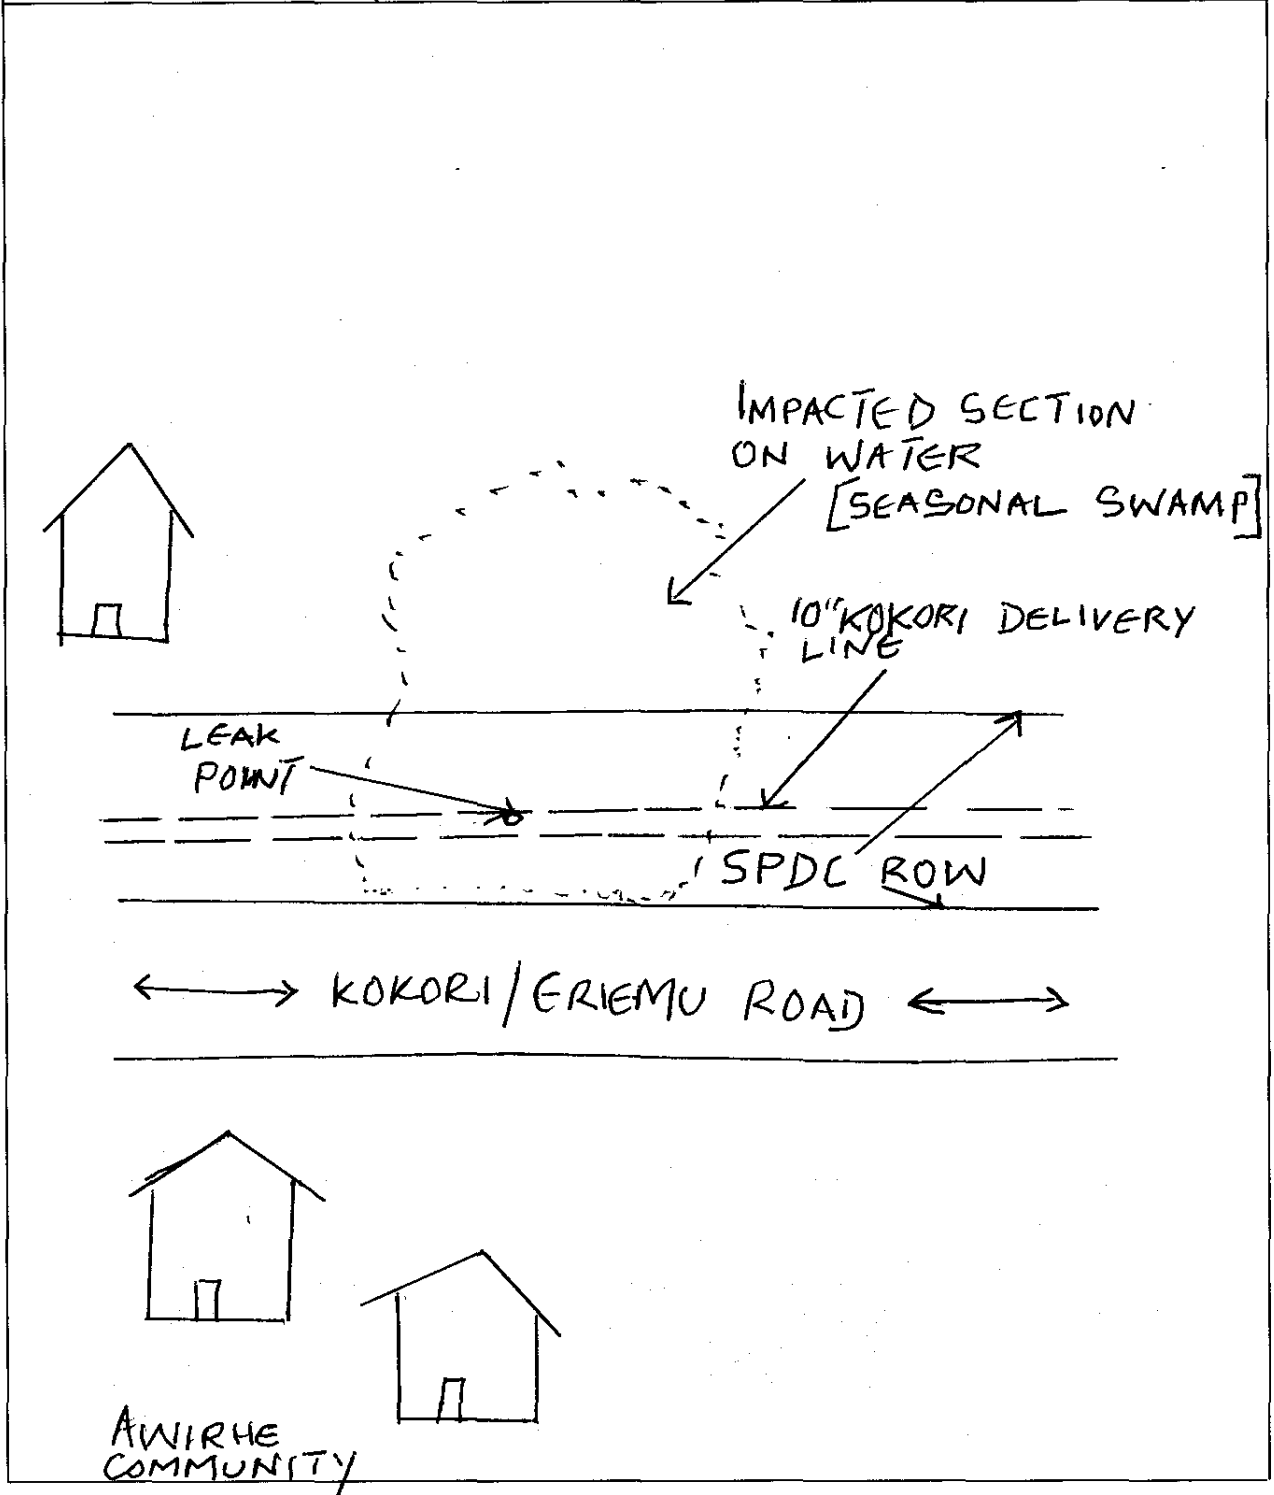
27. Appendix 1: Overview sketch of the site

Location: 10 INCH KOKORI DELIVERY LINE SPILL SITE
