THE SHELL PETROLEUM DEVELOPMENT COMPANY OF NIGERIA LIMITED

JOINT INVESTIGATION REPORT FOR INCIDENT NO: 0338 871766

1. Spill incident Number: 871766 2. Type of incident * OIL SPILL
 3. Name of Location NEMBE CREEK 1 WELL 19S WELL HEAD
 4. Name of nearest community MILE 2 5. State: BAYELSA 6. LGA NEMBE
 7. Type of Production facility/Installation OIL WELL HEAD 8. Asset owner/ District NEMBE DISTRICT (SWAMP 2)

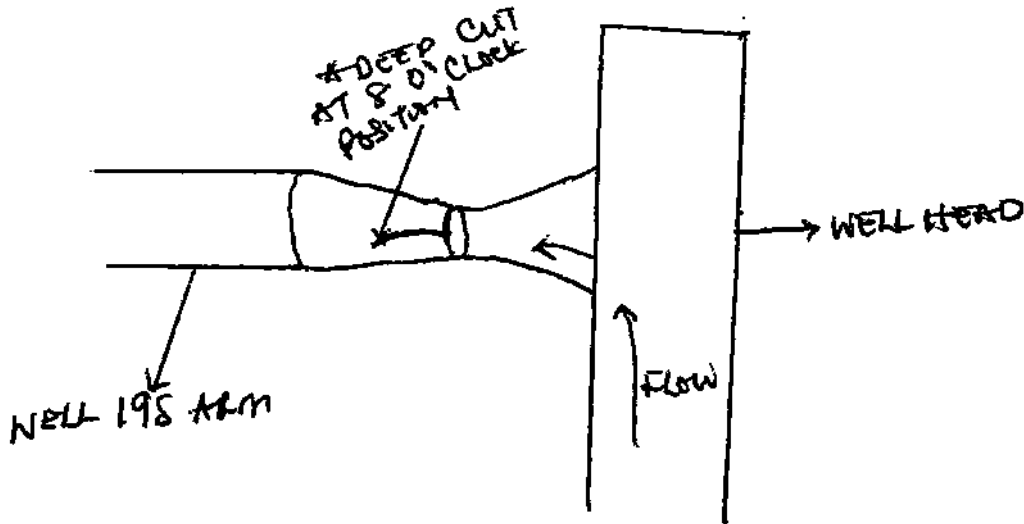
A SECTION OF WELL 19S ARM SHOWING A DEEP CUT AT 8 O'CLOCK POSITION

- a. Date of incident: 26th SEPTEMBER 2012
 b. Start date/time of investigation: 28th SEPTEMBER 2012
 c. Investigation End date: 29th SEPTEMBER 2012
 d. Description of spill point environment
 Firmed soil Loose soil Previously excavated area
 Under water Swampy Exposed pipe surface
 Well Platform (on Water) Rig
 e. Description of leak point (tick as applicable);
 Drilled hole Hack saw cut Explosive tear,
 Complete Rupture Inward dent, Well head tampering
 Failed Weld-on illegal hot tap valve, Missing Pipeline/Flowline)
 Crude oil theft (illegal) bunkering) point, Third party tampering with Clamp
 Third party tampering with valve setting, Third party tampering with flange,
 Corrosion Saver-pit over flow, Surge vessel overflow
 Outward dent Flare System/Bund wall failure
 Valve Failure com unit failure Cold vent
 Relief valve failure Others (specify) DEEP CUT

- f. Incident caused by:
 Third party interference Operational Mystery _____
