THE SHELL PETROLEUM DEVELOPMENT COMPANY OF NIGERIA LIMITED.

JOINT INVESTIGATION REPORT FOR INCIDENT NO: 965295 JIV report S/N: **0006**

1. Spill incident Number: 965295 2. Type of incident* OIL SPILL
 3. Name of Location 24" NKPOKY - BOMU TRANS NIGER PIPELINE
 4. Name of nearest community ELELENWO 5. State: RIVERS 6. LGA OBIOKPOR
 7. Type of Production facility/Installation CL PIPELINE 8. Asset owner/District PIPELINE / PHL LAND

SECTIONAL SKETCH OF LEAK POINT ON 24" NKPOKU - BOMU TRANS NIGER

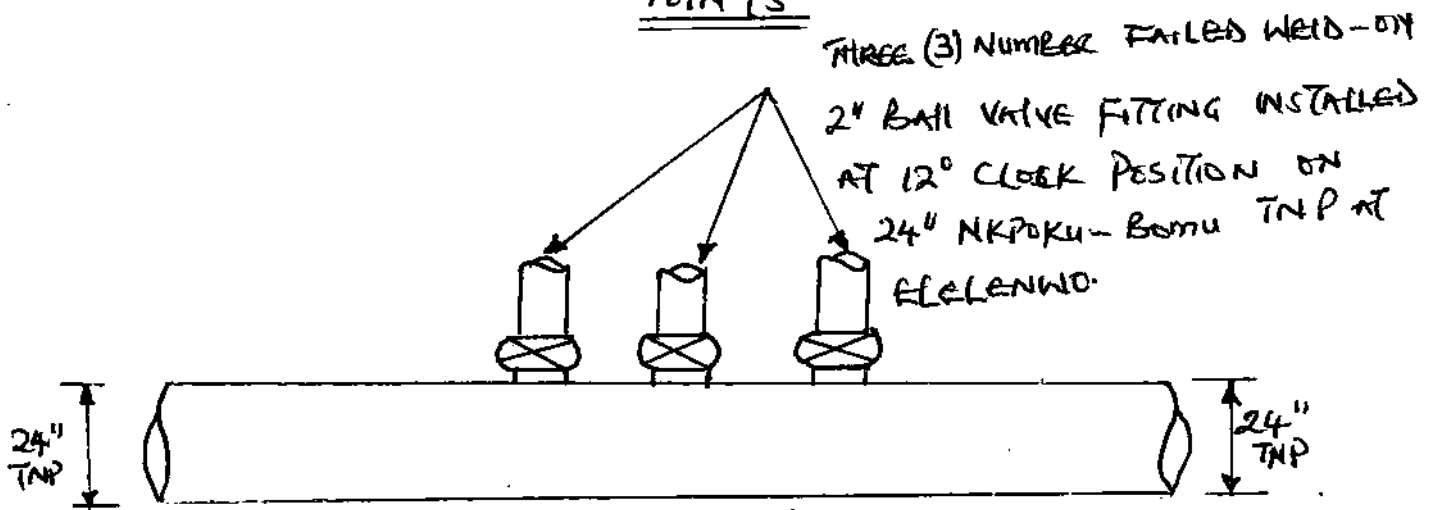
| <input checked="" type="checkbox"/> Failed Weld-on illegal hot tap valve, | <input type="checkbox"/> Failed Clamp | <input type="checkbox"/> Missing Pipeline/Flowline |
| <input checked="" type="checkbox"/> Crude oil theft (illegal bunkering) point, | | <input type="checkbox"/> Third party tampering with Clamp |

PIPELINE AT ELELENWO SHOWING THREE (3) BUNKERING POINTS
