THE SHELL PETROLEUM DEVELOPMENT COMPANY OF NIGERIA LIMITED.

JOINT INVESTIGATION REPORT FOR INCIDENT NO: 967604 JIV report S/N: 0055

1. Spill incident Number: 967604 2. Type of incident* OIL SPILL
 3. Name of Location ADIBAWA WELL 2S FLOWLINE
 4. Name of nearest community EDAGBERI 5. State: RIVERS 6. LGA AHOADA WEST
 7. Type of Production facility/Installation OIL FLOWLINE 8. Asset owner/District LAND 2

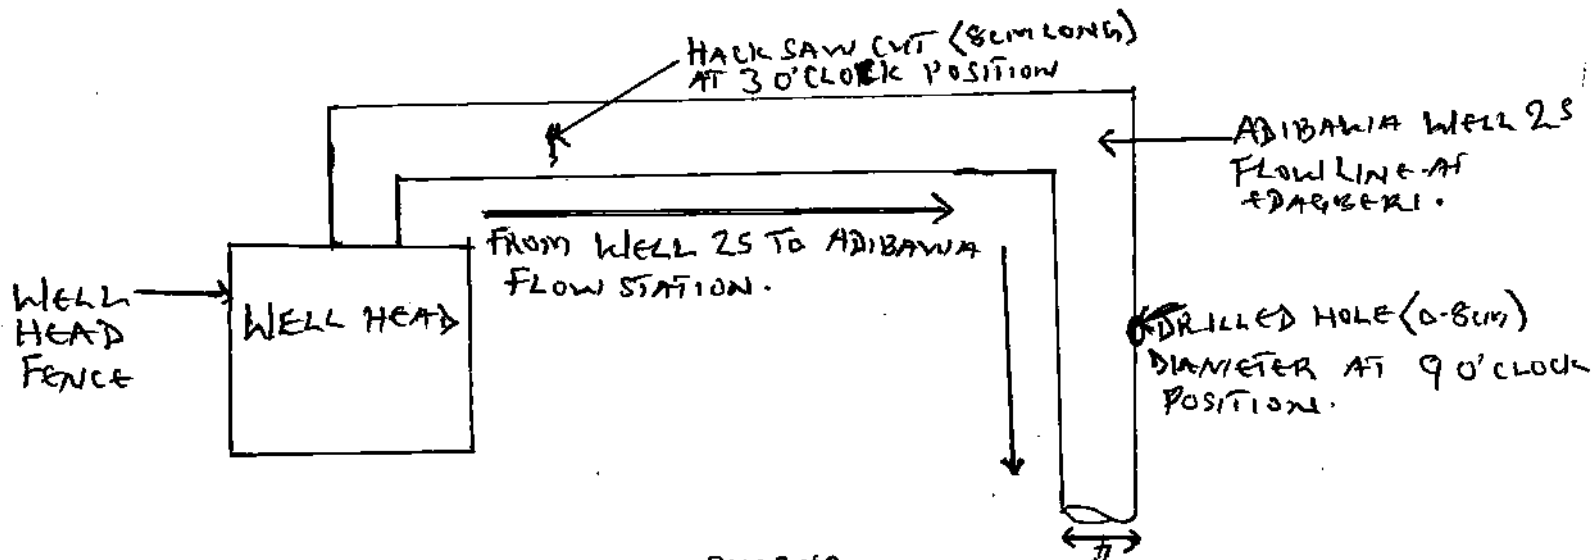
E. GRAPHIC DESCRIPTION OF LEAK POINT (while detail report of the leak point should be contained in the leak report, overview sketch of the site should be added as an appendix 1)

| <input checked="" type="checkbox"/> Drilled hole | <input checked="" type="checkbox"/> Hack saw cut | <input type="checkbox"/> Tear (_____), |

- Third party interference (Sabotage ; crude theft ; Line theft ; Accidental 3rd party damage
 Operational Others (including Mystery spills) _____

SECTION OF ADIBAWA WELLS FLOWLINE AT EDABERI SHOWING POSITIONS OF HACK SAW CUT AND DRILLED HOLE AT 3 AND 9 O' CLOCK POSITIONS RESPECTIVELY.

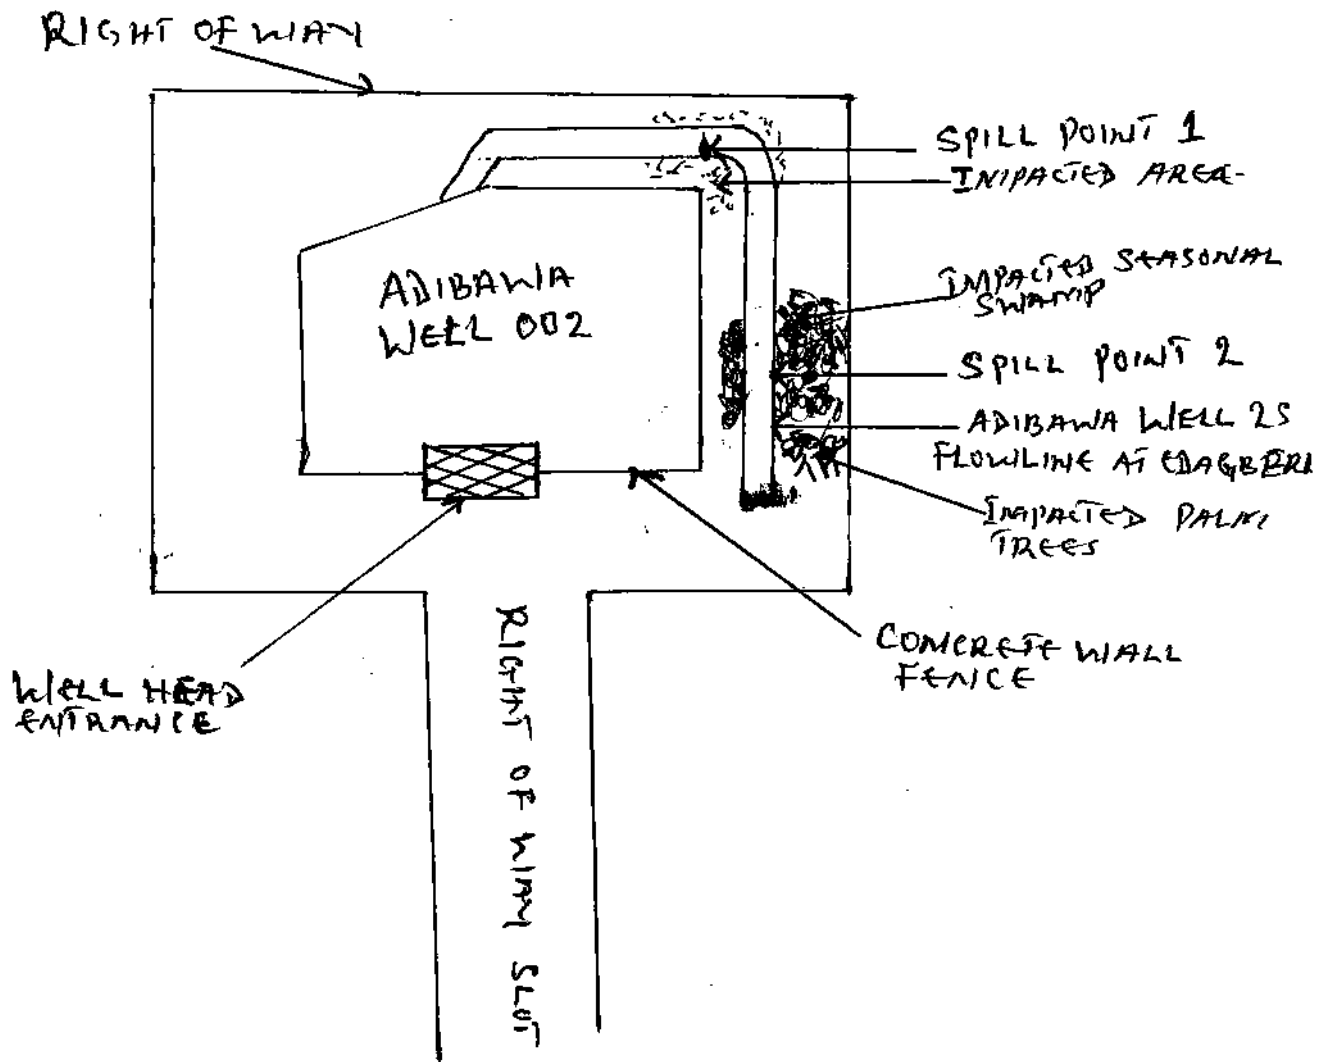
28. Appendix 1: Overview sketch of the site

Location: ADIBAWA WELL 2S FLOWLINE AT EDAGBERI
