THE SHELL PETROLEUM DEVELOPMENT COMPANY OF NIGERIA LIMITED.

JOINT INVESTIGATION REPORT FOR INCIDENT NO: 953753 JIV report S/N: 0030

1. Spill incident Number: 953753 2. Type of incident* OIL SPILL
 3. Name of Location IMO RIVER 4" WELL 64 L FLOWLINE
 4. Name of nearest community IGIKUKU 5. State: ABIA 6. LGA UKWA WEST
 7. Type of Production facility/Installation OIL FLOWLINE 8. Asset owner/District LADD 1

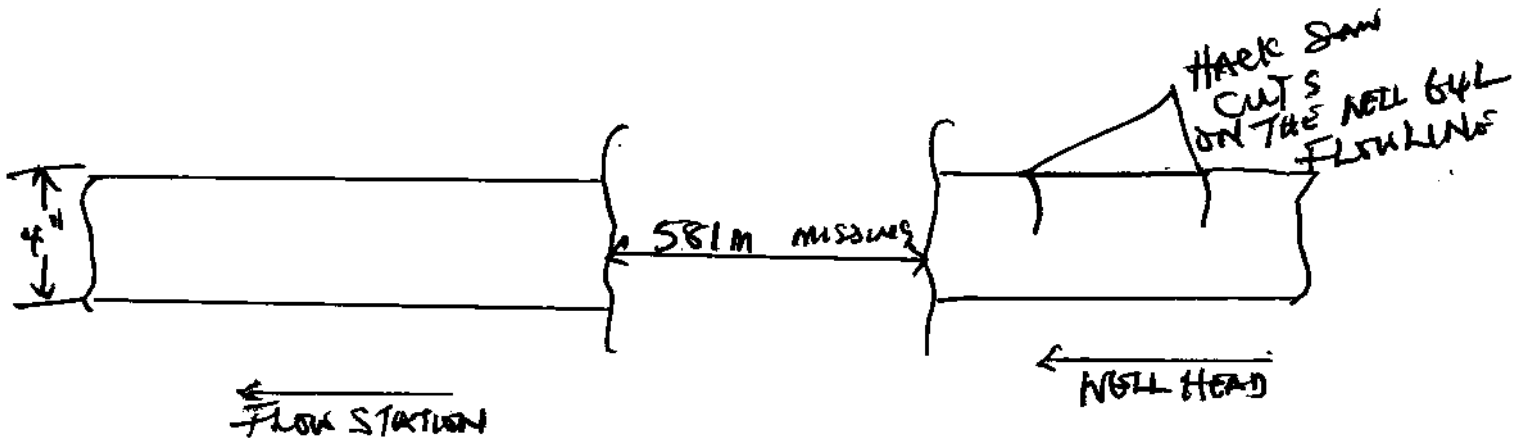
A SECTION OF 4" IWD RIVER WELL B4L FLOWLINE SHOWING HACK SAW CUT AND MISSING FLOWLINE AT 191210000.

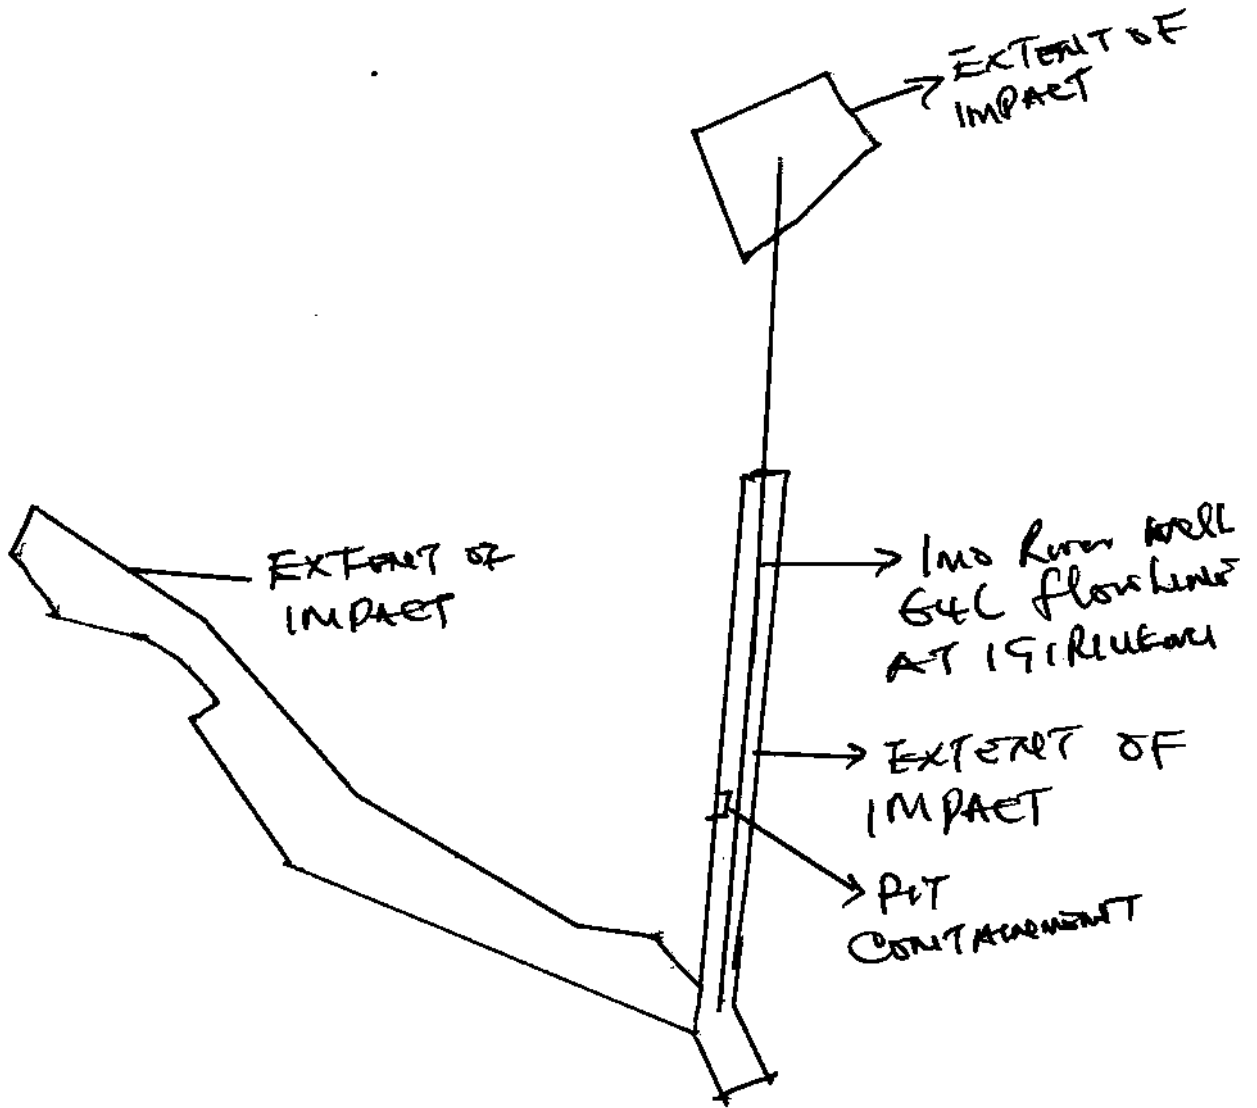
28. Appendix 1: Overview sketch of the site

Location: IMO RIVER 4" WELL 64L FLOWLINE AT ISIRIUBAY
