THE SHELL PETROLEUM DEVELOPMENT COMPANY OF NIGERIA LIMITED.

JOINT INVESTIGATION REPORT FOR INCIDENT NO: 956377 JIV report S/N: 02 &

1. Spill incident Number: 956377 2. Type of incident* OIL SPILL
 3. Name of Location 20 INCH OPUKUSHI - BRASS CREEK TRUNKLINE AT TAMOGBENE
 4. Name of nearest community TAMOGBENE 5. State: BAYELSA 6. LGA EKEREMOR
 7. Type of Production facility/Installation TRUNKLINE 8. Asset owner/District PIPELINE WEST

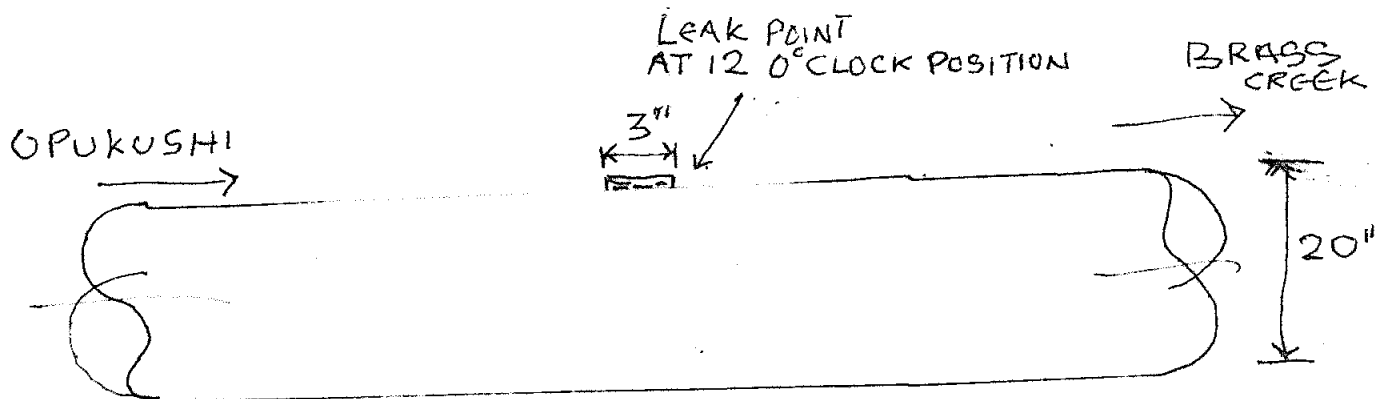
E. GRAPHIC DESCRIPTION OF LEAK POINT (while detail report of the leak point should be contained in the leak report, overview sketch of the site should be added as an appendix 1)

| <input checked="" type="checkbox"/> Drilled hole | <input type="checkbox"/> Hack saw cut | <input type="checkbox"/> Tear (_____). |
| <input checked="" type="checkbox"/> Crude oil theft (illegal bunkering) point, | | <input type="checkbox"/> Third party tampering with Clamp |

- Third party interference (Sabotage ; crude theft ; Line theft ; Accidental 3rd party damage
 Operational Others (including Mystery spills) _____

SECTION OF 20" OPUKUSHI - BRASS CREEK TRUNKLINE SHOWING A 3" DRILLED HOLE AT 12 O'CLOCK POSITION
