THE SHELL PETROLEUM DEVELOPMENT COMPANY OF NIGERIA LIMITED.

JOINT INVESTIGATION REPORT FOR INCIDENT NO: 957706 JIV report S/N: 0052

1. Spill incident Number: 957706 2. Type of incident* OIL SPILL
 3. Name of Location ADIBAWA WELL 8S FLOWLINE
 4. Name of nearest community EDAGBERI 5. State: RIVERS 6. LGA AHOADA WEST
 7. Type of Production facility/Installation OIL FLOWLINE 8. Asset owner/District LAND 2.

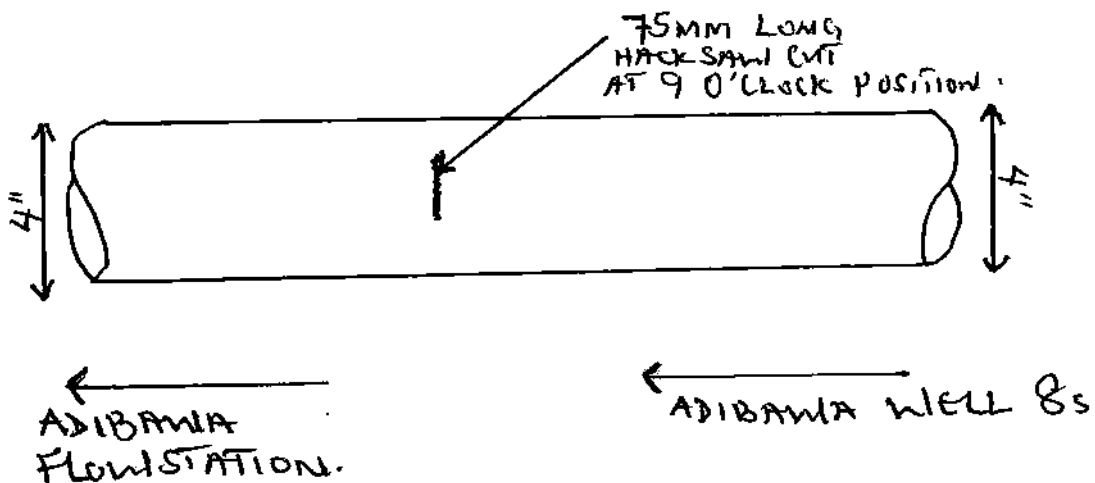
| <input type="checkbox"/> Drilled hole | <input checked="" type="checkbox"/> Hack saw cut | <input type="checkbox"/> Tear (_____). |

f. Incident caused by:

- Third party interference (Sabotage, crude theft; Line theft; Accidental 3rd party damage)
 Operational Others (including Mystery spills) _____

SECTION OF ADIBAWIA WELL BS FLOWLINE AT EDAGBERI
SHOWING POSITION OF HACKSAW CUT AT 9 O'CLOCK POSITION.
