THE SHELL PETROLEUM DEVELOPMENT COMPANY OF NIGERIA LIMITED.

JOINT INVESTIGATION REPORT FOR INCIDENT NO: 958807 JIV report S/N: 0039

1. Spill incident Number: 958807 2. Type of incident* OIL SPILL
 3. Name of Location 4th ADIBAWA WELL & S FLOWLINE
 4. Name of nearest community EDAGBERI 5. State: RIVERS 6. LGA AKHADA WEST
 7. Type of Production facility/Installation OIL FLOWLINE 8. Asset owner/District LAND 2

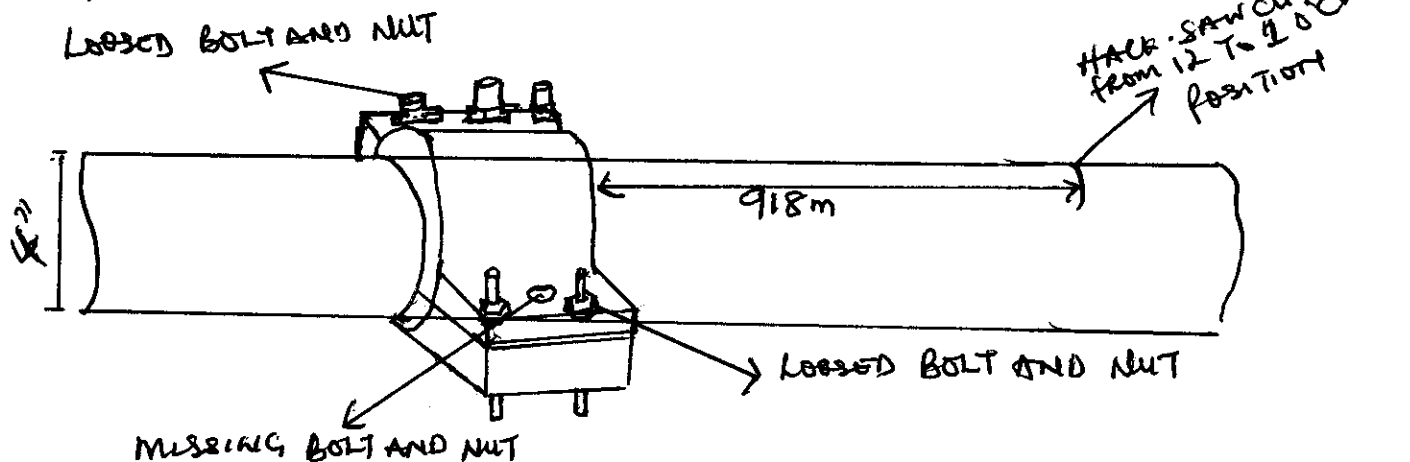
e. Description of leak point (tick as applicable);
 Drilled hole Hack saw cut Tear (_____),
 Complete Rupture Inward dent, Well head tampering
 Failed Weld-on illegal hot tap valve, Failed Clamp Missing Pipeline/Flowline
 Crude oil theft (illegal bunkering) point, Third party tampering with Clamp
 Third party tampering with valve setting, Third party tampering with flange,
 Corrosion Saver-pit over flow, Surge vessel overflow,
 Bulging Outward Flare System/Bund wall failure Accidental 3rd party equipment
 impact Valve Failure com unit failure Cold vent
 Relief valve failure Others (specify) _____

f. Incident caused by:
 Third party interference (Sabotage, crude theft; Line theft; Accidental 3rd party damage)
 Operational Others (including Mystery spills) _____

A SECTION OF 4" ADIBAWA WELL B'S FLOWLINE AT EDACIBERI SHOWING CLAMP TAMPERING AND HACK SAW CUT

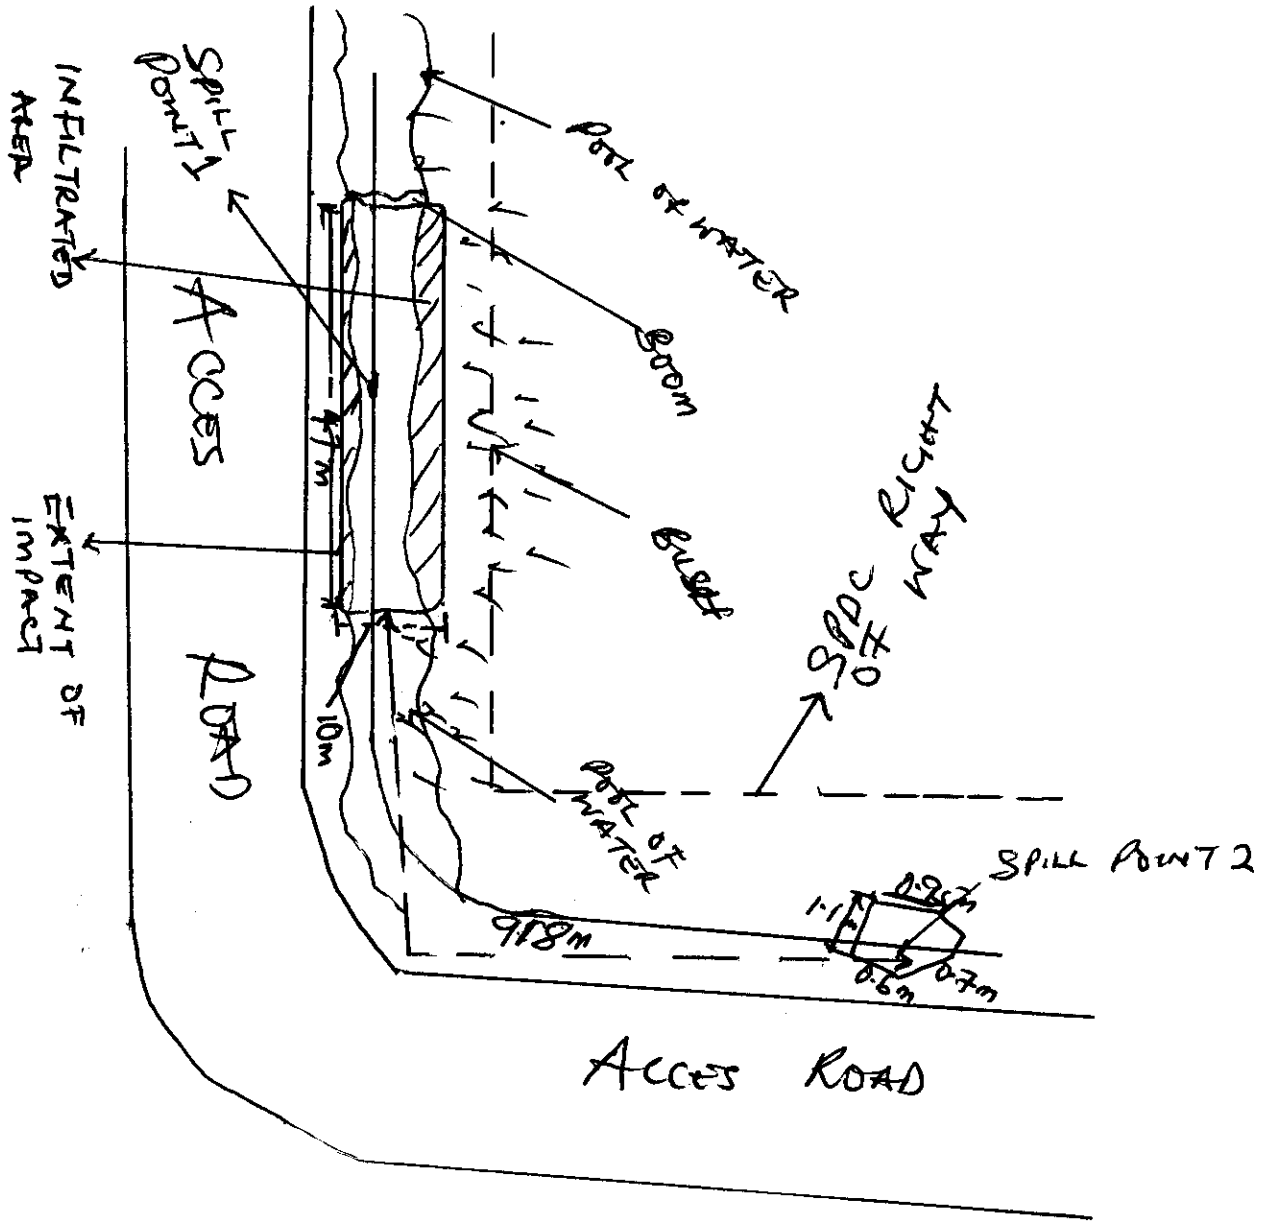
28. Appendix 1: Overview sketch of the site

Location: 4" ADIBANA WELL 8 S FLOW LINE AT EDACIBERI
