THE SHELL PETROLEUM DEVELOPMENT COMPANY OF NIGERIA LIMITED.

JOINT INVESTIGATION REPORT FOR INCIDENT NO: 970287 JIV report S/N: 0074

1. Spill incident Number: 970287 2. Type of incident* OIL SPILL
 3. Name of Location 6" ADIBAWA NORTH EAST BULK LINE
 4. Name of nearest community BISENI 5. State: BAYELSA 6. LGA TENEKORA
 7. Type of Production facility/Installation BULK LINE 8. Asset owner/District LANDR

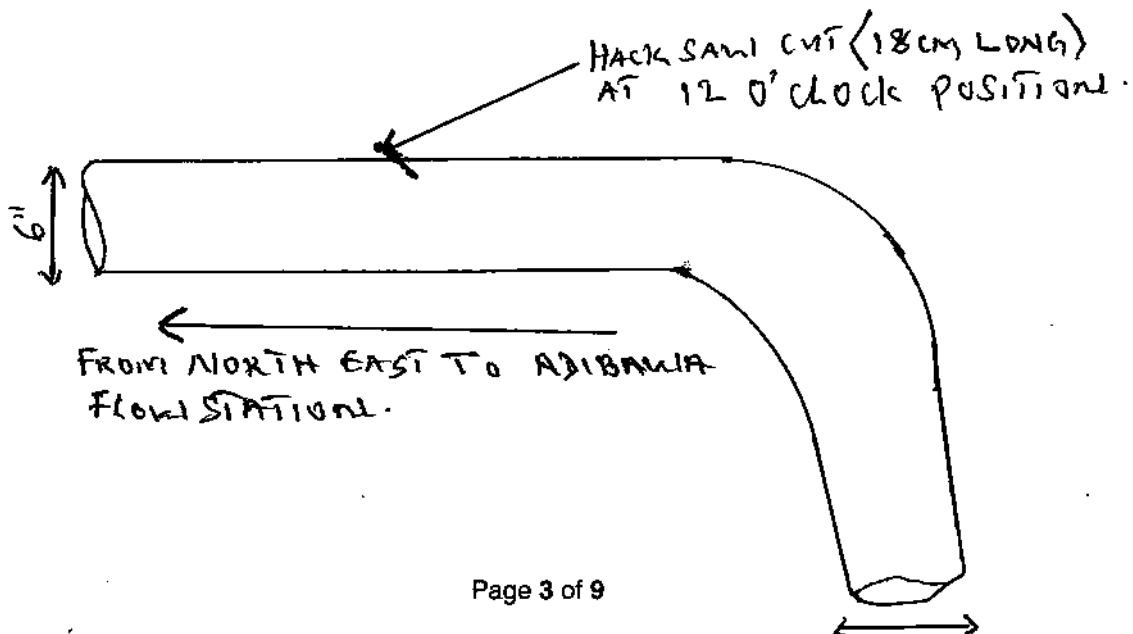
E. GRAPHIC DESCRIPTION OF LEAK POINT (while detail report of the leak point should be contained in the leak report, overview sketch of the site should be added as an appendix 1)

SECTION OF 6" ADIBAWIA NORTH EAST BULKLINE AT BISENI SHOWING POSITION OF HACK SAW CUT AT 12 O'CLOCK POSITION.
