THE SHELL PETROLEUM DEVELOPMENT COMPANY OF NIGERIA LIMITED.

JOINT INVESTIGATION REPORT FOR INCIDENT NO: 1024129 JIV report S/N: 0138

1. Spill incident Number: 1024129 2. Type of incident* OIL SPILL
 3. Name of Location CAWTHORNE CHANNEL 6" WELL 457 FLOWLINE
 4. Name of nearest community MBIAMA 5. State: RIVERS 6. LGA DEGENIA
 7. Type of Production facility/Installation FLOWLINE 8. Asset owner/District SWAMP 1/CANICH

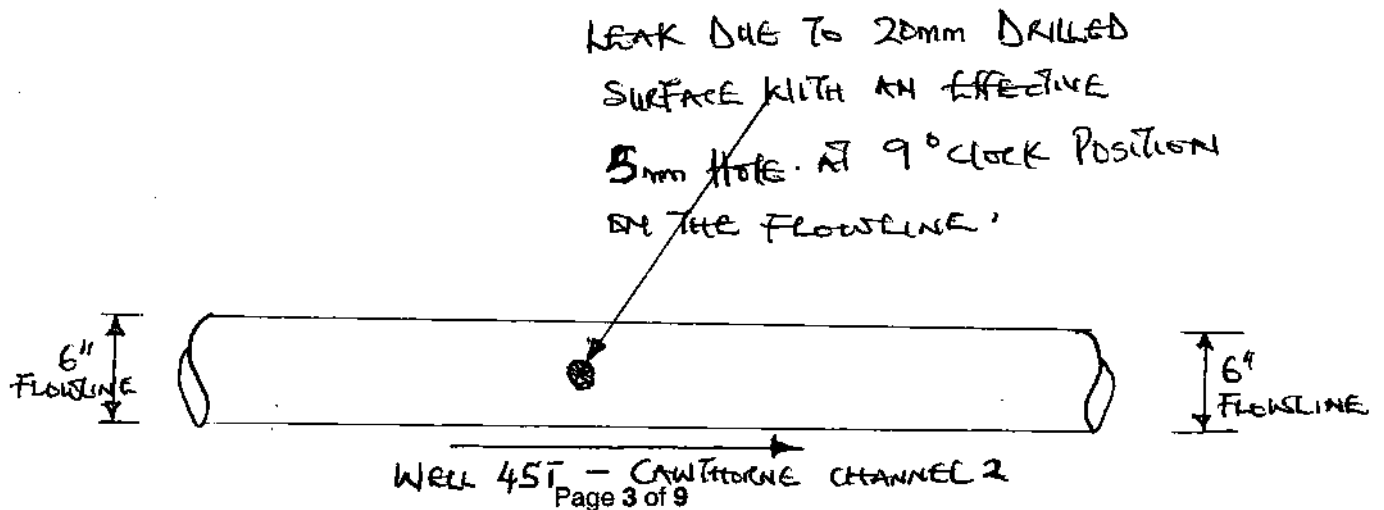
E. GRAPHIC DESCRIPTION OF LEAK POINT (while detail report of the leak point should be contained in the leak report, overview sketch of the site should be added as an appendix 1)

e. Description of leak point (tick as applicable);
 Drilled hole Hack saw cut Tear (_____),
 Complete Rupture Inward dent, Well head tampering
 Failed Weld-on illegal hot tap valve, Failed Clamp Missing Pipeline/Flowline
 Crude oil theft (illegal bunkering) point, Third party tampering with Clamp
 Third party tampering with valve setting, Third party tampering with flange,
 Corrosion Saver-pit over flow, Surge vessel overflow,
 Bulging Outward Flare System/Bund wall failure Accidental 3rd party equipment
 impact Valve Failure com unit failure Cold vent
 Relief valve failure Others (specify) _____

f. Incident caused by:
 Third party interference (Sabotage; crude theft; Line theft; Accidental 3rd party damage)
 Operational Others (including Mystery spills) _____

SECTIONAL VIEW OF CAWTHORNE CHANNEL 2 6" WELL 45T FLOWLINE
AT MBANNA, CAUSE SHOWING ILLEGAL DRILLED HOLE.

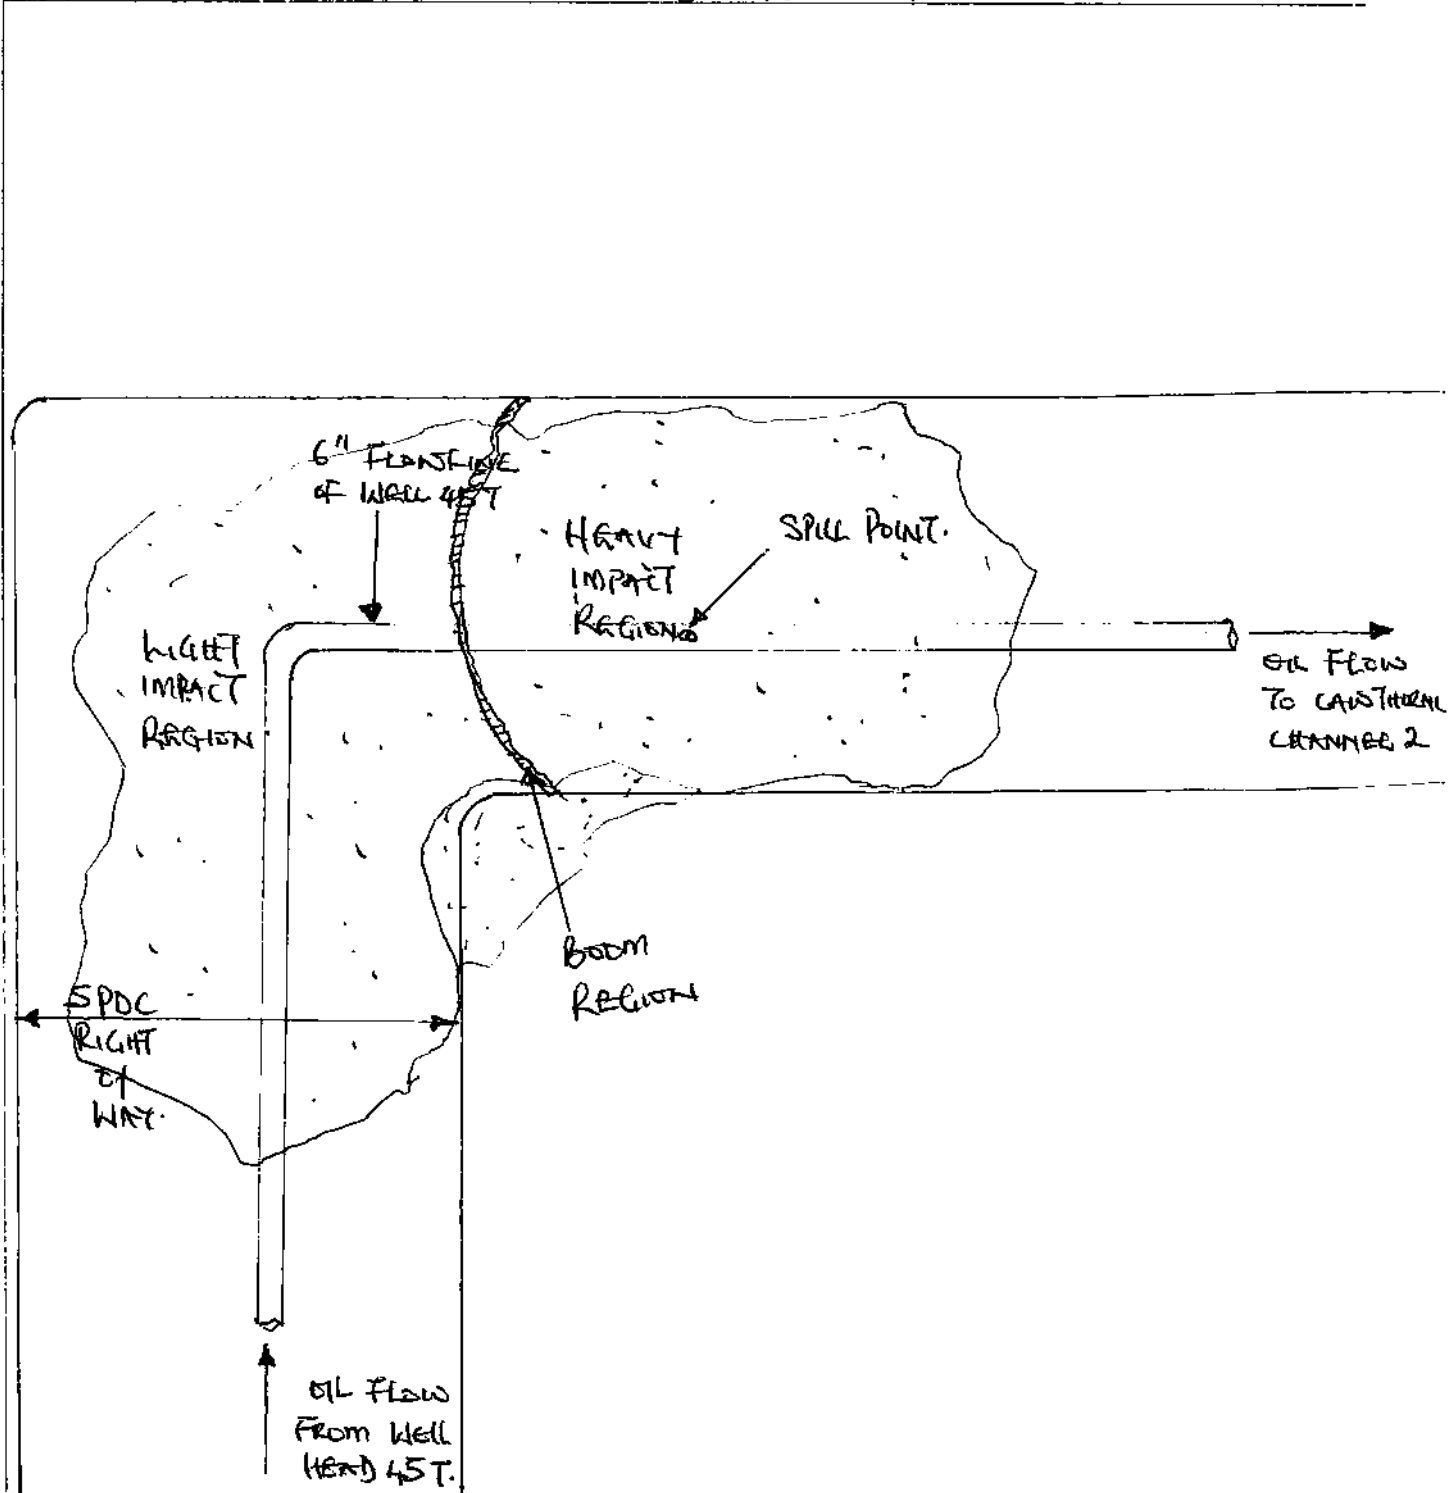
28. Appendix 1: Overview sketch of the site

Location: CANTHORNE CHANNEL 6" WELL 45T FLOWLINE AT MBAMA
