**THE SHELL PETROLEUM DEVELOPMENT COMPANY OF NIGERIA LIMITED.**

JOINT INVESTIGATION REPORT FOR INCIDENT NO: ~~1028642~~ <sup>1031366</sup> JIV report S/N: ~~0133~~ <sup>0133</sup>

1. Spill incident Number: ~~1028642~~ <sup>1031366</sup> 2. Type of incident\* OIL SPILL  
 3. Name of Location 6" OBIGBO NORTH RIVER - OGARE PIPELINE  
 4. Name of nearest community OGARE 5. State: RIVERS 6. LGA ELEME  
 7. Type of Production facility/Installation OIL PIPELINE 8. Asset owner/District PIPELINE

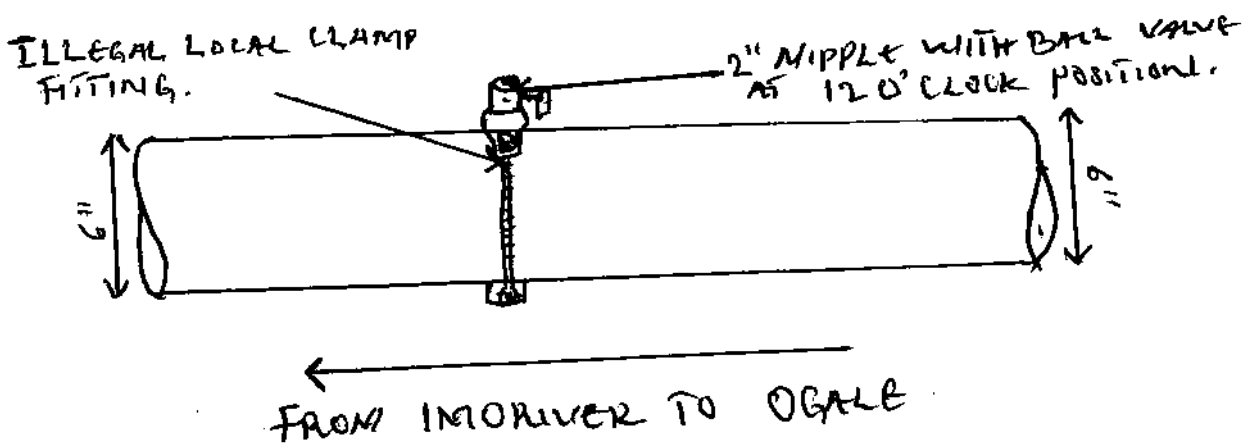
E. GRAPHIC DESCRIPTION OF LEAK POINT (while detail report of the leak point should be contained in the leak report, overview sketch of the site should be added as an appendix 1)

SECTION OF 6" ~~INTEGRATED~~ OGALE PIPELINE AT OGALE SHOWING CRUDE OIL THEFT POINT AT 12 O'CLOCK POSITION.
