THE SHELL PETROLEUM DEVELOPMENT COMPANY OF NIGERIA LIMITED.

JOINT INVESTIGATION REPORT FOR INCIDENT NO: 1022382 JIV report S/N: 0172

1. Spill incident Number: 1022382 2. Type of incident* OIL SPILL
 3. Name of Location 14" OKORDIA - RUKWUKEPE PIPELINE
 4. Name of nearest community AKARAMINI 5. State: RIVER 6. LGA AHOADA WEST
 7. Type of Production facility/Installation OIL PIPELINE 8. Asset owner/District PIPELINE

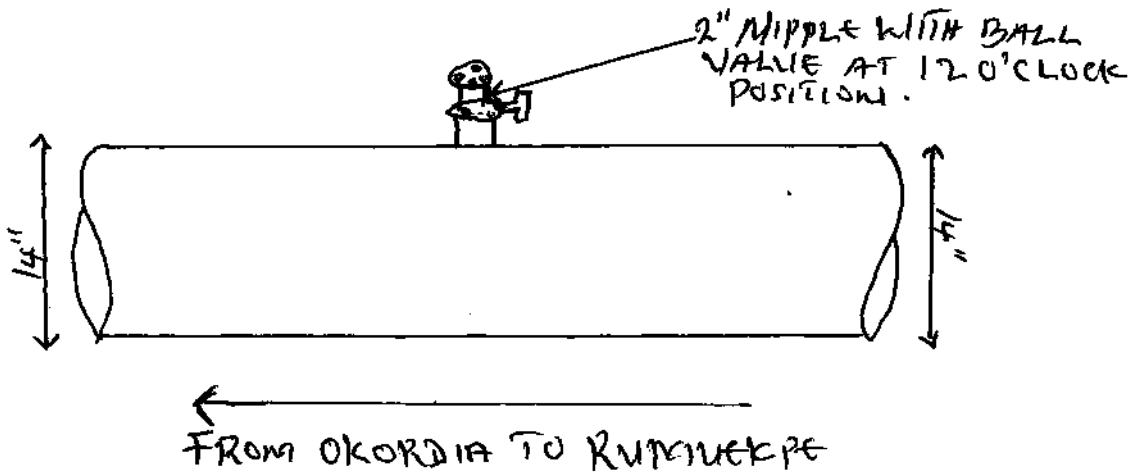
| <input checked="" type="checkbox"/> Failed Weld-on illegal hot tap valve, | <input type="checkbox"/> Failed Clamp | <input type="checkbox"/> Missing Pipeline/Flowline |

SECTION OF 14" OKORDIA - RUMUKPE PIPELINE AT AKARAMINI SHOWING POSITION OF CRUDE OIL THEFT POINT AT 12 O'CLOCK POSITION.
