THE SHELL PETROLEUM DEVELOPMENT COMPANY OF NIGERIA LIMITED.

JOINT INVESTIGATION REPORT FOR INCIDENT NO: 1089703 JIV report S/N: 0449

1. Spill incident Number: 1089703 2. Type of incident* OIL SPILL
 3. Name of Location 20" OTUMARA - ESCRAVOS PIPELINE
 4. Name of nearest community UGBODEGUNWU. State: DELTA 6. LGA WARRI SOUTH - WEST
 7. Type of Production facility/Installation OIL PIPELINE 8. Asset owner/District PIPELINE

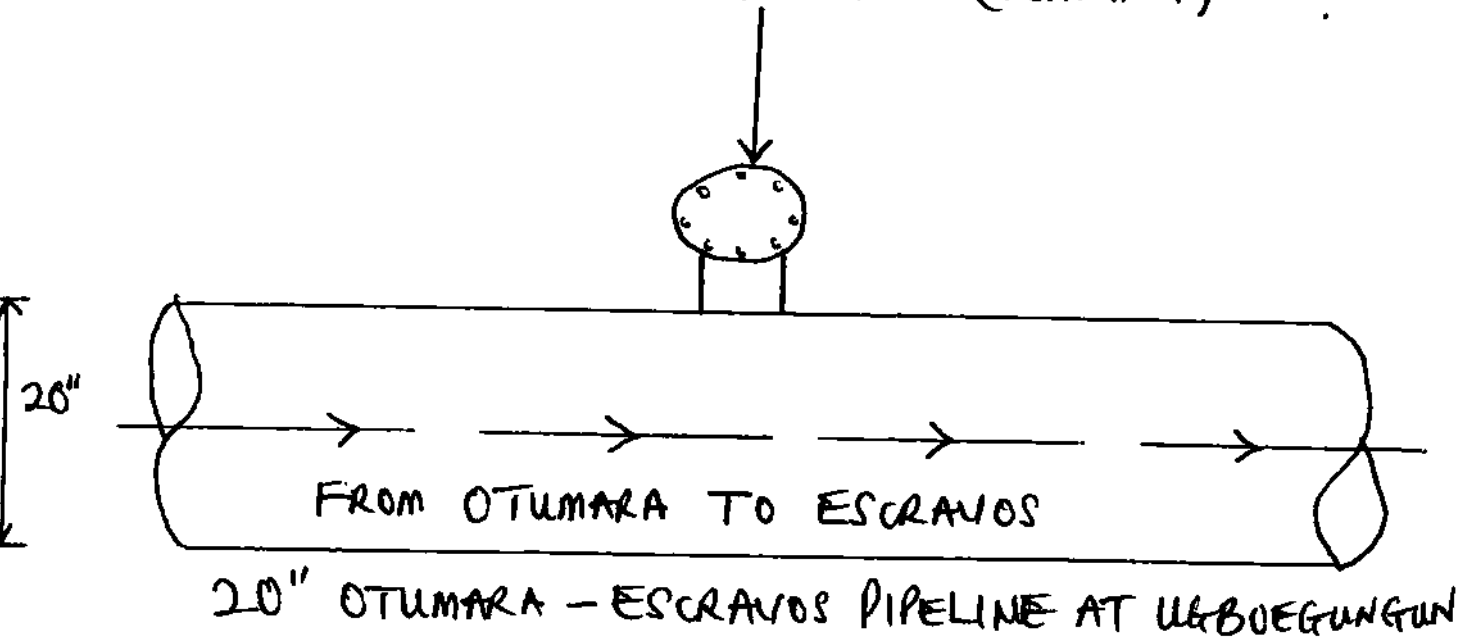
20" OTUMARA - ESCRAVOS PIPELINE AT URBUEGUNGUN

| <input checked="" type="checkbox"/> Failed Weld-on illegal hot tap valve, | <input type="checkbox"/> Failed Clamp | <input type="checkbox"/> Missing Pipeline/Flowline |
| <input checked="" type="checkbox"/> Crude oil theft (illegal bunkering) point, | | <input type="checkbox"/> Third party tampering with Clamp |

3" WELD-ON ILLEGAL HOT-TAP FLANGE
AT 12 O'CLOCK POSITION (LEAKING)

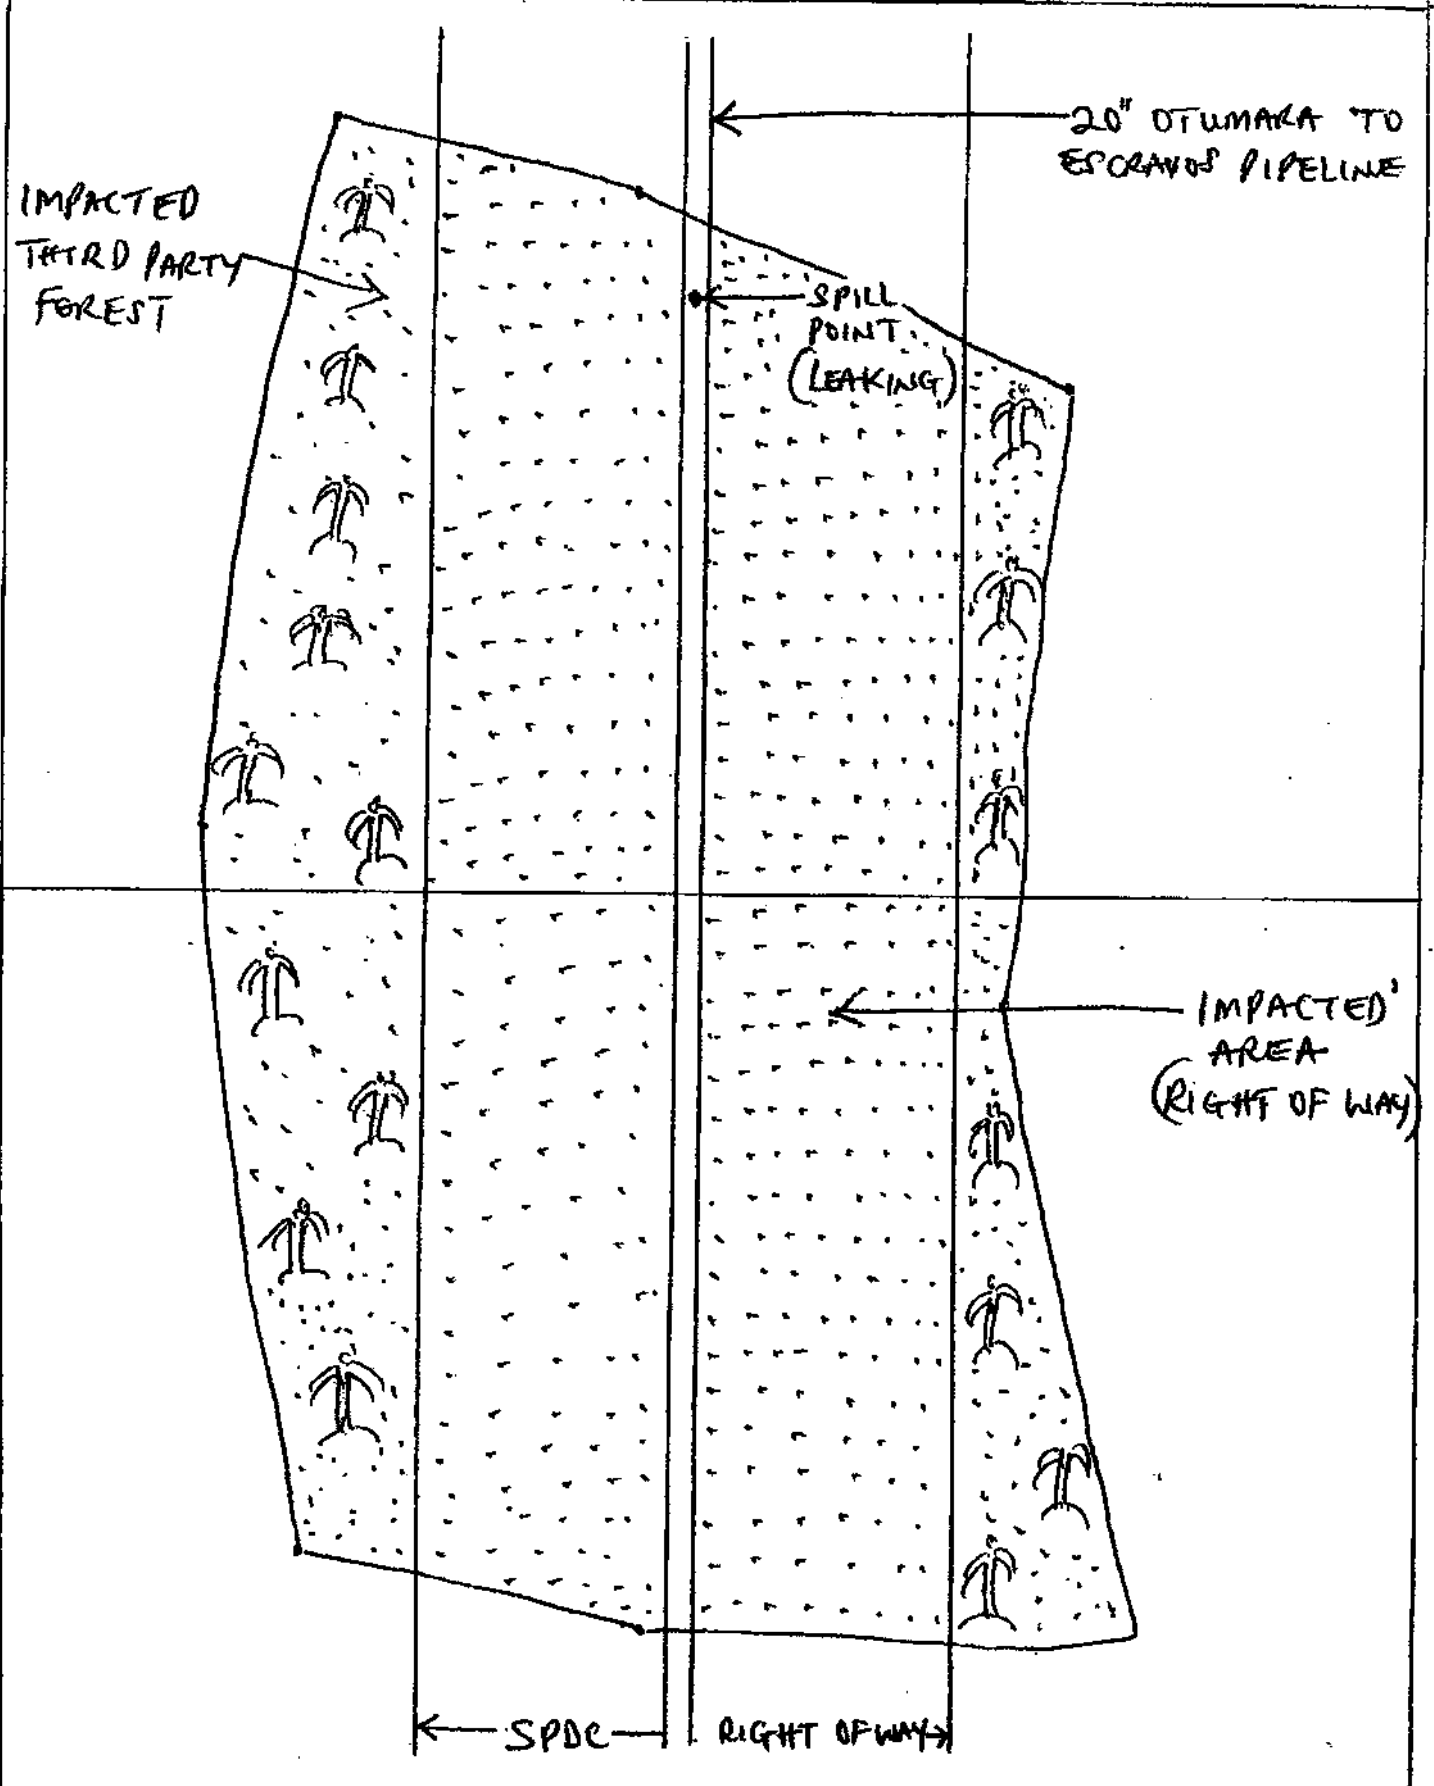
LOCATION: 20" OTUMARA - ESCRAVOS PIPELINE AT UGBOEGUNGTUN

28. Appendix 1: Overview sketch of the site
