THE SHELL PETROLEUM DEVELOPMENT COMPANY OF NIGERIA LIMITED.

JOINT INVESTIGATION REPORT FOR INCIDENT NO: 1093203 JIV report S/N: 0372

1. Spill incident Number: 1093203 2. Type of incident* OIL SPILL
 3. Name of Location 12" OGBIN - EGBEMA PIPELINE
 4. Name of nearest community OBIAKPU 5. State: IMO 6. LGA EGBEMA
 7. Type of Production facility/Installation OIL PIPELINE 8. Asset owner/District PIPELINE

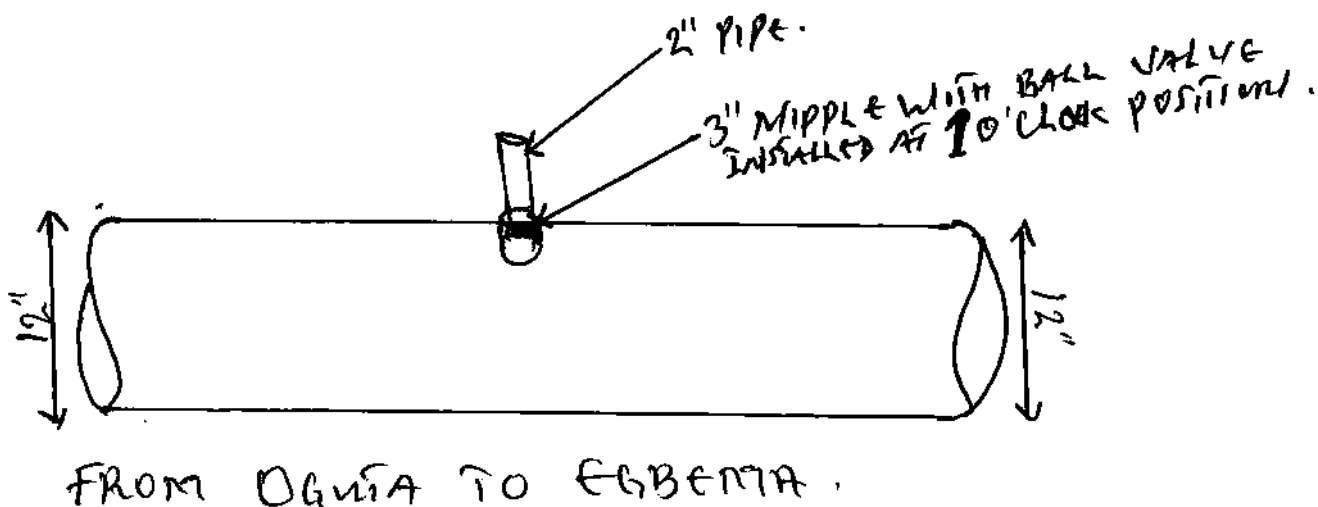
| <input checked="" type="checkbox"/> Failed Weld-on illegal hot tap valve, | <input type="checkbox"/> Failed Clamp | <input type="checkbox"/> Missing Pipeline/Flowline |
| <input checked="" type="checkbox"/> Crude oil theft (illegal bunkering) point, | | <input type="checkbox"/> Third party tampering with Clamp |

SECTION OF 12" OGUJA - EGBEMA PIPELINE AS DBIAKPU SHOWING POSITION OF CRUDE TAP POINT AT 1 O'CLOCK POSITION.

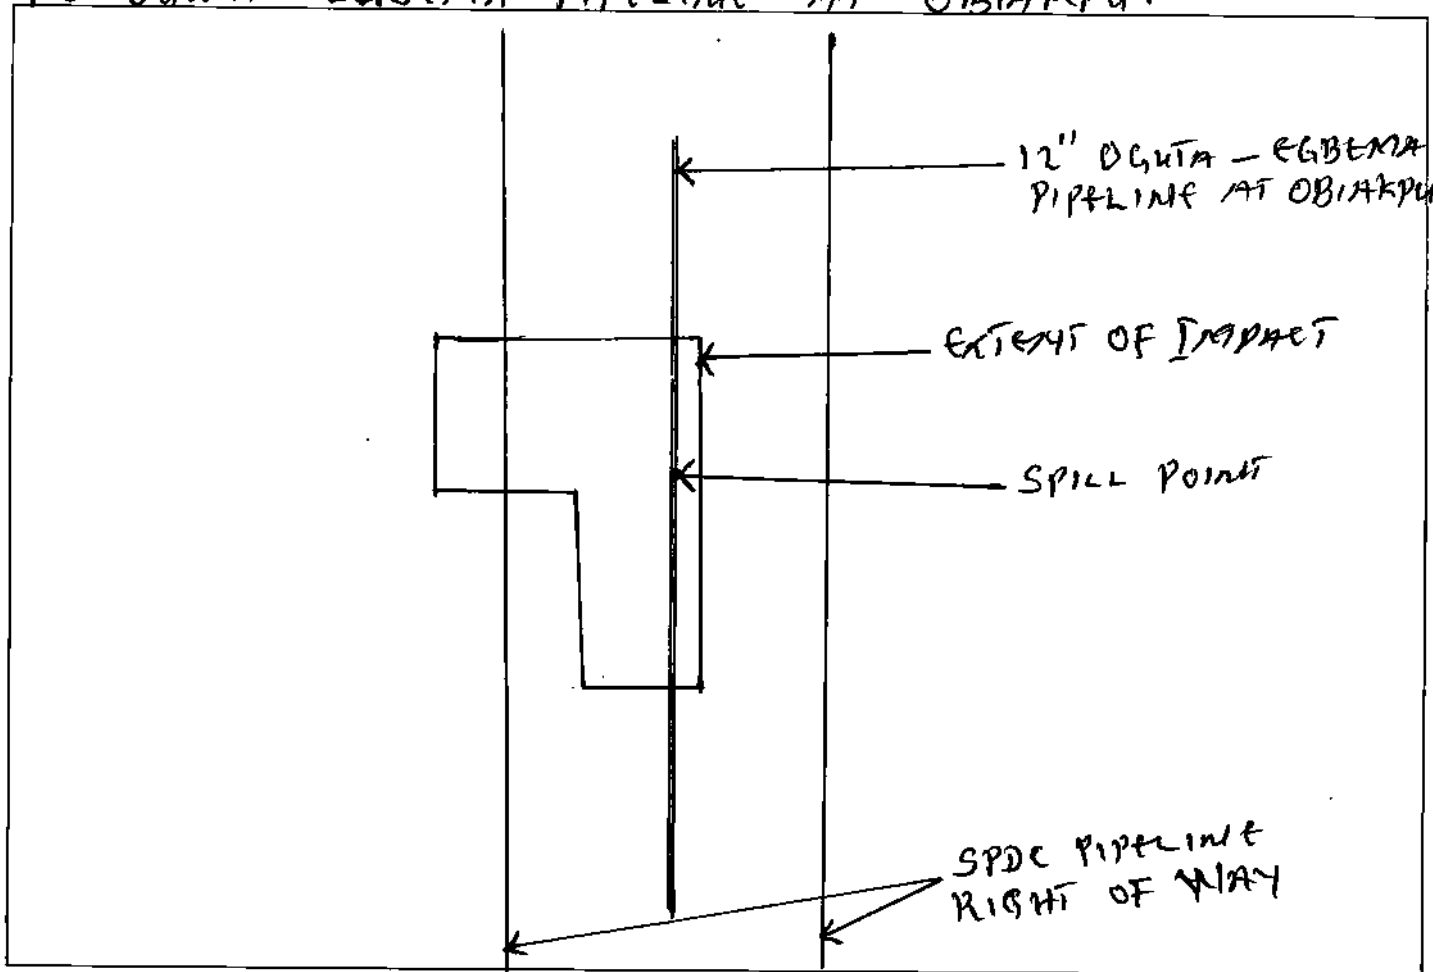
28. Appendix 1: Overview sketch of the site

Location: 12" Obvina - Egbema Pipeline at Obiakpu.

JOINT INVESTIGATION REPORT FOR INCIDENT NO: 1093203 JIV report S/N: 0372
12" OGUTA - EGBEMA PIPELINE AT OBIAKPU.
