JOINT INVESTIGATION REPORT FOR INCIDENT NO: 10 8 2130 JIV report S/N:

(Note: As practicable as possible the JIT report is to be signed in the field by all the participating parties) A. GENERAL INFORMATION: 1. Spill incident Number: 1082130 2. Type of incident\* 011 OBIGBO NORTH PIPELINE 4. Name of nearest community OBOLO 5. State: RIVERS 6. LGA FLEME 7. Type of Production facility/Installation DIL PIPELINE. Asset owner/District PIPELINE **B. INCIDENT INFORMATION:** 9. Details of incident a. Date of incident: b. Start date/time of investigation: c. Investigation End date: 6TH DECEMBER Actual investigation duration, days: THREE(3) DAYS d. Description of spill point environment Firmed soil Loose soil Recently excavated area Under water □ Swampy Exposed pipe surface Well Platform (on Water) Drill Rig e. Description of leak point (tick as applicable); □Drilled hole Hack saw cut Tear ( Complete Rupture ☐Inward dent. ☐Well head tampering Failed Weld-on illegal hot tap valve, Failed Clamp ☐Missing Pipeline/Flowline Crude oil theft (illegal bunkering) point, Third party tampering with Clamp Third party tampering with valve setting, Third party tampering with flange. Corrosion ☐Saver-pit ov

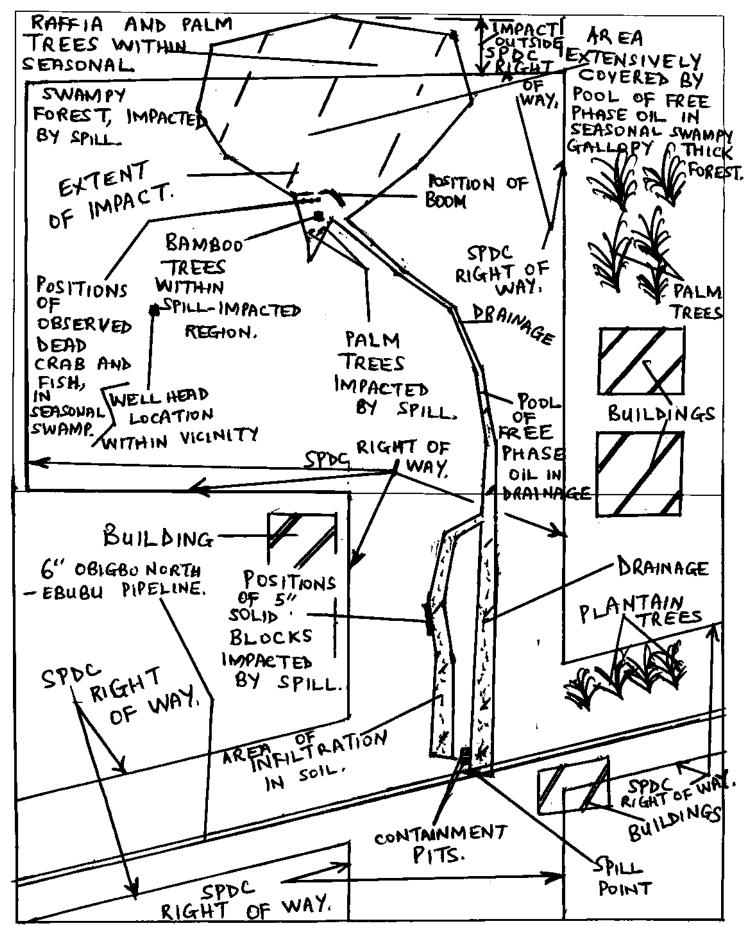
#### 28. Appendix 1: Overview sketch of the site

E. GRAPHIC DESCRIPTION OF LEAK POINT (while detail report of the leak point should be contained in the leak report, overview sketch of the site should be added as an appendix 1) OBSERVED 4" FLOWLINES ABOVE LEAKING PIPELINE. OBIGBO NORTH - EBUBU AT OBOLD SHOWING POSITION OF CORROSION 25MM DIAMETER PL PITTINGS POLYKENE COATING AROUND SPILL POINT 8 0' CLOCK OBSERVED TO BE INTACT. F: TABLE SHOWING SOME OF COORDINATES TAKEN CALCULATION OBIGBO NORTH TO
