JOINT INVESTIGATION REPORT FOR INCIDENT NO: 1085924 JIV report S/N: 0366

1. Spill incident Number: 1085924 2. Type of incident\* 011 SP111

OBIGBO NORTH - OGALE PIPELINE 4. Name of nearest community UMUSOYA 5. State: RIVERS 6. LGA OYIGBO 7. Type of Production facility/Installation OIL PIPELINE. Asset owner/District PIPELINE B. INCIDENT INFORMATION: 9. Details of incident a. Date of incident: b. Start date/time of investigation: b. Start date/time of investigation: ITH DECEMBER, 201 c. Investigation End date: ITH DECEMBERActual investigation duration, days: d. Description of spill point environment 2013 ☐Firmed soil Recently excavated area Loose soil ☐Under water □Swampy DExposed pipe surface Well Platform (on Water) □Drill Rig e. Description of leak point (tick as applicable); Drilled hole ☐Hack saw cut ☐ Tear ( Complete Rupture ☐Inward dent. ☐Well head tampering Failed Weld-on illegal hot tap valve, Failed Clamp ☐Missing Pipeline/Flowline Crude oil theft (illegal bunkering) point, ☐ Third party tampering with Clamp Third party tampering with valve setting, ☐ Third party tampering with flange, . Corrosion ☐Saver-pit over flow, ☐Surge vessel overflow. ☐Bulging Outward □Flare System

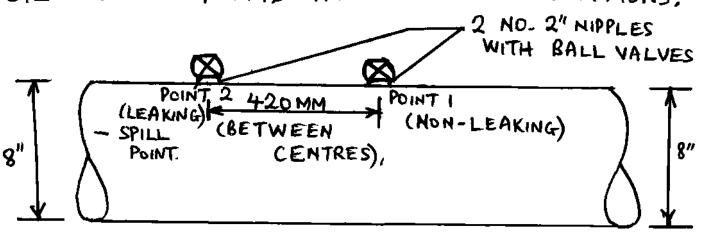
SECTION OF 8" OBIGBO NORTH - OGALE PIPELINE AT UMUSOYA SHOWING 2 NO. CRUDE OIL THEFT POINTS AT 120' CLOCK POSITIONS,

FROM OBIGBO NORTH - OGALE.

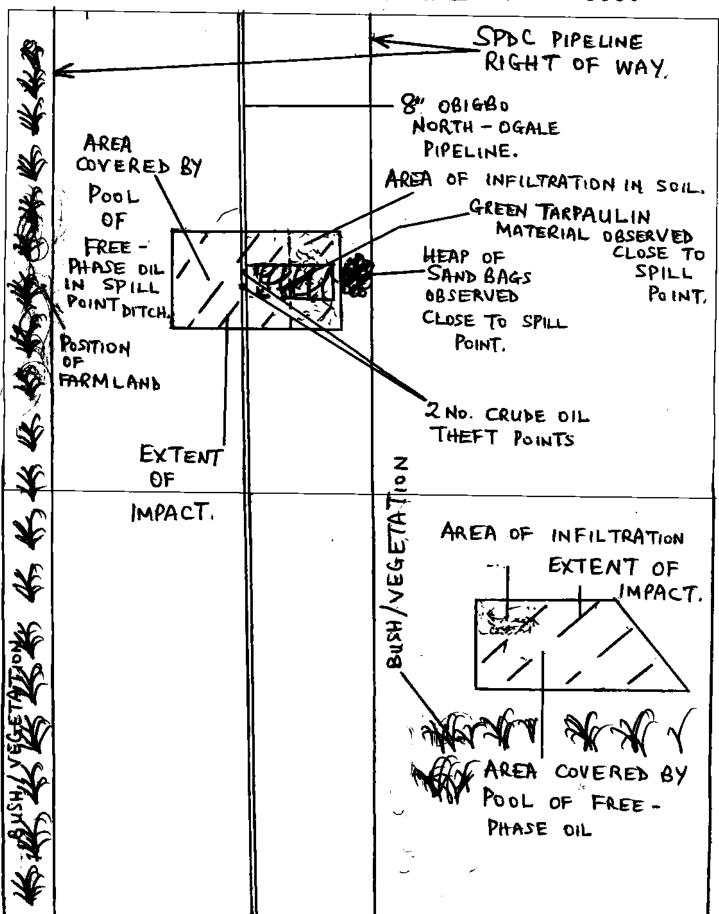
#### 28. Appendix 1: Overview sketch of the site

Location : 8	OBIGBO	NORTH-	OGALE	PIPELINE	AT	AYO2 HMU	
			·		•	•	
				•			
			_	,	-
