**THE SHELL PETROLEUM DEVELOPMENT COMPANY OF NIGERIA LIMITED.**

JOINT INVESTIGATION REPORT FOR INCIDENT NO: 929469 JIV report S/N 0017

1. Spill incident Number: 929469 2. Type of incident\* OIL SPILL  
 3. Name of Location OBIGBO WELL 9L FLOWLINE.  
 4. Name of nearest community UMUBVILLU 5. State: RIVERS 6. LGA ETCHI  
 7. Type of Production facility/Installation OIL FLOWLINE 8. Asset owner/District PH2 / LAND 1

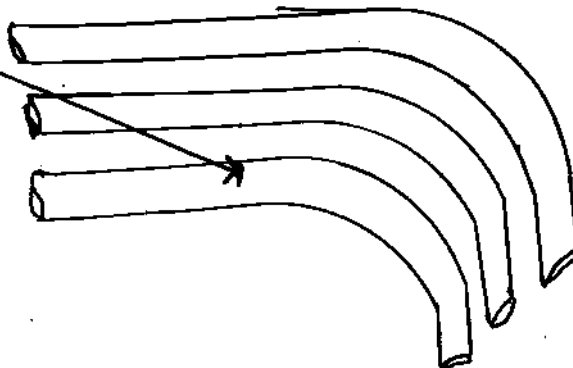
| <input type="checkbox"/> Drilled hole | <input checked="" type="checkbox"/> Hack saw cut | <input type="checkbox"/> Tear (_____). |

SECTIONAL VIEW OF OBIGBO WELL 9L FLOWLINE AT UMUEBUU SHOWING HACKSAW CUT AT 2 O'CLOCK POSITION.

HACKSAW CUT  
AT 2 O'CLOCK  
POSITION

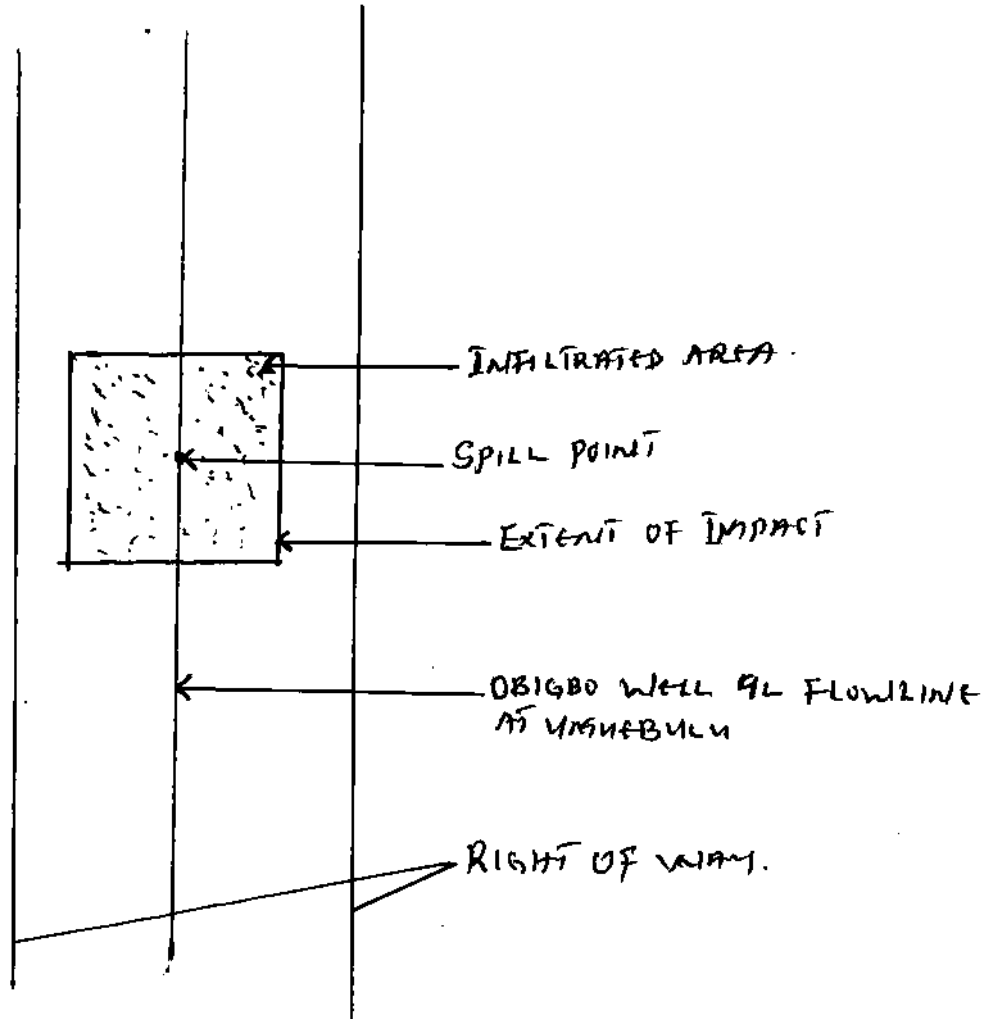
28. Appendix 1: Overview sketch of the site

Location: OBIGBO Well 9L FLOWLINE AT UMBUBULU
