THE SHELL PETROLEUM DEVELOPMENT COMPANY OF NIGERIA LIMITED.

JOINT INVESTIGATION REPORT FOR INCIDENT NO: 1012824 JIV report S/N: 0163

1. Spill incident Number: 1012824 2. Type of incident* OIL SPILL
 3. Name of Location 12" IMO RIVER 2 - OGALE PIPELINE
UMUEDEKWARA
 4. Name of nearest community (ODAGWA) 5. State: RIVERS 6. LGA ETCHE
 7. Type of Production facility/Installation OIL PIPELINE Asset owner/District PIPELINE

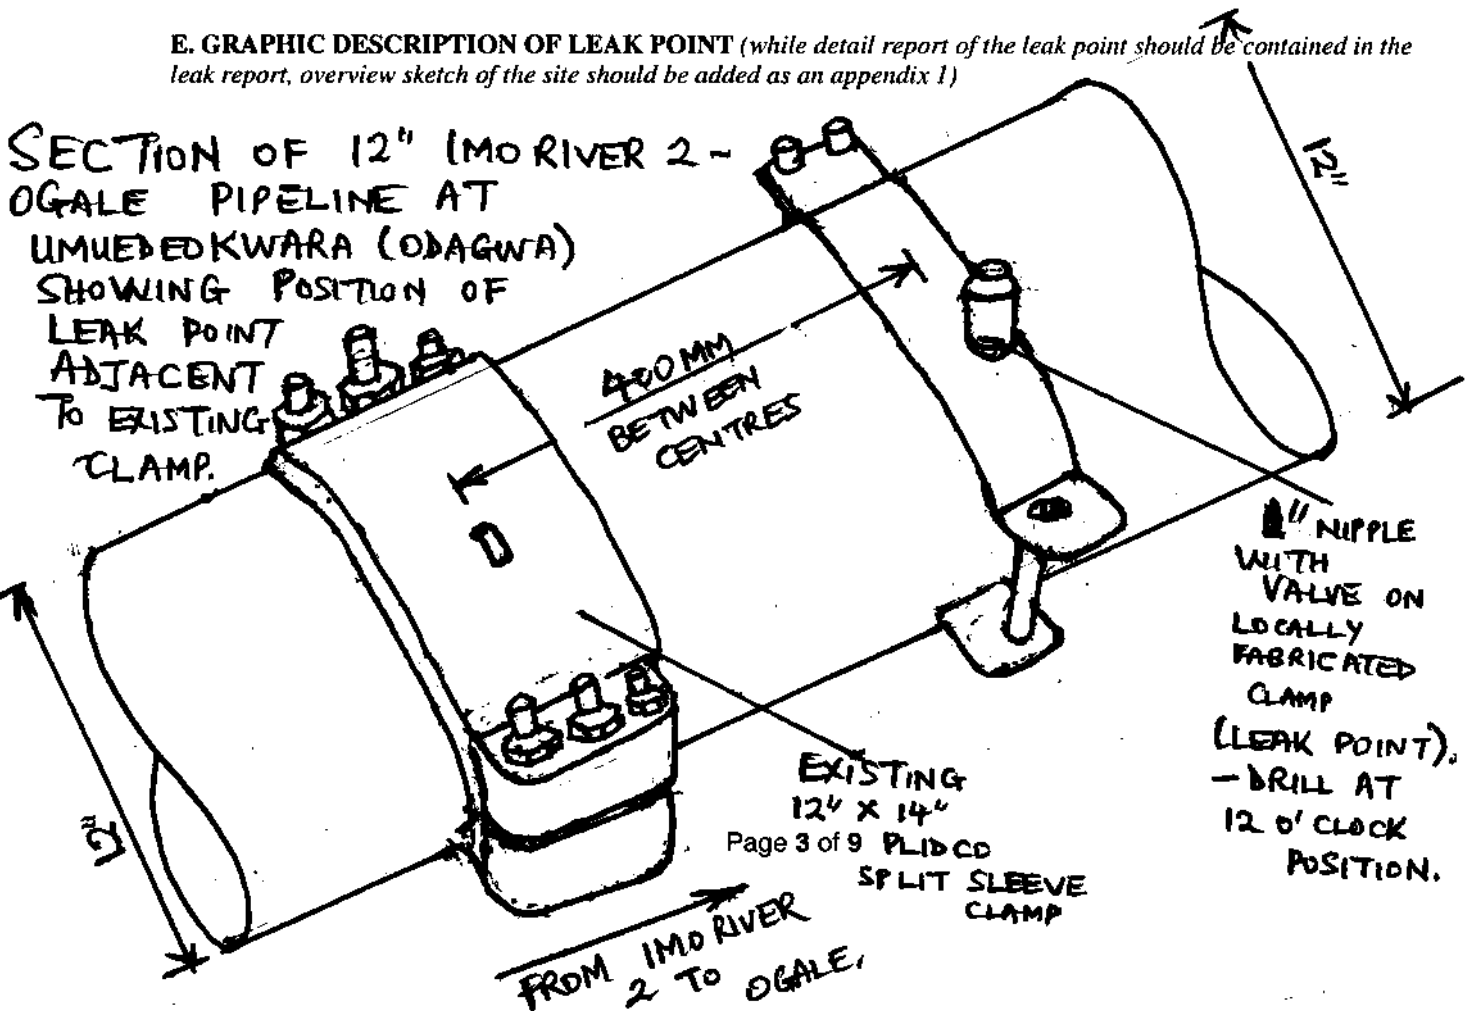
| <input checked="" type="checkbox"/> Failed Weld-on illegal hot tap valve, | <input type="checkbox"/> Failed Clamp | <input type="checkbox"/> Missing Pipeline/Flowline " |
| <input checked="" type="checkbox"/> Crude oil theft (illegal bunkering) point, | | <input type="checkbox"/> Third party tampering with Clamp |

E. GRAPHIC DESCRIPTION OF LEAK POINT (while detail report of the leak point should be contained in the leak report, overview sketch of the site should be added as an appendix 1)
