THE SHELL PETROLEUM DEVELOPMENT COMPANY OF NIGERIA LIMITED

JOINT INVESTIGATION REPORT FOR INCIDENT NO: 1016247 JIV report S/N: 0168

1. Spill incident Number: 1016247 2. Type of incident* OIL SPILL
 3. Name of Location 4th IMO RIVER WELL S5 B FLOWLINE
 4. Name of nearest community IGIRUKWY 5. State: ABIA 6. LGA UKWA - WEST
 7. Type of Production facility/Installation OIL FLOWLINE 8. Asset owner/District LAND 1

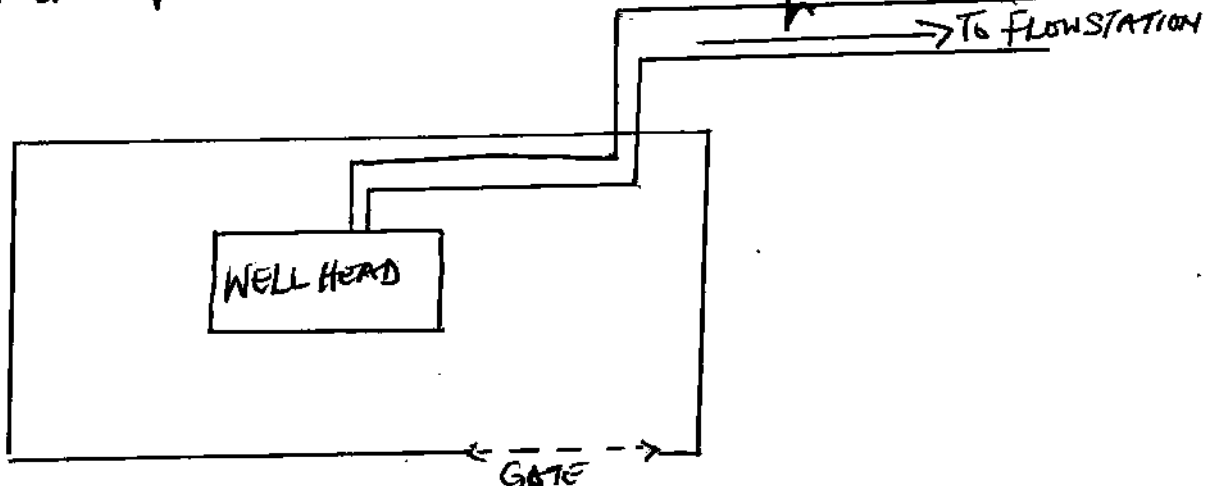
E. GRAPHIC DESCRIPTION OF LEAK POINT (while detail report of the leak point should be contained in the leak report, overview sketch of the site should be added as an appendix 1)

| <input type="checkbox"/> Drilled hole | <input checked="" type="checkbox"/> Hack saw cut | <input type="checkbox"/> Tear (_____). |

- Third party interference (Sabotage ; crude theft ; Line theft ; Accidental 3rd party damage
 Operational Others (including Mystery spills) _____

4" 1MO RIVER WELL 95 S FLOWLINE AT
19121UKWY STOPPING HACK SAW CUT
FORM 8 TO 11 O' CLOCK POSITION.

90mm HACK SAW CUT
FROM 8 TO 11 O' CLOCK
POSITION.
→ TO FLOWSTATION

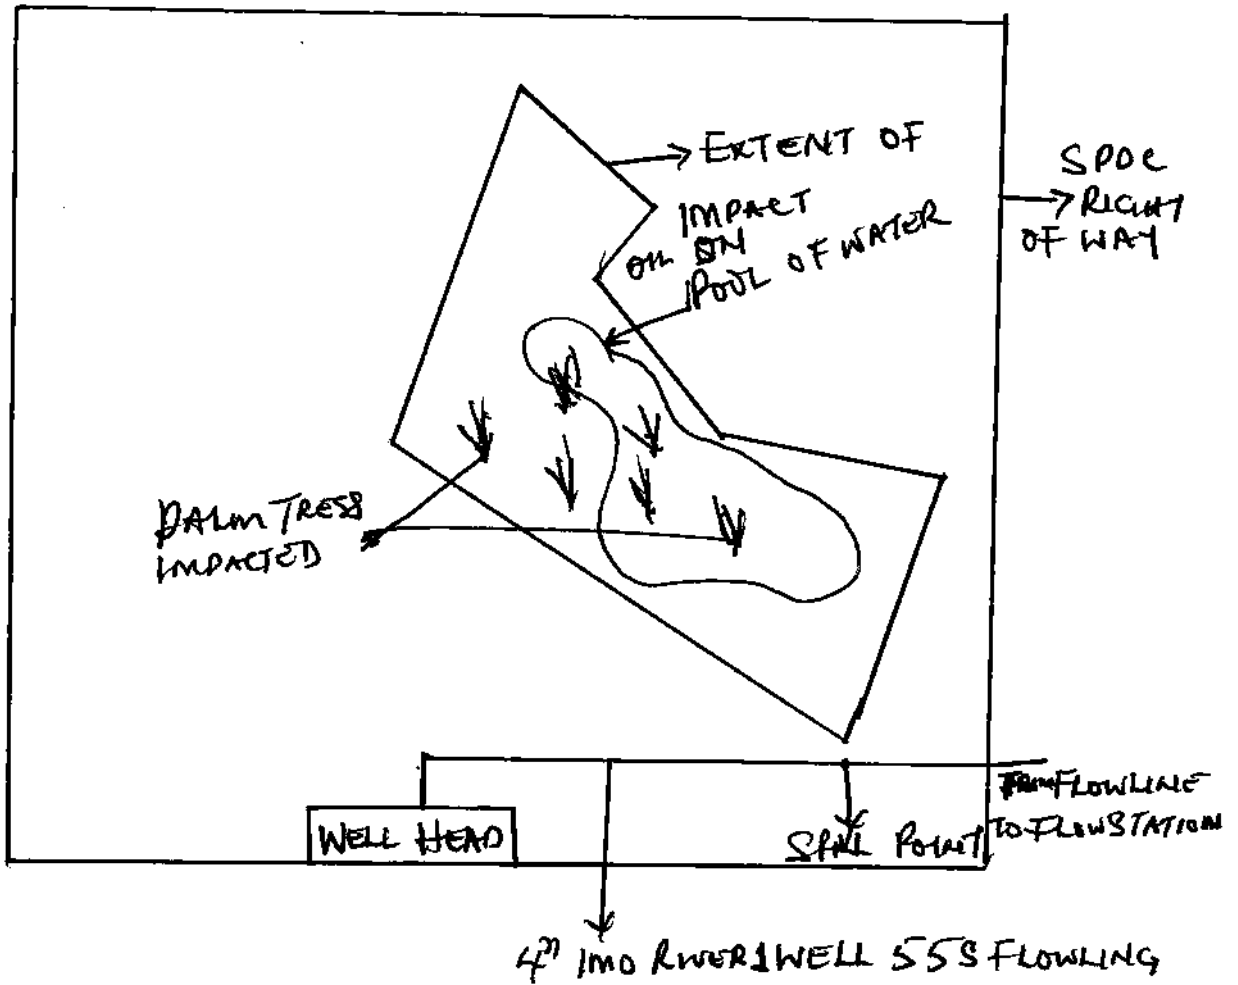
28. Appendix 1: Overview sketch of the site

Location: 4th IMO RIVER WELL 55S FLOWLINE AT IGIKRIEWA
