IOINT INVESTIGATION REPORT FOR INCIDENT NO: 10143	67 JIV report S/N: 0165
(Note: As practicable as possible the JIT report is to be signed in the	field by all the participating parties)

A. GENERAL INFORMATION:	
1. Spill incident Number: 1014367 2.Type	of incident* OIL SPILL
3. Name of Location 28" BEMY - BONNY TRA	MS NIGER PIPELINE
4. Name of nearest community FRECTOWN 5. State: R	WERS 6. LGA ANDONI

THE SHELI	L PETROLEUM DEVELOP	MENT COMPANY	OF NIGERIA LI	MTED.
OINT INVESTIGATION F	REPORT FOR INCIDENT NO:	1014367	JIV report S/N:	400
G. INCIDENT INFO	RMATION:		. 0	165

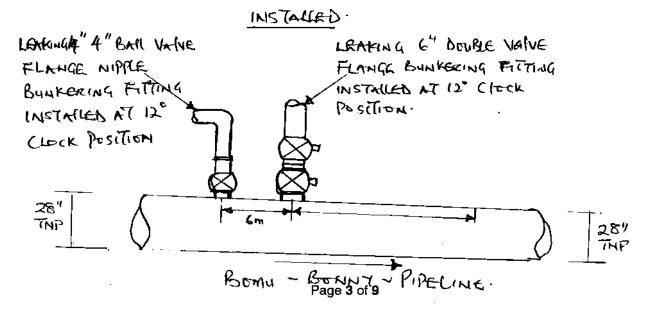
SCOTIONAL VIEW OF 28" BOMY - RONLY TRANS HIGER PIPCLINE AT FREETOWN

FID 1014367, SHOWING BUNKERINGS FITTINGS ILLREMET
