THE SHELL PETROLEUM DEVELOPMENT COMPANY OF NIGERIA LIMITED.

JOINT INVESTIGATION REPORT FOR INCIDENT NO: 1000706 JIV report SN: 0216

1. Spill incident Number: 1000706 2. Type of incident* OIL SPILL
 3. Name of location 20 INCH OTUMARA - ESCRAVOS TRUNKLINE
 4. Name of nearest community AJUDAIBO 5. State: DELTA 6. LGA WARRI-SOUTH WEST
 7. Type of Production facility/Installation TRUNKLINE 8. Asset owner/District PIPELINE

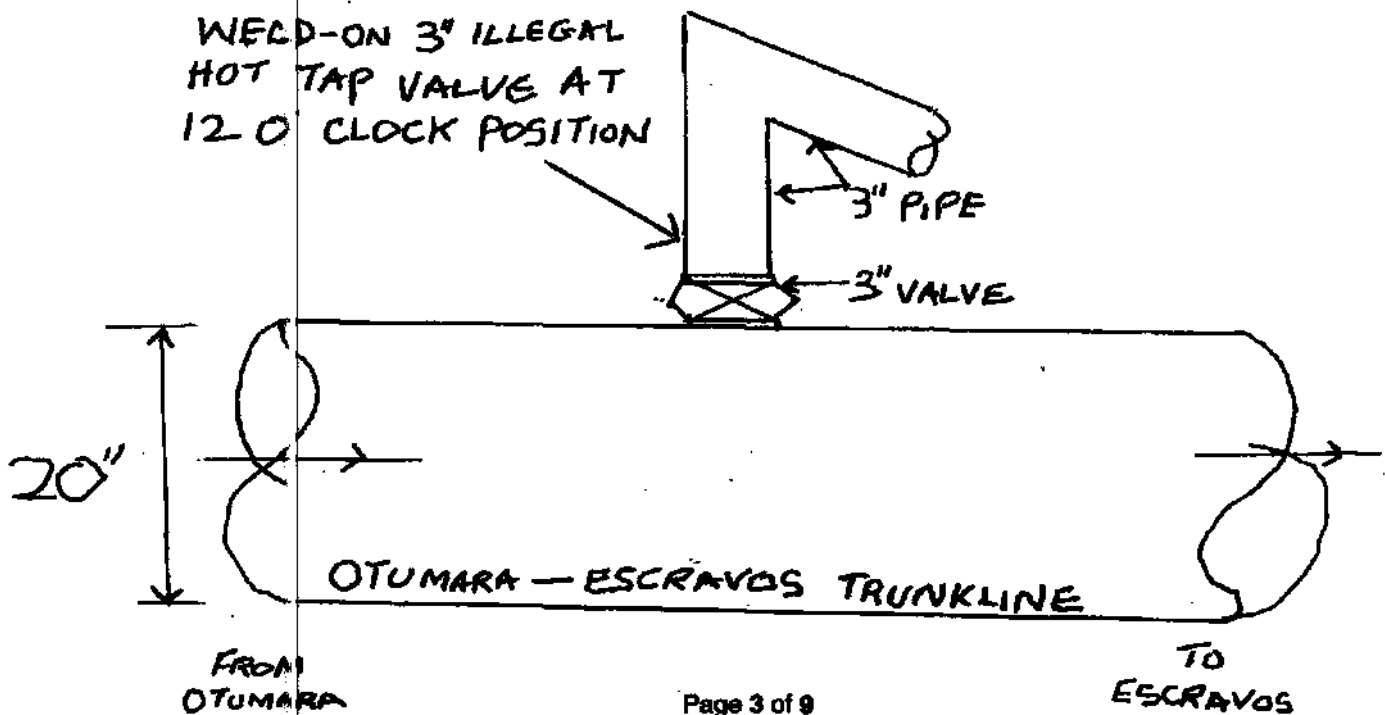
E. GRAPHIC DESCRIPTION OF LEAK POINT (while detail report of the leak point should be contained in the leak report, a overview sketch of the site should be added as an appendix 1)

- Drilled hole Hack saw cut Tear (_____).
 Complete Rupture Inward dent, Well head tampering
 Failed Weld-on illegal hot tap valve, Failed Clamp Missing Pipeline/Flowline
 Crude oil theft (illegal bunkering) point. Third party tampering with Clamp
 Third party tampering with valve setting, Third party tampering with flange.
 Corrosion Saver-pit over flow, Surge vessel overflow,
 Bulging Outward Flare System/Bund wall failure Accidental 3rd party equipment
 impact Valve Failure com unit failure Cold vent
 Relief valve failure Others (specify) WELD-ON ILLEGAL HOT TAP VALVE

- BUNKERING VALVE AND FITTINGS NOT LEAKING ON SPDC RIGHT OF WAY.
- WEATHERED CRUDE OIL IMPACT WAS FOUND ON SPDC RIGHT OF WAY RESULTING FROM CRUDE OIL THEFT AND ILLEGAL LOCAL REFINERY ACTIVITIES ON THIRD PARTY AREA

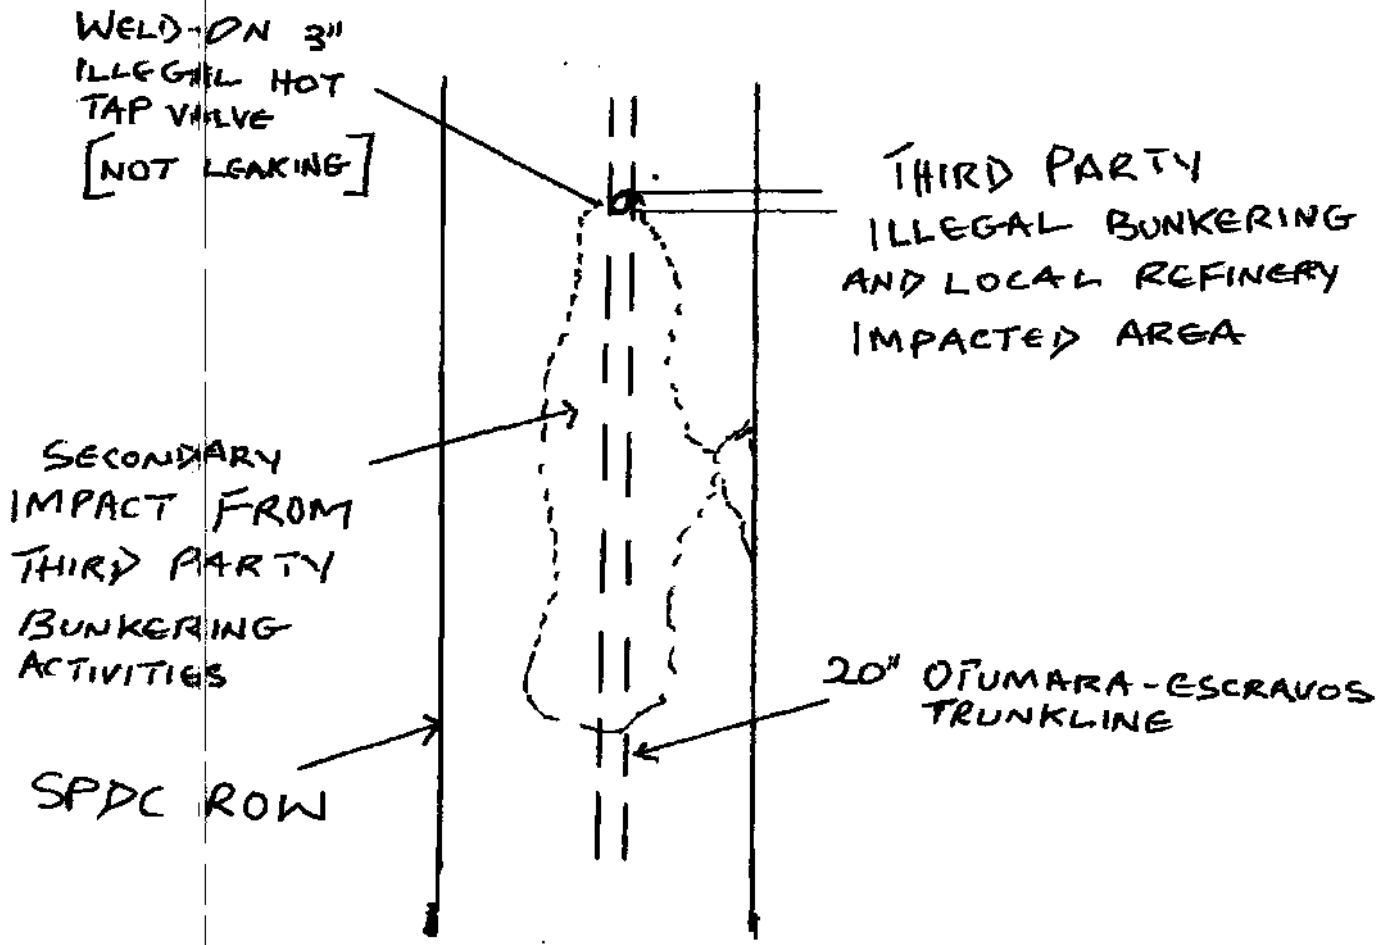
28. Appendix I: Overview sketch of the site

Location: 20" OTUMARE-ESCRAVOS TRUNKLINE SPILL SITE

A. Joint investigation of the incident site found that there is no residual impact after the initial response and therefore recommend that the site be closed out <input type="checkbox"/>
B. Investigation of the incident site showed that there is residual impact on site requiring further works <input checked="" type="checkbox"/>
