THE SHELL PETROLEUM DEVELOPMENT COMPANY OF NIGERIA LIMITED.

JOINT INVESTIGATION REPORT FOR INCIDENT NO: 941219 JIV report S/N: 0013

1. Spill incident Number: 941219 2. Type of incident* OIL SPILL
 3. Name of Location 12" IMO RIVER 2 PIPELINE
 4. Name of nearest community ODAGUA 5. State: RIVERS 6. LGA ETCHE
 7. Type of Production facility/Installation OIL PIPELINE 8. Asset owner/District NPE/LAND 1

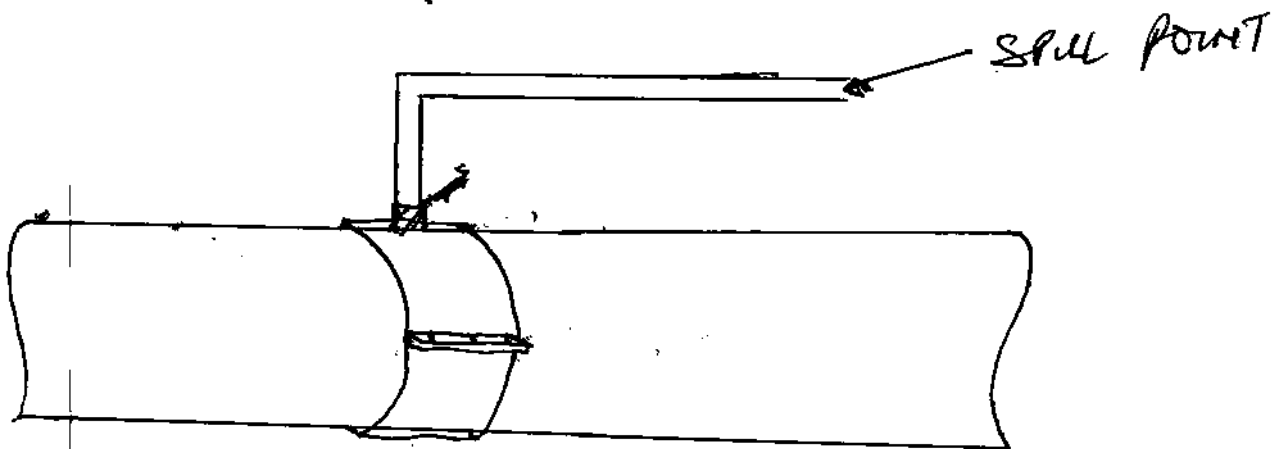
E. GRAPHIC DESCRIPTION OF LEAK POINT (while detail report of the leak point should be contained in the leak report, overview sketch of the site should be added as an appendix 1)

A SECTION OF 12" IMD RWER 2 PIPELINE AT ODAQWA SHOWING
ILLEGAL BUNKERING POINT INSTALLED AT 12 O'CLOCK POSITION

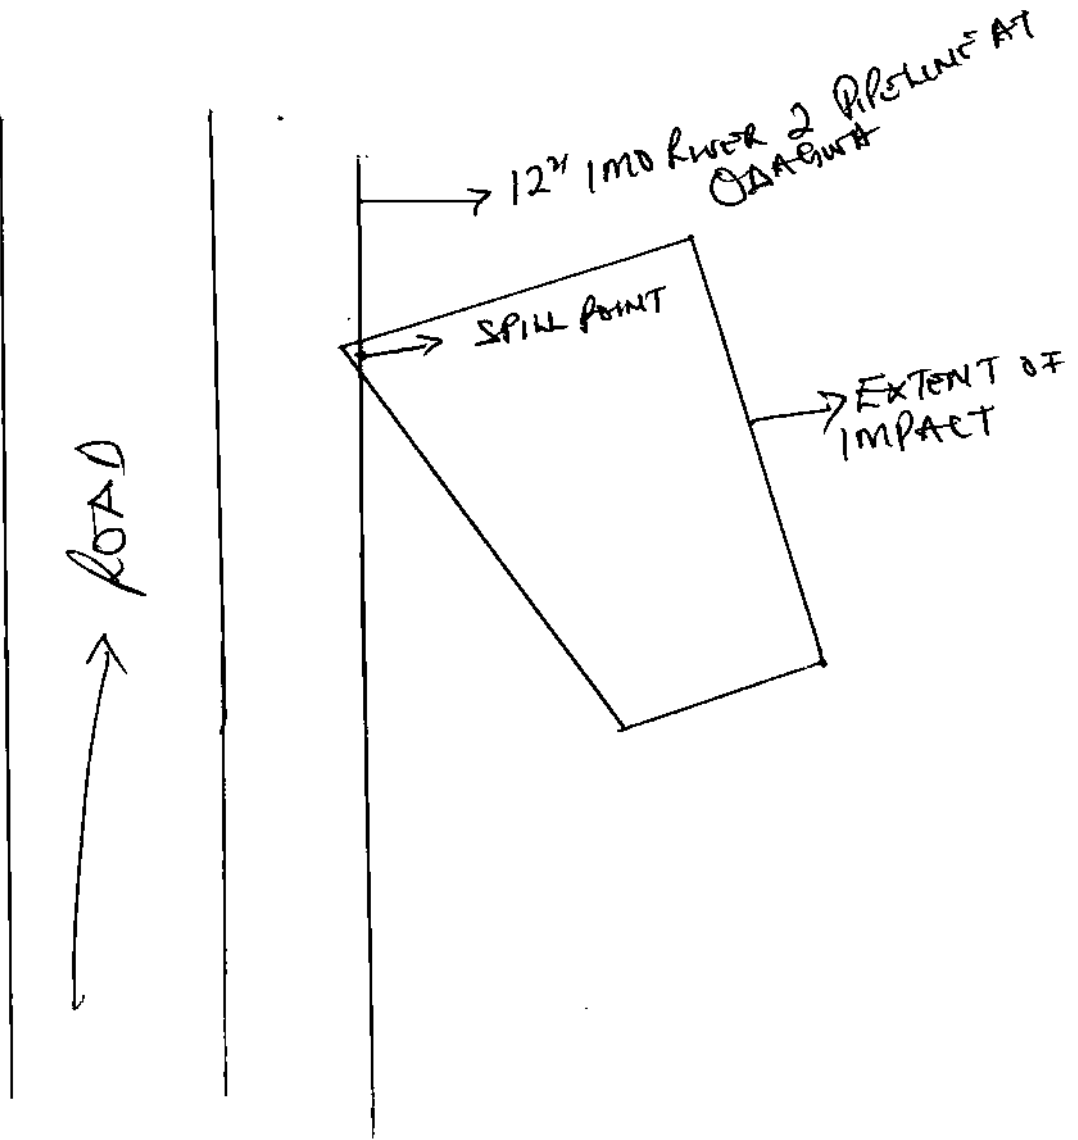
28. Appendix 1: Overview sketch of the site

Location: 12" IMO RIVER 2 PIPELINE AT ODAGWA
