THE SHELL PETROLEUM DEVELOPMENT COMPANY OF NIGERIA LIMITED.

JOINT INVESTIGATION REPORT FOR INCIDENT NO: 946875 JIV report S/N: **0060**

1. Spill incident Number: 946875 2. Type of incident* OIL SPILL
 3. Name of Location 4" CANTHORNE CHANNEL 1 WELL 49 FLOWLINE
 4. Name of nearest community MBIAMA 5. State: RIVERS 6. LGA DEGEMA
 7. Type of Production facility/Installation OIL FLOWLINE 8. Asset owner/District SWAMP I EAST

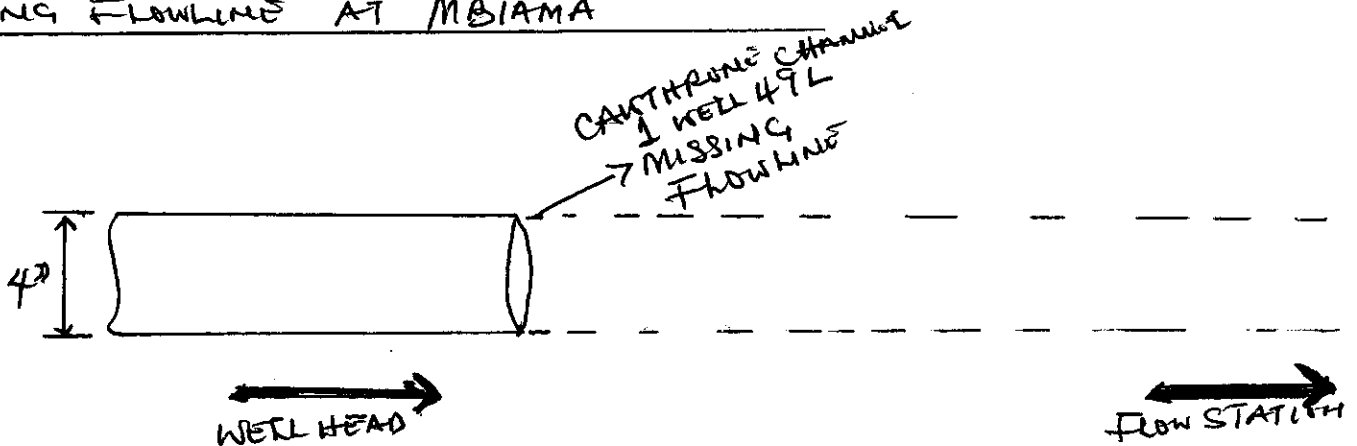
| <input type="checkbox"/> Failed Weld-on illegal hot tap valve, | <input type="checkbox"/> Failed Clamp | <input checked="" type="checkbox"/> Missing Pipeline/Flowline |

- f. Incident caused by:
- Third party interference (Sabotage ; crude theft ; Line theft ; Accidental 3rd party damage
 Operational Others (including Mystery spills) _____

A SECTION OF 4" CAUTION CHANNEL 1 WELL 49L FLOWLINE SHOWING MISSING FLOWLINE AT MBIAMA

A. Joint investigation of the incident site found that there is no residual impact after the initial response and therefore recommend that the site be closed out <input type="checkbox"/>
B. Investigation of the incident site showed that there is residual impact on site requiring further works <input checked="" type="checkbox"/>
