**THE SHELL PETROLEUM DEVELOPMENT COMPANY OF NIGERIA LIMITED.**

JOINT INVESTIGATION REPORT FOR INCIDENT NO: 949459 JIV report S/N: 0037

1. Spill incident Number: 949459 2. Type of incident\* OIL SPILL  
 3. Name of Location 12" IMO RIVER 2 - OGALE PIPELINE  
 4. Name of nearest community KOM KOM 5. State: RIVERS 6. LGA OYIGBO  
 7. Type of Production facility/Installation OIL PIPELINE 8. Asset owner/District NPE/PH 1

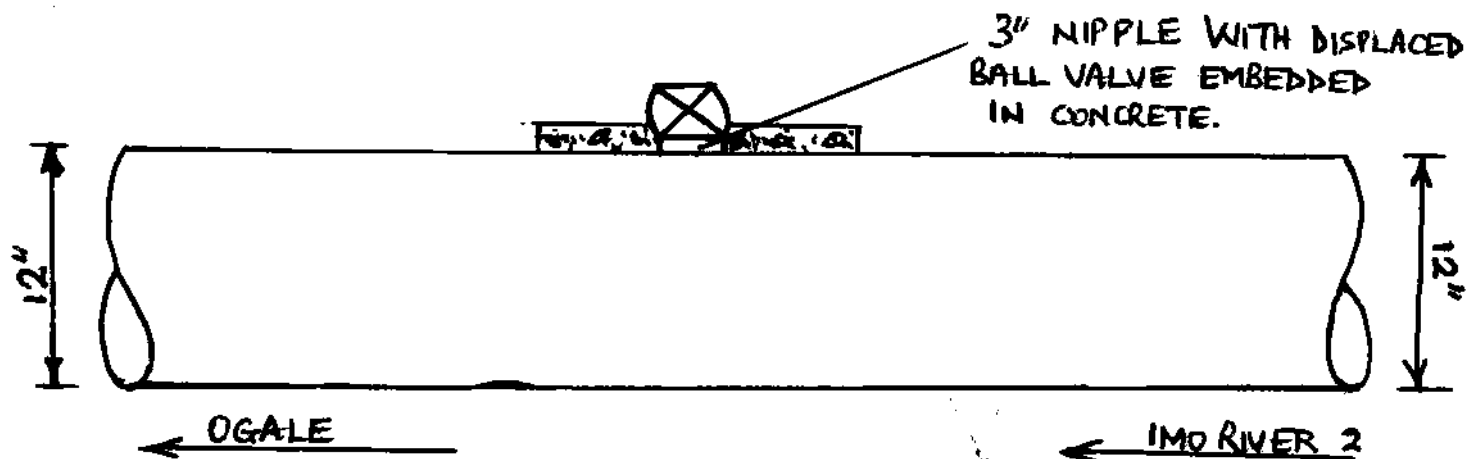
E. GRAPHIC DESCRIPTION OF LEAK POINT (while detail report of the leak point should be contained in the leak report, overview sketch of the site should be added as an appendix 1)

| <input checked="" type="checkbox"/> Failed Weld-on illegal hot tap valve, | <input type="checkbox"/> Failed Clamp | <input type="checkbox"/> Missing Pipeline/Flowline |
| <input checked="" type="checkbox"/> Crude oil theft (illegal bunkering) point, | | <input type="checkbox"/> Third party tampering with Clamp |

SECTION OF 12" IMO RIVER 2 - OGALE PIPELINE AT KOMKOM SHOWING ONE NO. CRUDE OIL THEFT POINT AT 12 O' CLOCK POSITION.
