THE SHELL PETROLEUM DEVELOPMENT COMPANY OF NIGERIA LIMITED.

JOINT INVESTIGATION REPORT FOR INCIDENT NO: 981063 JIV report S/N: 0087

1. Spill incident Number: 981063 2. Type of incident* OIL SPILL
 3. Name of Location 12" ADIBAWA - OKORDIA PIPELINE
 4. Name of nearest community IKARAMA 5. State: BAYELSA 6. LGA YENAGOA
 7. Type of Production facility/Installation OIL PIPELINE 8. Asset owner/District PIPELINE

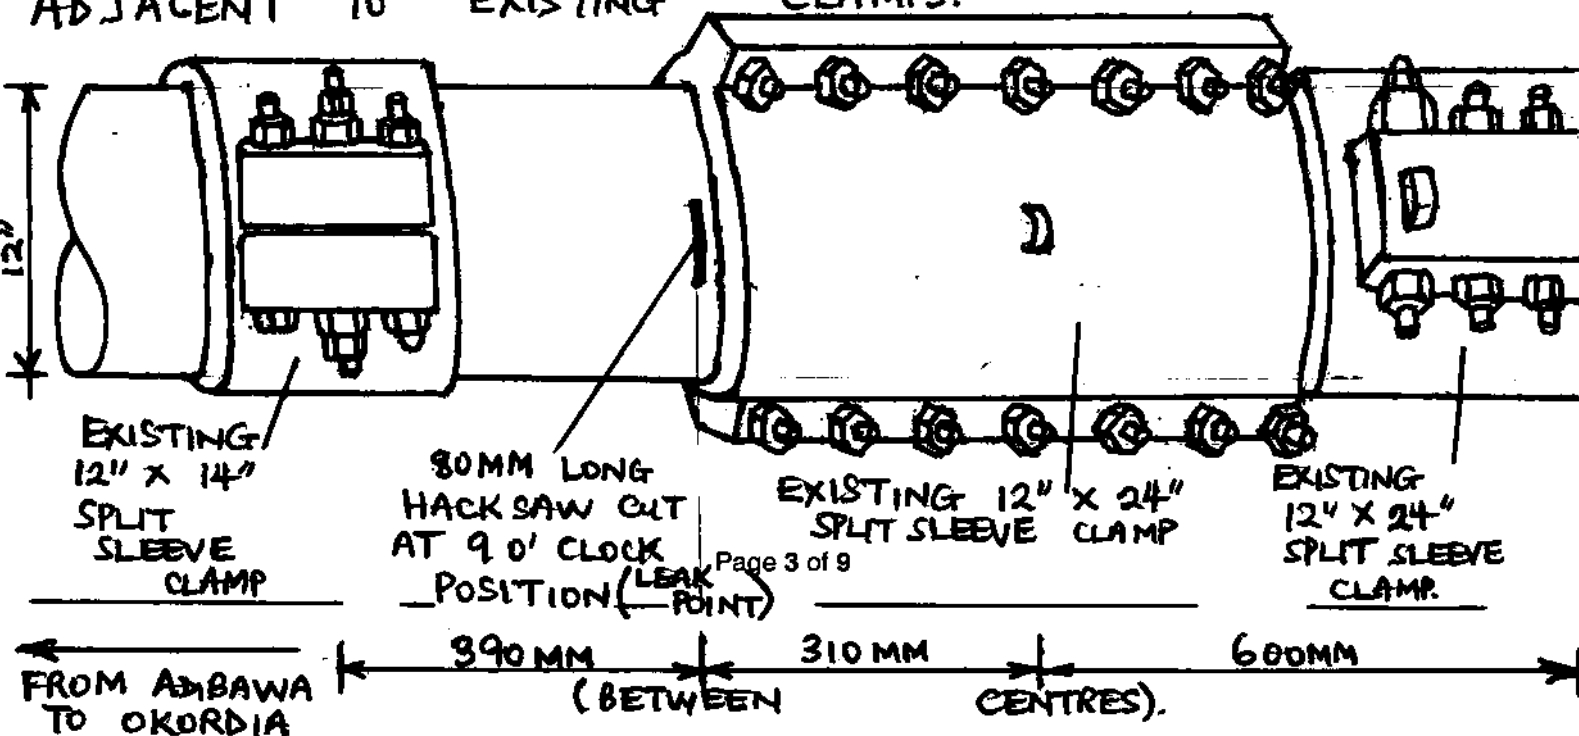
| <input type="checkbox"/> Drilled hole | <input checked="" type="checkbox"/> Hack saw cut | <input type="checkbox"/> Tear (_____), |

- Third party interference (Sabotage ; crude theft ; Line theft ; Accidental 3rd party damage
 Operational Others (including Mystery spills) _____

SECTION OF 12" ADIBAWA - OKORDIA PIPELINE (OLD LINE) AT IKARAMA SHOWING POSITION OF HACK SAW CUT ADJACENT TO EXISTING CLAMPS.
