THE SHELL PETROLEUM DEVELOPMENT COMPANY OF NIGERIA LIMITED.

JOINT INVESTIGATION REPORT FOR INCIDENT NO: 972834 JIV report S/N: 0075

1. Spill incident Number: 972834 2. Type of incident* OIL SPILL
 3. Name of Location ADIBAWA NORTH EAST WELL 12 FLOWLINE
 4. Name of nearest community BISENI 5. State: BAYELSA 6. LGA YENEGOR
 7. Type of Production facility/Installation OIL FLOWLINE 8. Asset owner/District LAND 2

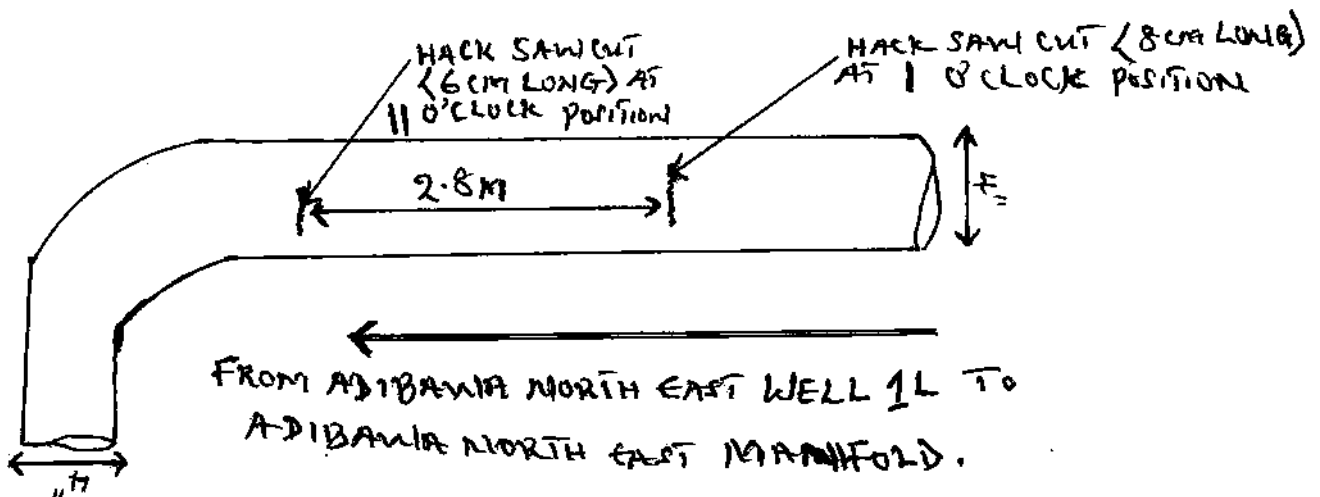
SECTION OF ADIBAWA NORTH EAST WELL 1L FLOWLINE AT BISENII

e. Description of leak point (tick as applicable);
 Drilled hole Hack saw cut Tear (_____),
 Complete Rupture Inward dent, Well head tampering
 Failed Weld-on illegal hot tap valve, Failed Clamp Missing Pipeline/Flowline
 Crude oil theft (illegal bunkering) point, Third party tampering with Clamp
 Third party tampering with valve setting, Third party tampering with flange,
 Corrosion Saver-pit over flow, Surge vessel overflow,
 Bulging Outward Flare System/Bund wall failure Accidental 3rd party equipment
 impact Valve Failure com unit failure Cold vent
 Relief valve failure Others (specify) _____

f. Incident caused by:
 Third party interference (Sabotage; crude theft; Line theft; Accidental 3rd party damage
 Operational Others (including Mystery spills) _____

SHOWING POSITION OF HACK SAW CUTS AT 1 AND 11 O'CLOCK POSITION RESPECTIVELY.

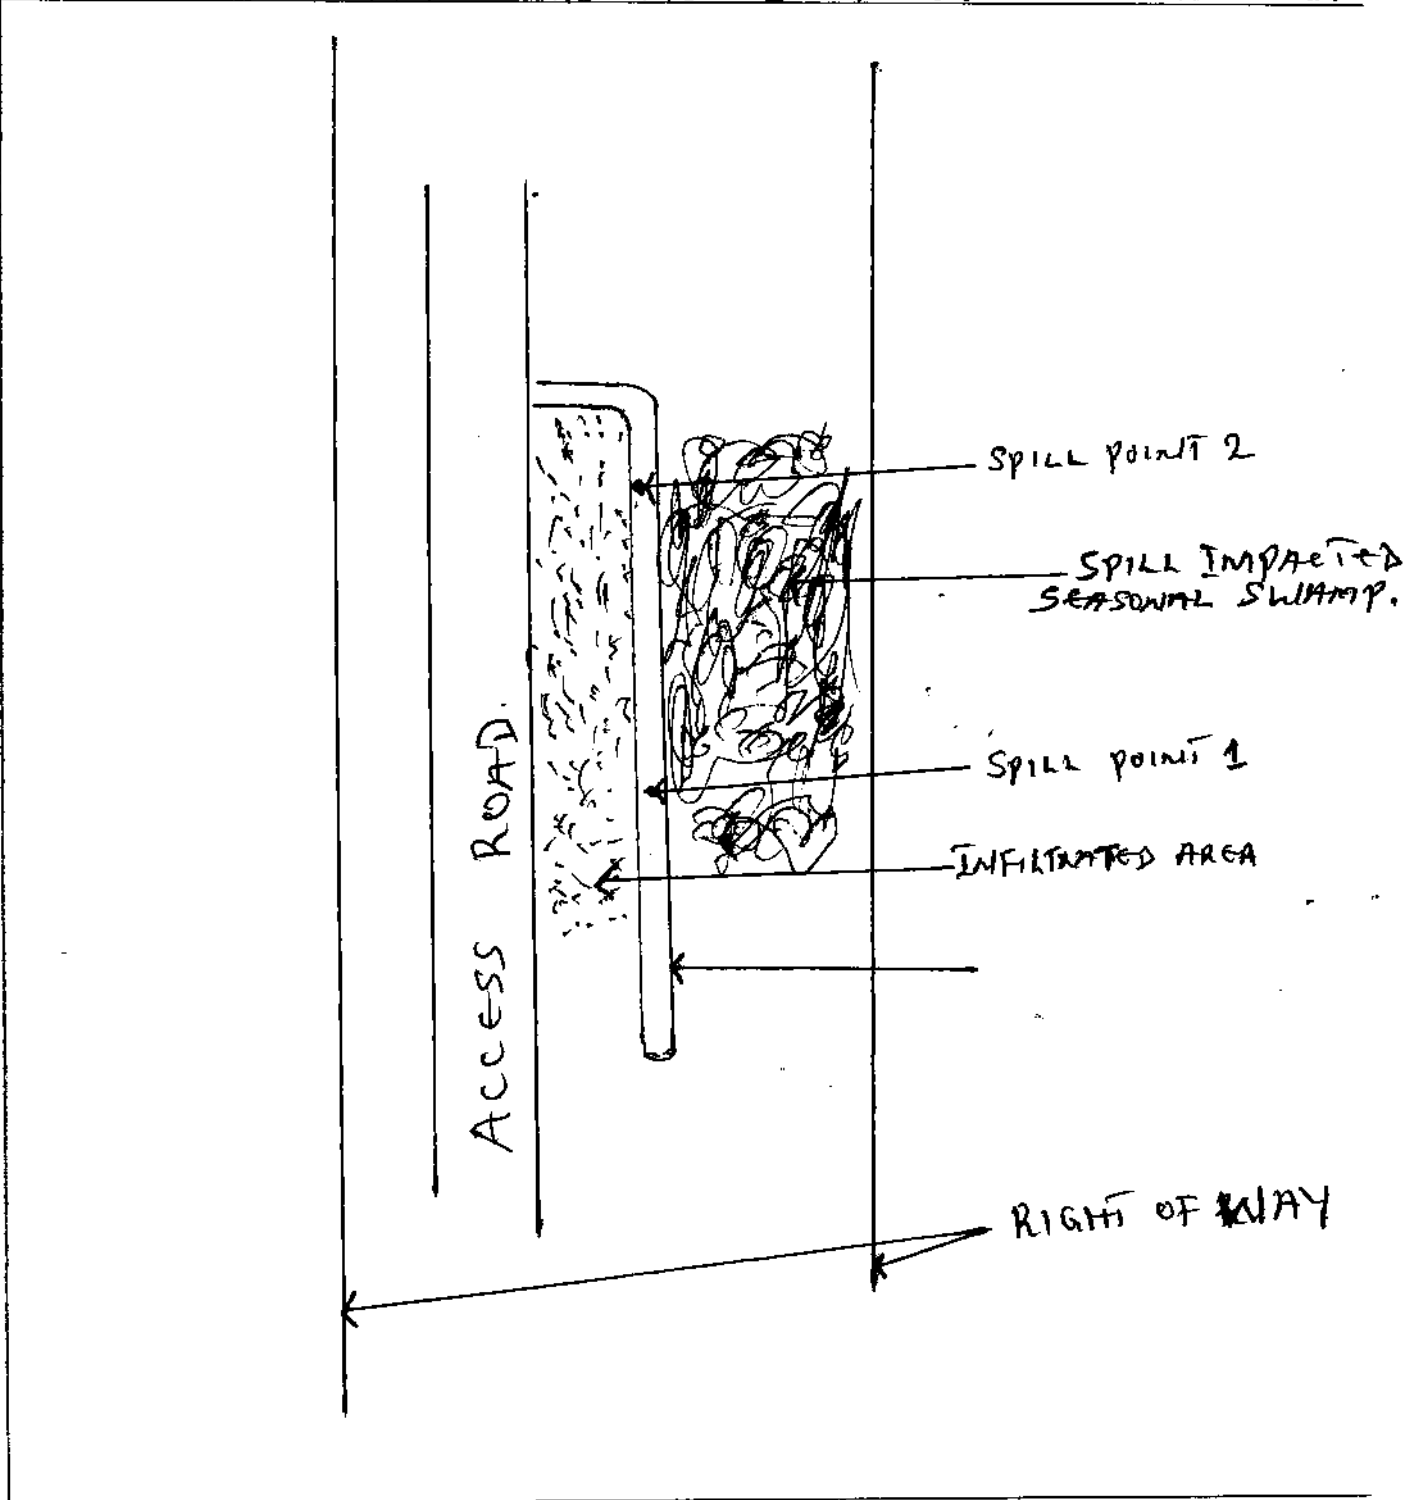
28. Appendix 1: Overview sketch of the site

Location: ADIBAMA NORTH EAST WELL 1L FLOWLINE AT BISENI
