THE SHELL PETROLEUM DEVELOPMENT COMPANY OF NIGERIA LIMITED.

JOINT INVESTIGATION REPORT FOR INCIDENT NO: 1070674 JIV report S/N: 0342

1. Spill incident Number: 1070674 2. Type of incident* OIL SPILL
 3. Name of Location 6" OBIGBO NORTH - OGALE PIPELINE
 4. Name of nearest community OGALE 5. State: RIVERS 6. LGA ELEME
 7. Type of Production facility/Installation OIL PIPELINE 8. Asset owner/District PIPELINE

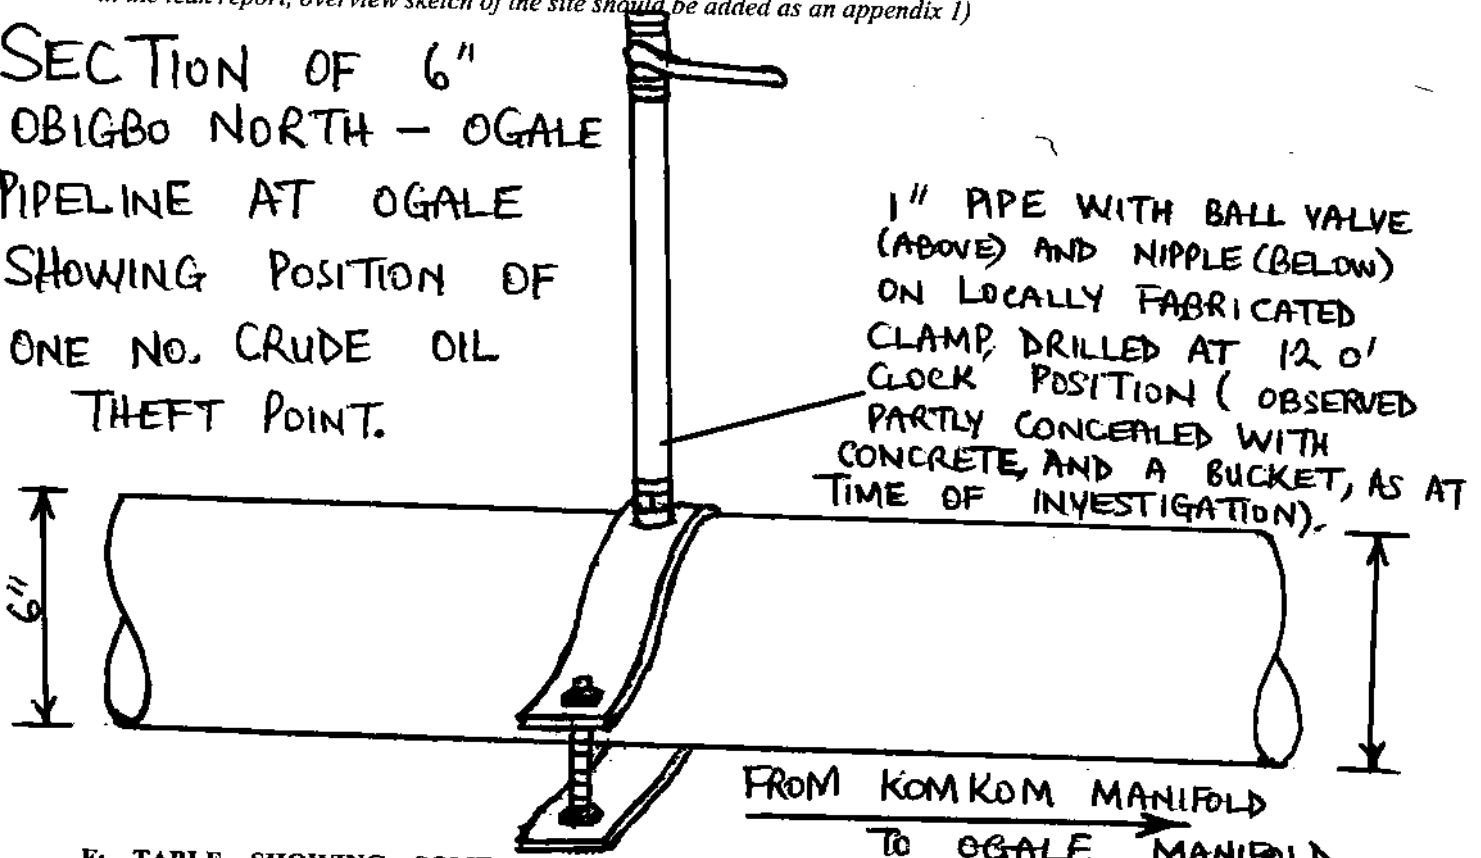
SECTION OF 6" OBIGBO NORTH - OGALE PIPELINE AT OGALE SHOWING POSITION OF ONE NO. CRUDE OIL THEFT POINT.

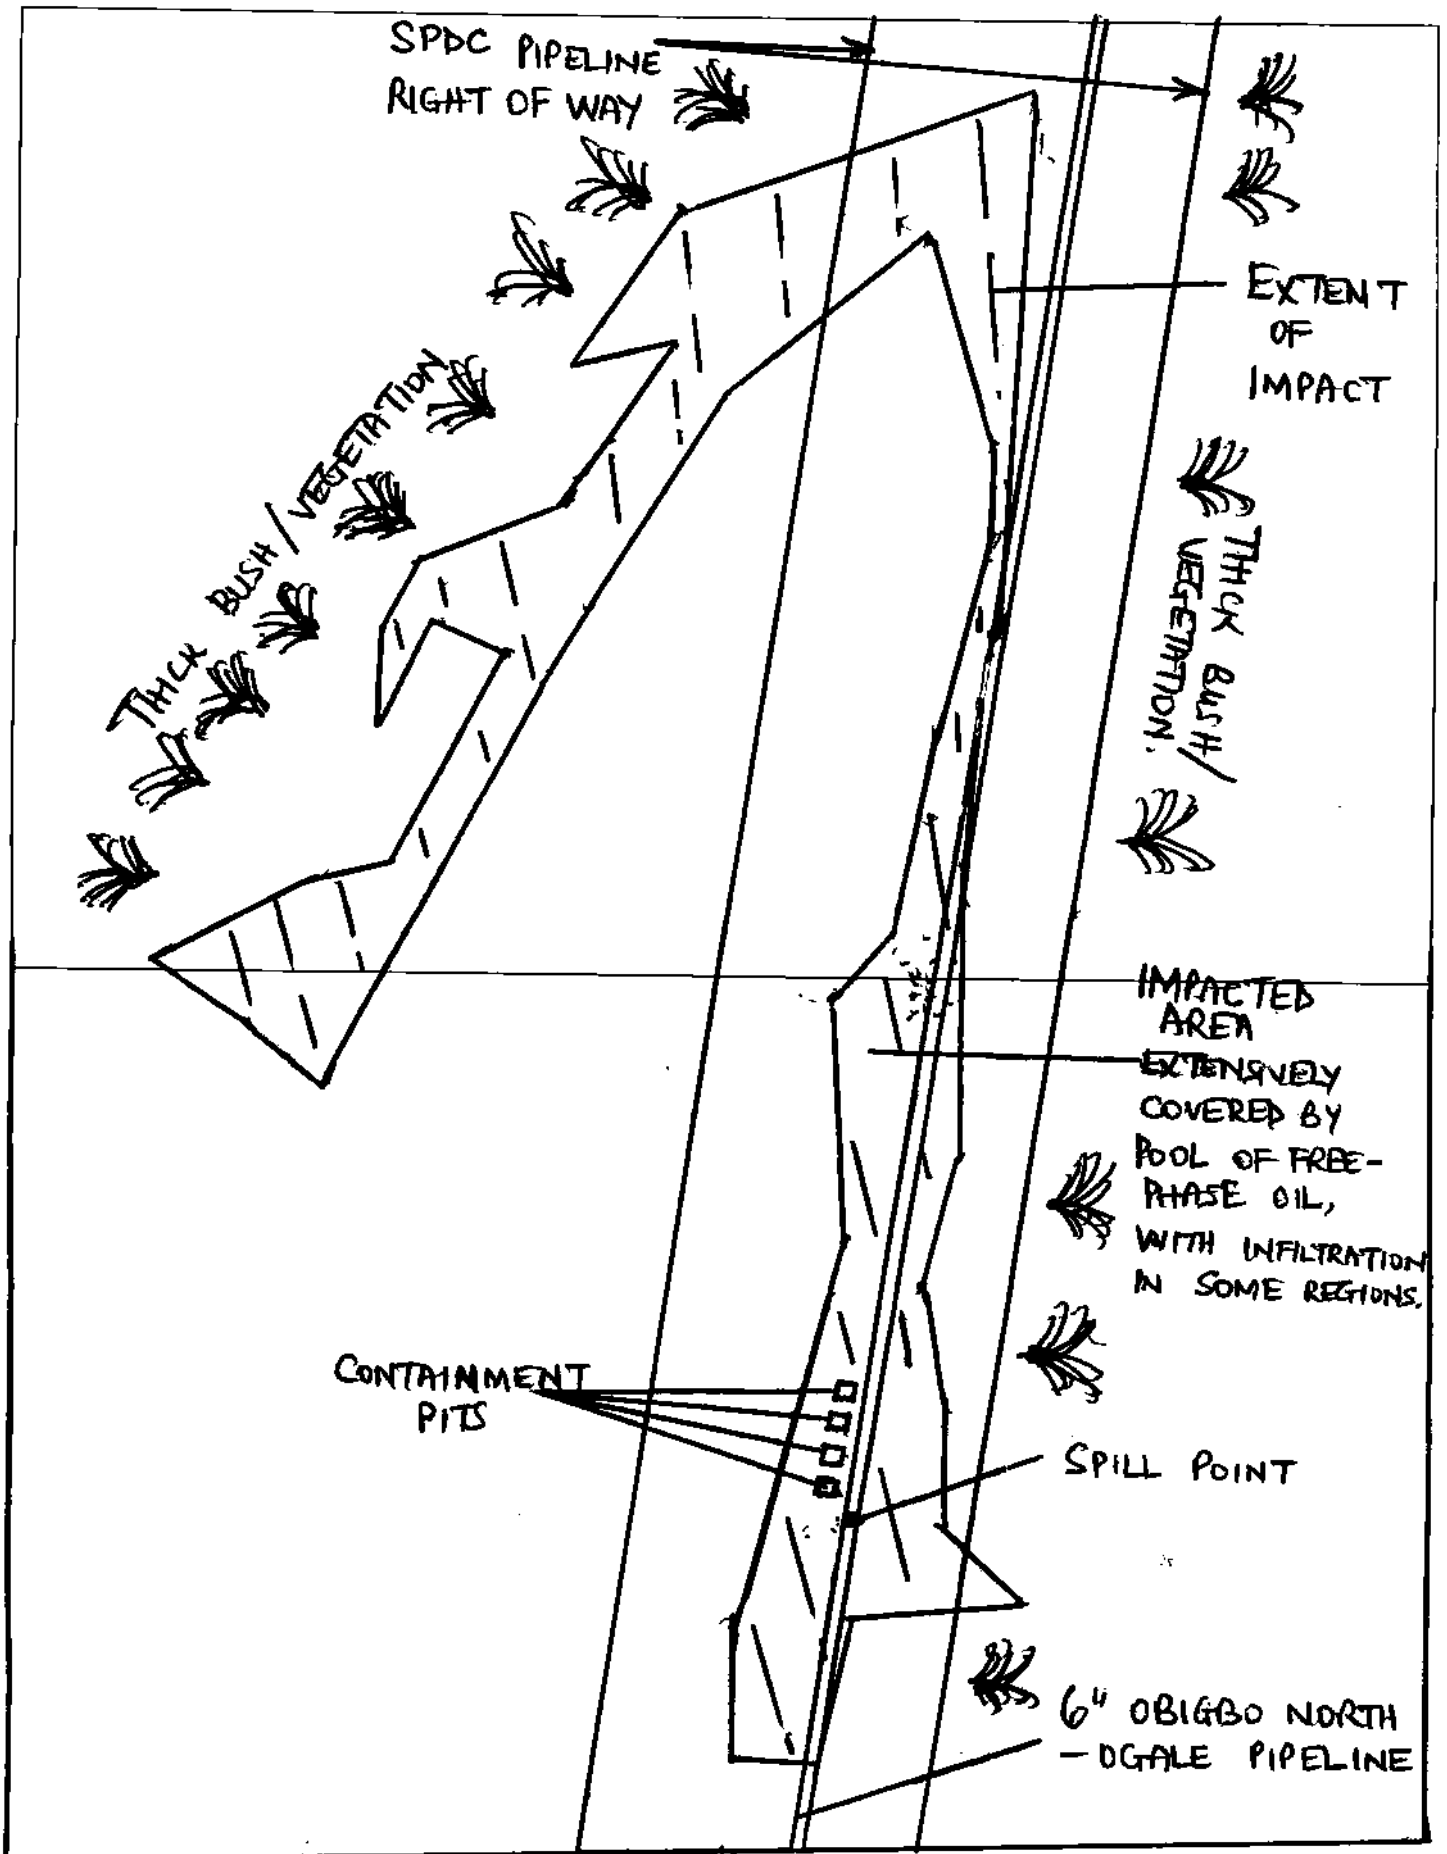
28. Appendix 1: Overview sketch of the site

Location: 6" OBIGBO NORTH - OGALE PIPELINE AT OGALE
