THE SHELL PETROLEUM DEVELOPMENT COMPANY OF NIGERIA LIMITED.

JOINT INVESTIGATION REPORT FOR INCIDENT NO: 1069586 JIV report S/N: 0344

1. Spill incident Number: 1069586 2. Type of incident* OIL SPILL
 3. Name of Location IMO RIVER Well 21 L FLOWLINE
IGIRIKUMI
 4. Name of nearest community ESI-ETIHA 5. State: ABIA 6. LGA UKWA WEST
 7. Type of Production facility/Installation OIL FLOWLINE 8. Asset owner/District LAND 1

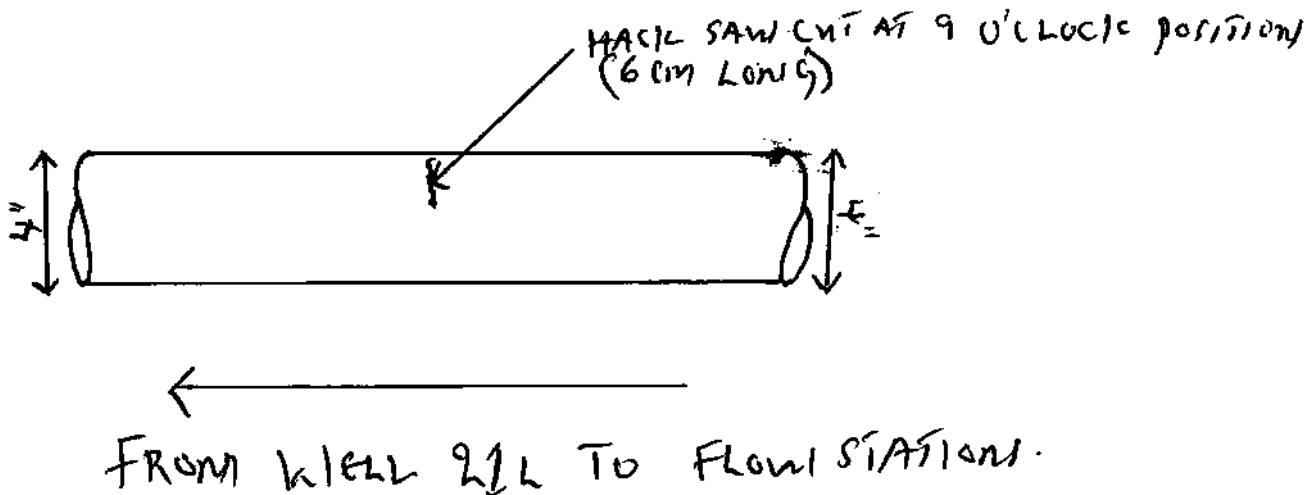
SECTION OF IMP RIVER WELL 21L FLOWLINE AT IGIRIKWU /
 S1 - FTIIOHA SHOWING THE POSITION OF HACK SAW CUT AT 9 O'CLOCK
 POSITION.

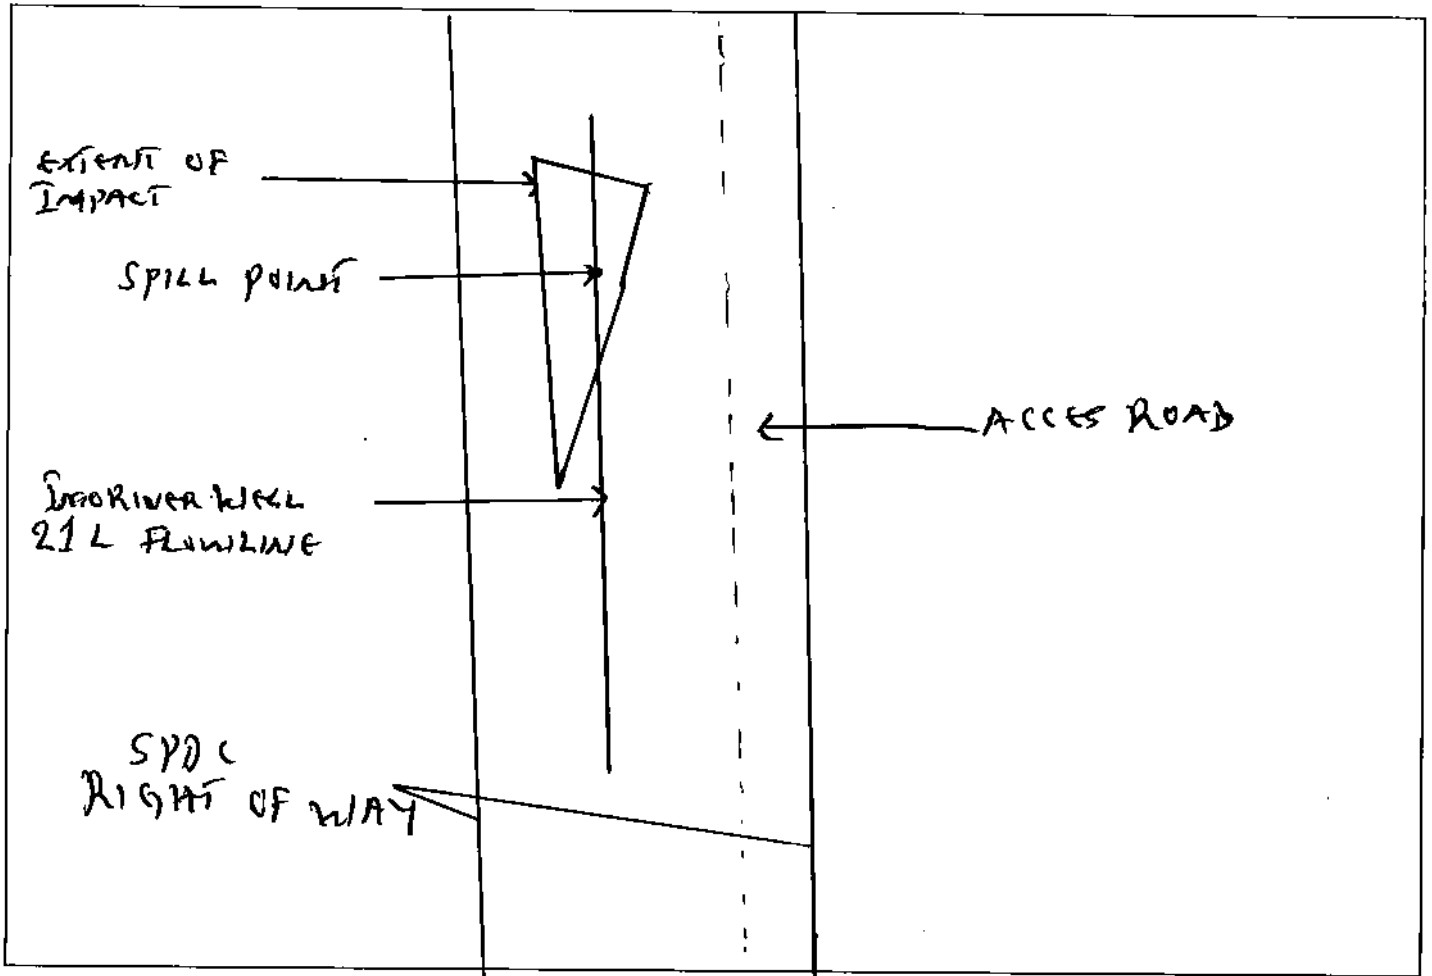
28. Appendix 1: Overview sketch of the site

Location: IMO RIVER WELL 21 L FLOWLINE AT IGIRUKWU / ES1 - ESTION
