THE SHELL PETROLEUM DEVELOPMENT COMPANY OF NIGERIA LIMITED.

JOINT INVESTIGATION REPORT FOR INCIDENT NO: 1073629 JIV report S/N: 0295

1. Spill incident Number: 1073629 2. Type of incident* OIL SPILL
 3. Name of Location 24" NKPOKU - BOMU TRANS NIGER PIPELINE
 4. Name of nearest community ETEO 5. State: RIVERS 6. LGA ELEME
 7. Type of Production facility/Installation OIL PIPELINE 8. Asset owner/District PIPELINE/ENGT.

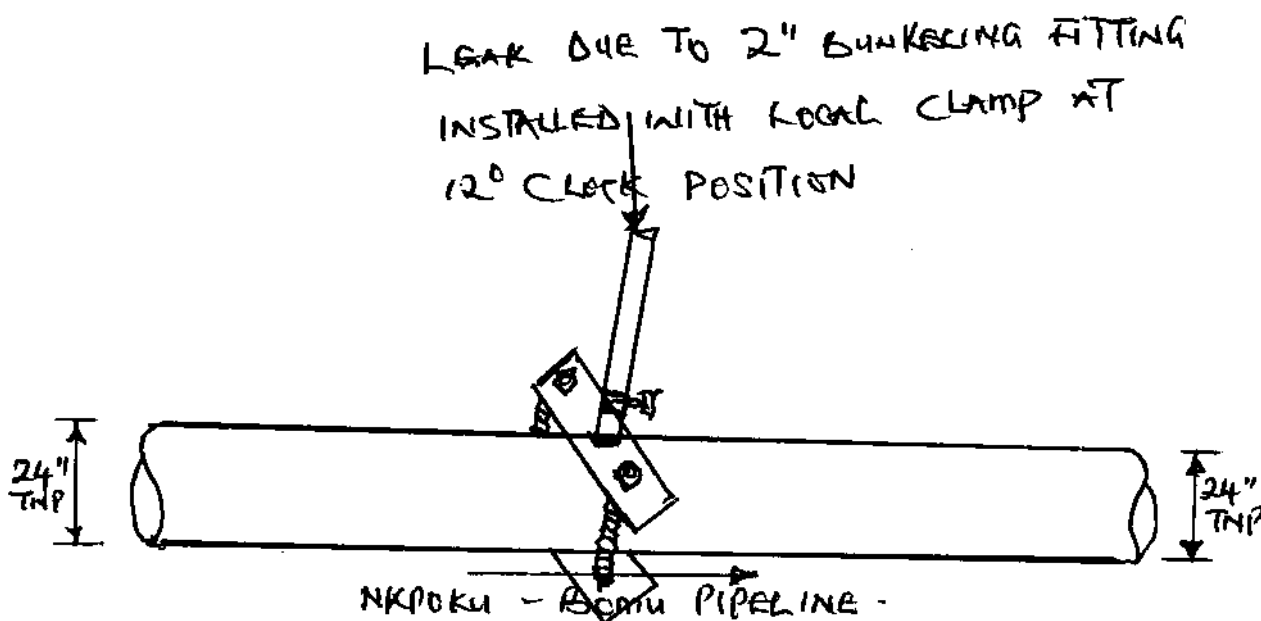
SECTIONAL VIEW OF 24" NKPOKU - BOMU TRANS NIGER PIPELINE

ETEO SHOWING ILLEGAL THEFT POINT FITTING.

| <input checked="" type="checkbox"/> Drilled hole | <input type="checkbox"/> Hack saw cut | <input type="checkbox"/> Tear (_____). |
| <input checked="" type="checkbox"/> Crude oil theft (illegal bunkering) point, | | <input type="checkbox"/> Third party tampering with Clamp |

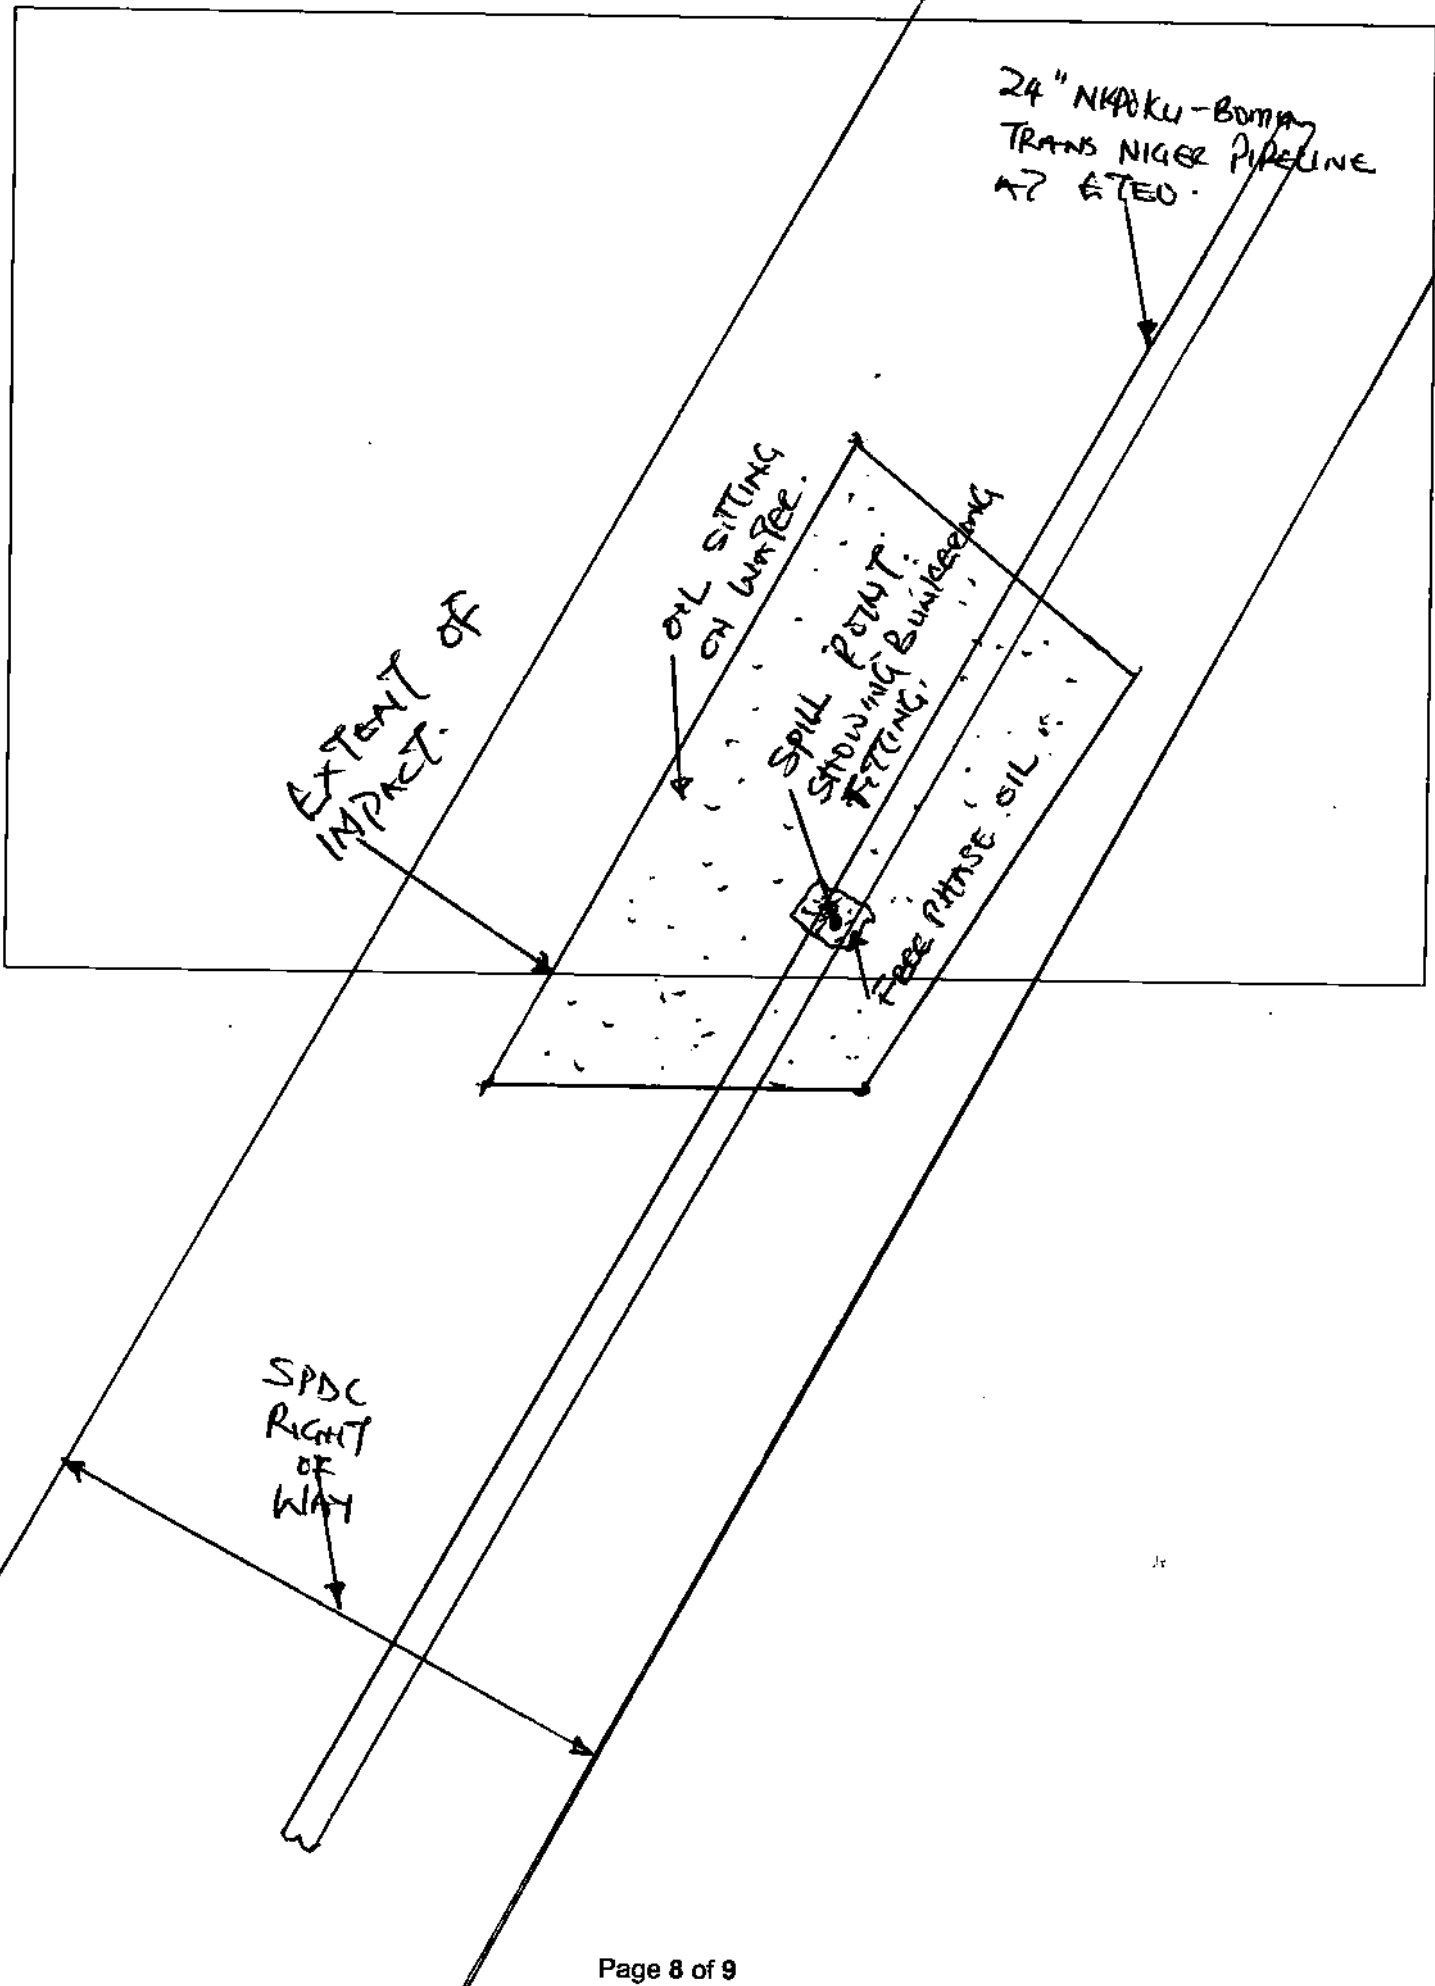
28. Appendix 1: Overview sketch of the site

Location: 24" NKPUKU - BOMU TRANS NIGER PIPELINE AT ETRO
