THE SHELL PETROLEUM DEVELOPMENT COMPANY OF NIGERIA LIMITED.

JOINT INVESTIGATION REPORT FOR INCIDENT NO: 1058084 JIV report S/N: 0288

1. Spill incident Number: 1058084 2. Type of incident* OIL SPILL
 3. Name of Location 6" OBIGBO NORTH - EBUBU PIPELINE
 4. Name of nearest community OBOLU 5. State: RIVERS 6. LGA ELEME
 7. Type of Production facility/Installation OIL PIPELINE 8. Asset owner/District PIPELINE

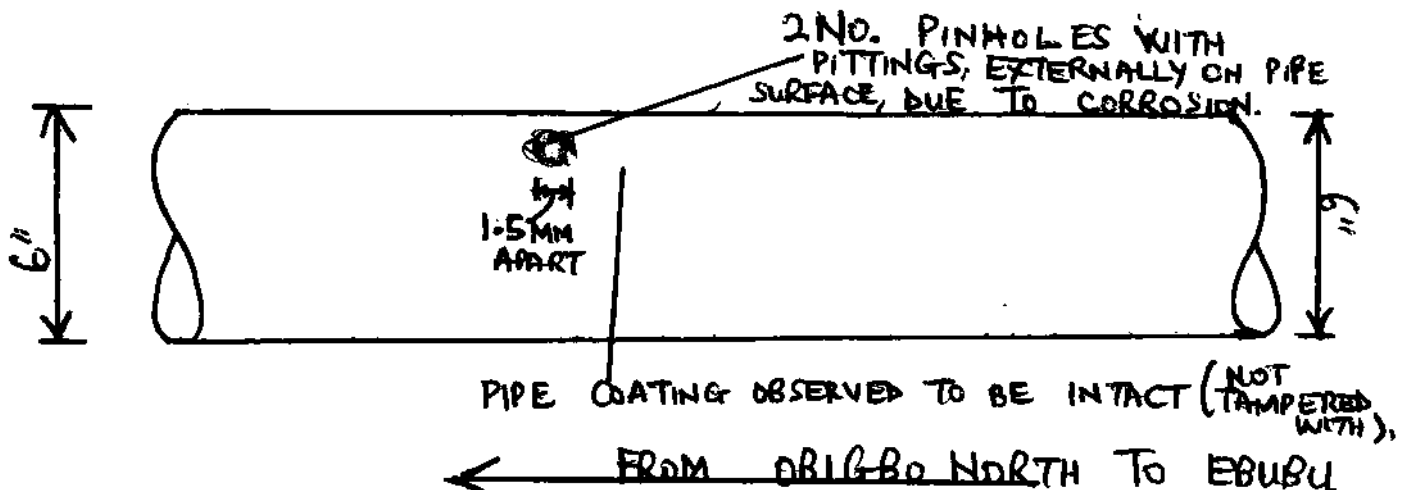
E. GRAPHIC DESCRIPTION OF LEAK POINT (while detail report of the leak point should be contained in the leak report, overview sketch of the site should be added as an appendix 1)

SECTION OF 6" OBLGBO NORTH - EBUBU PIPELINE AT OBOLO SHOWING 2 NO. PINHOLES (DUE TO CORROSION) AT 11 O' CLOCK POSITIONS.

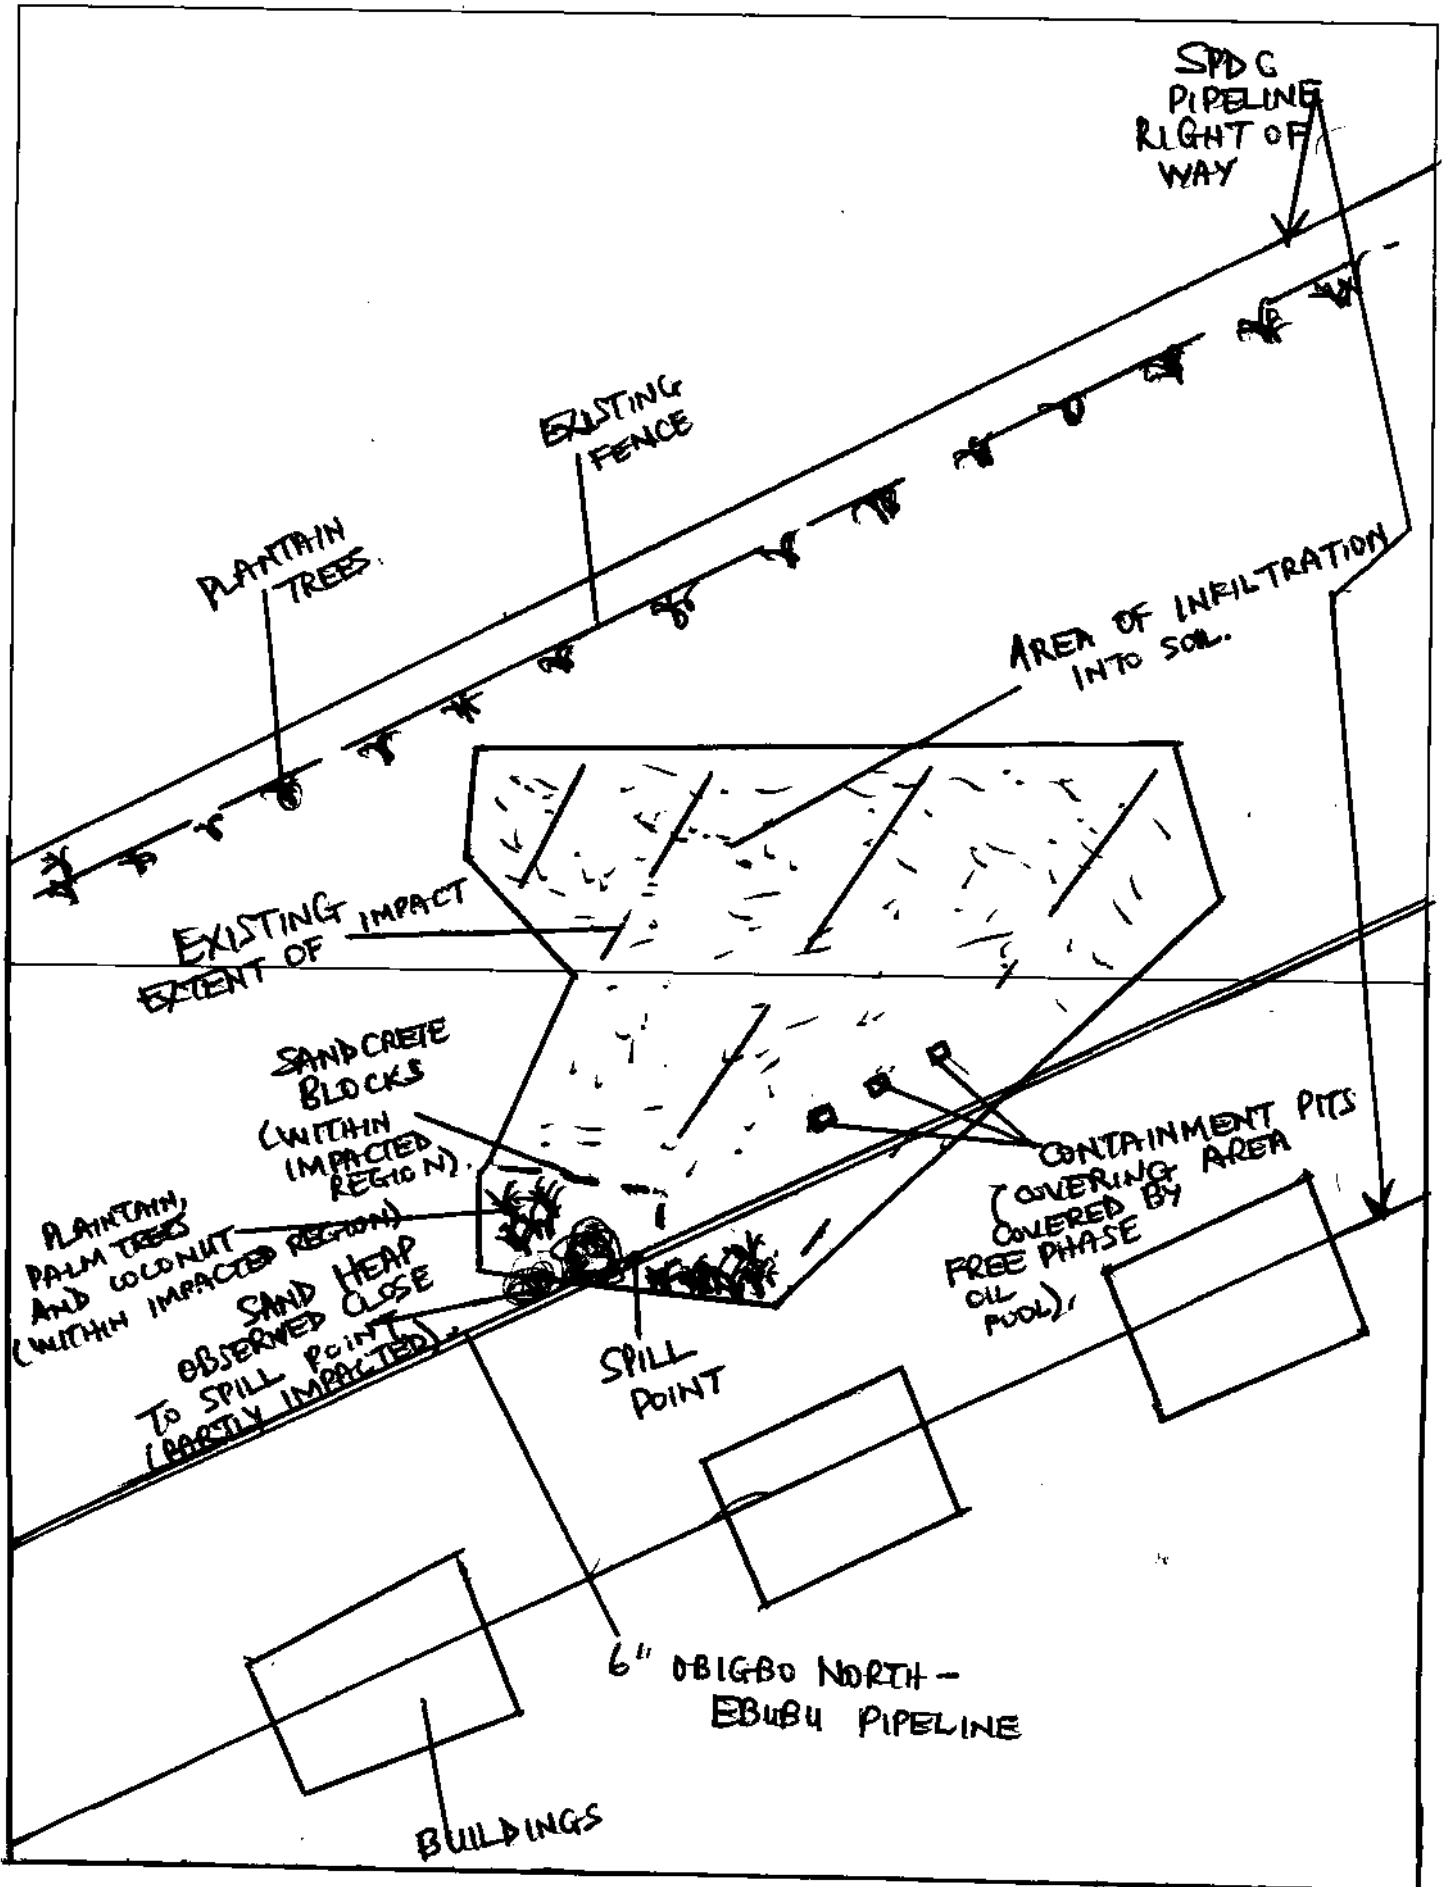
28. Appendix 1: Overview sketch of the site

Location: 6' OBIGBO NORTH - EBUBU PIPELINE AT OBOLD.
