THE SHELL PETROLEUM DEVELOPMENT COMPANY OF NIGERIA LIMITED.

JOINT INVESTIGATION REPORT FOR INCIDENT NO: 1060611 JIV report S/N: 0323

1. Spill incident Number: 1060611 2. Type of incident* OIL SPILL
 3. Name of Location 12" IMORIVER - OGALE PIPELINE
 4. Name of nearest community OKOHIA 5. State: ABIA 6. LGA UKWA WEST
 7. Type of Production facility/Installation OIL PIPELINE 8. Asset owner/District PIPELINE

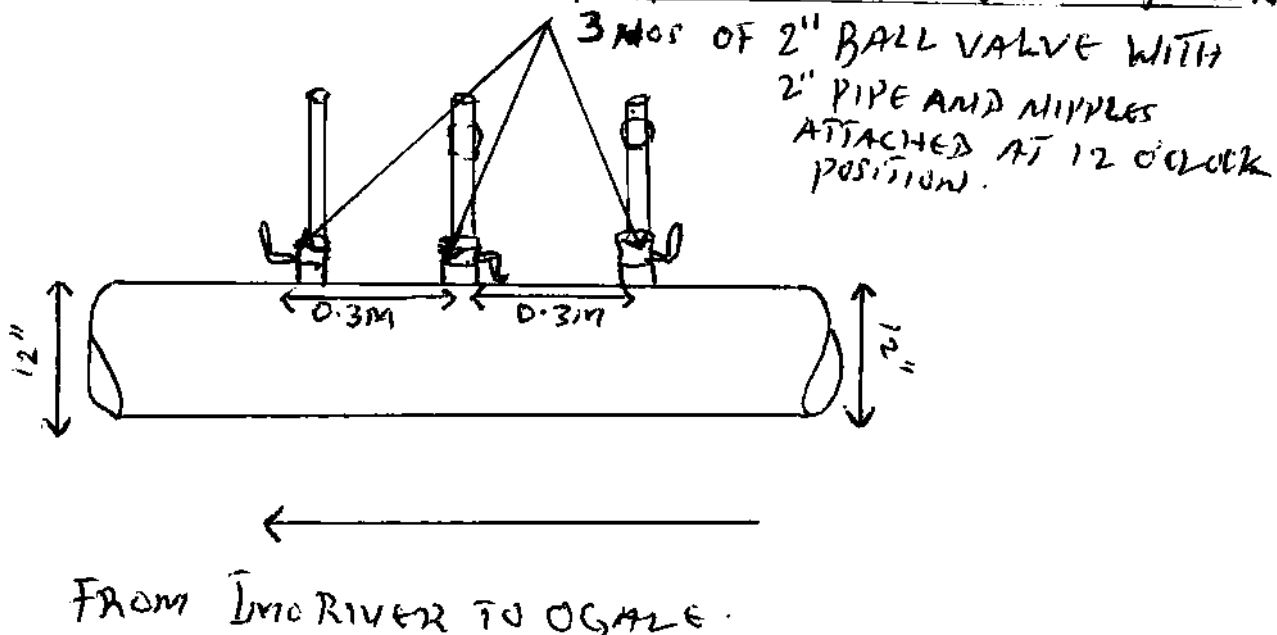
| <input checked="" type="checkbox"/> Failed Weld-on illegal hot tap valve, | <input type="checkbox"/> Failed Clamp | <input type="checkbox"/> Missing Pipeline/Flowline |
| <input checked="" type="checkbox"/> Crude oil theft (illegal bunkering) point, | | <input type="checkbox"/> Third party tampering with Clamp |

SECTION OF 12" IMO RIVER - OGALE PIPELINE AT OKOHA
 SHOWING POSITION OF CRUDE OIL THEFT POINTS AT 12 O'CLOCK POSITION

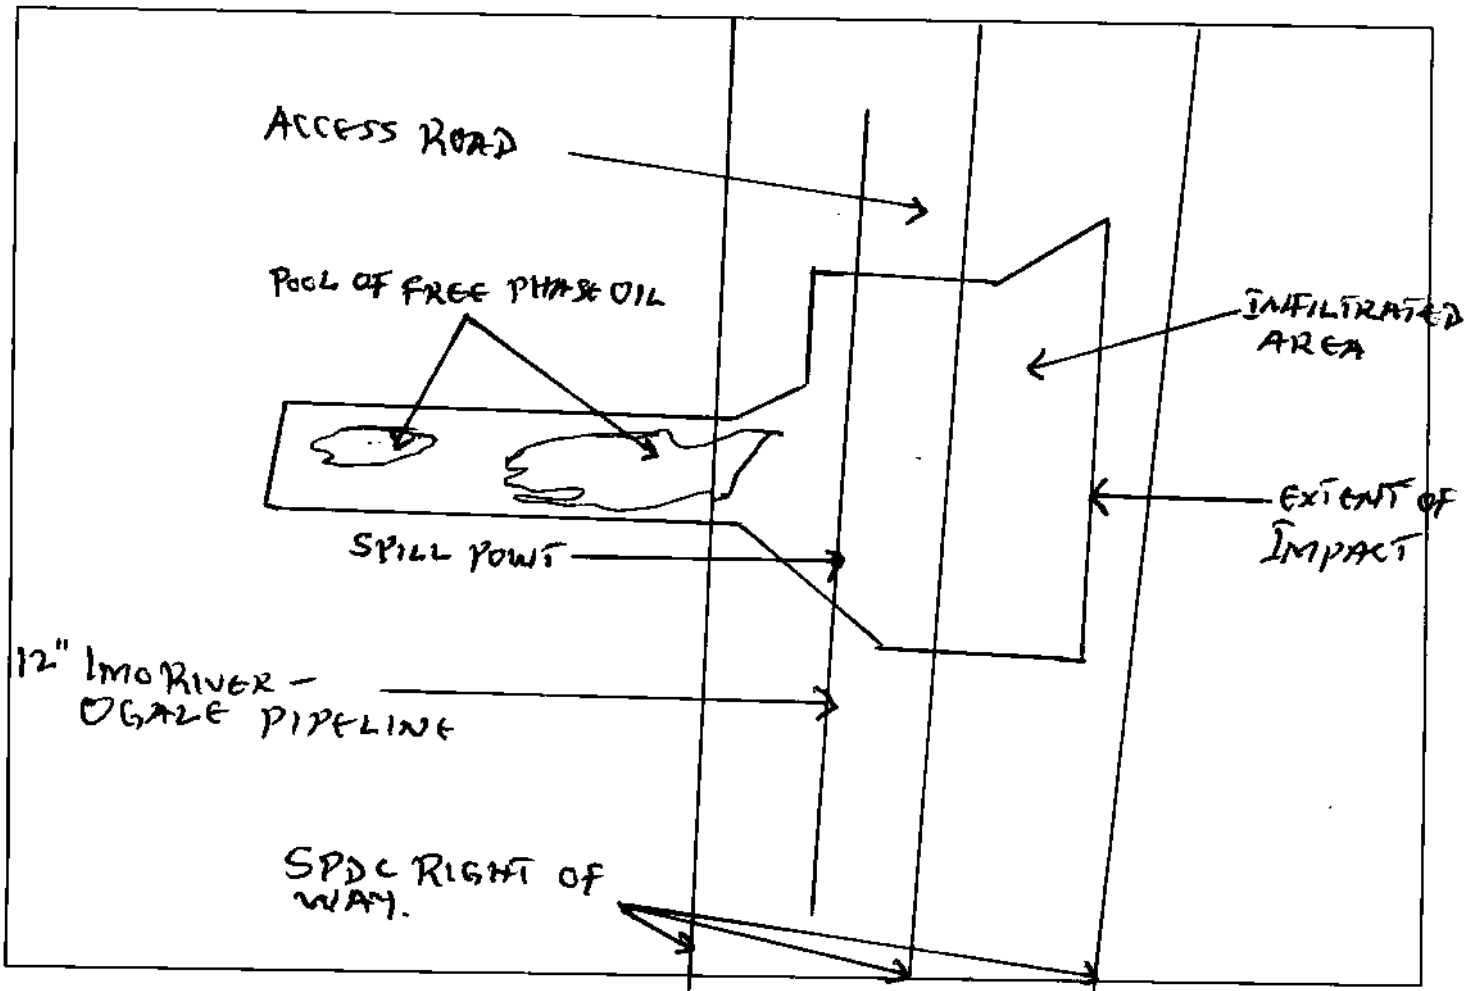
28. Appendix 1: Overview sketch of the site

Location: 12" IMORIVER - OGALE PIPELINE AT OKOTIA.
