**THE SHELL PETROLEUM DEVELOPMENT COMPANY OF NIGERIA LIMITED.**

JOINT INVESTIGATION REPORT FOR INCIDENT NO: 1063401 JIV report S/N: 0329

1. Spill incident Number: 1063401 2. Type of incident\* OIL SPILL  
 3. Name of Location 36" RUMUEKPE-NKPOKU TRANS NIGER PIPELINE  
 4. Name of nearest community OMUIGWE-ALUJI 5. State: RIVERS 6. LGA IKWERRE  
OBLODOKOR IKWERRE  
 7. Type of Production facility/Installation OIL PIPELINE 8. Asset owner/District PIPELINE

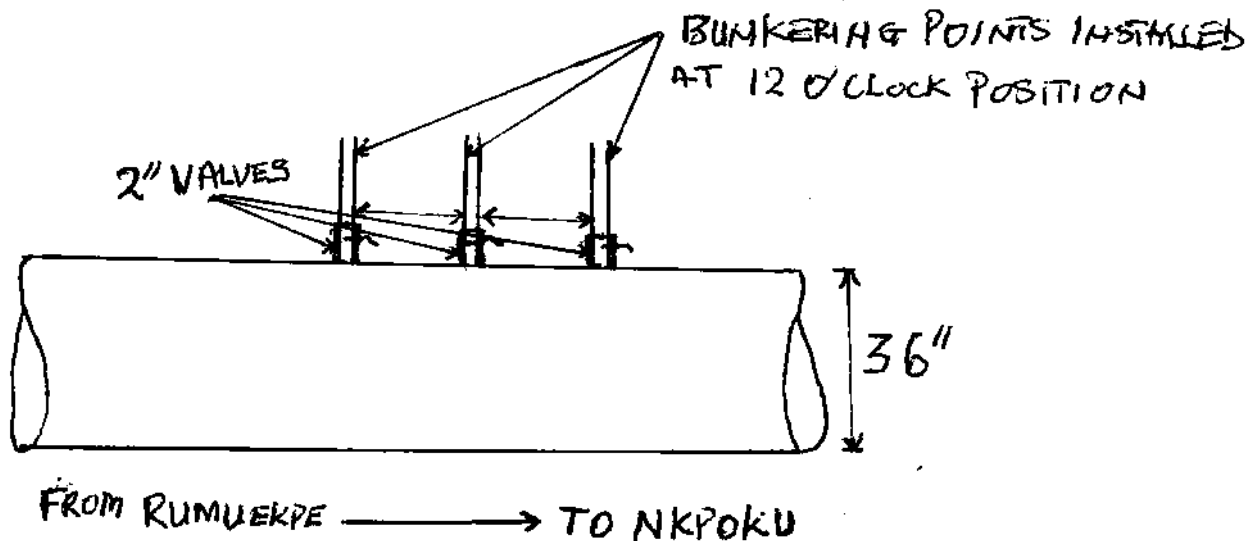
E. GRAPHIC DESCRIPTION OF LEAK POINT (while detail report of the leak point should be contained in the leak report, overview sketch of the site should be added as an appendix 1)

| <input checked="" type="checkbox"/> Failed Weld-on illegal hot tap valve, | <input type="checkbox"/> Failed Clamp | <input type="checkbox"/> Missing Pipeline/Flowline |
| <input checked="" type="checkbox"/> Crude oil theft (illegal bunkering) point, | | <input type="checkbox"/> Third party tampering with Clamp |

A SECTION OF 36" RUMUKPE - NKPOKU TRANS NIGER PIPELINE AT  
OMUGWE - ALUU SHOWING BUNKERING POINTS INSTALLED AT  
12 O'CLOCK POSITION

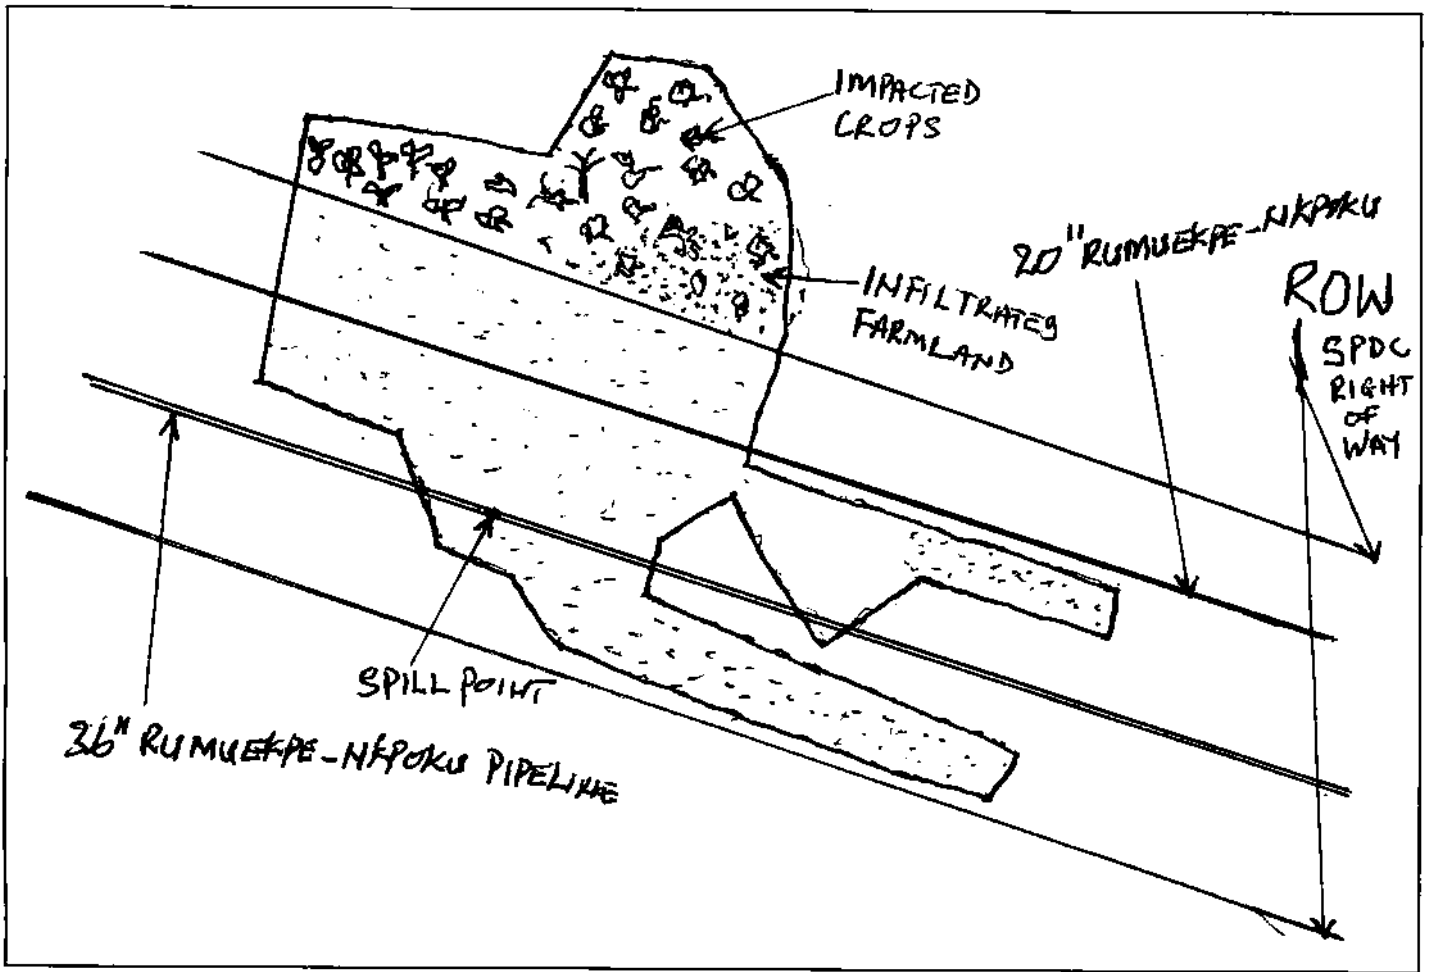
28. Appendix 1: Overview sketch of the site

Location: 36" RUMUEKPE - NKPOKU TRANS NIGER PIPELINE AT OMOIGWE - ALU4
