THE SHELL PETROLEUM DEVELOPMENT COMPANY OF NIGERIA LIMITED.

JOINT INVESTIGATION REPORT FOR INCIDENT NO: 1039184 JIV report S/N 0186

1. Spill incident Number: 1039184 2. Type of incident* OIL SPILL
 3. Name of Location 20" OTUMARA - ESCRAVOS TRUNKLINE
 4. Name of nearest community ADJUDAIBO 5. State: DELTA 6. LGA WARRI - SOUTH WEST
 7. Type of Production facility/Installation OIL PIPELINE 8. Asset owner/District PIPELINE

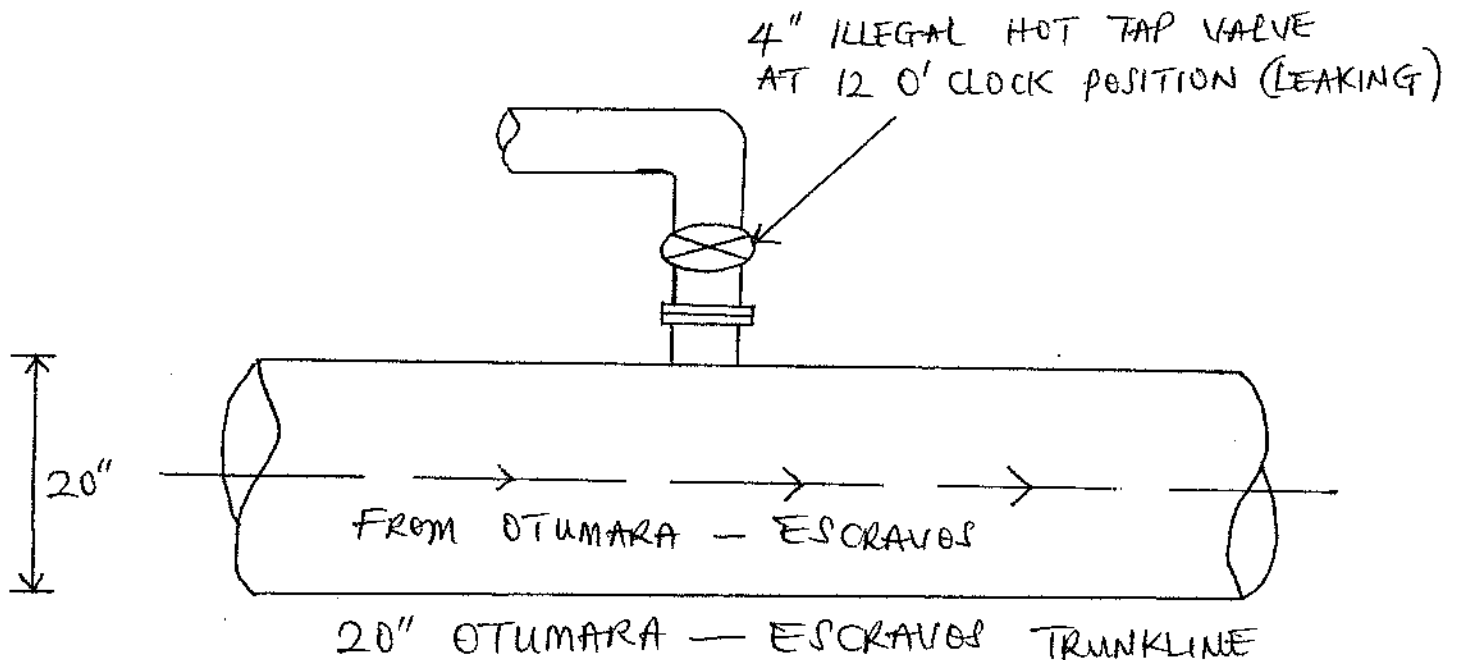
E. GRAPHIC DESCRIPTION OF LEAK POINT (while detail report of the leak point should be contained in the leak report, overview sketch of the site should be added as an appendix 1)

| <input checked="" type="checkbox"/> Failed Weld-on illegal hot tap valve, | <input type="checkbox"/> Failed Clamp | <input type="checkbox"/> Missing Pipeline/Flowline |
| <input checked="" type="checkbox"/> Crude oil theft (illegal bunkering) point, | | <input type="checkbox"/> Third party tampering with Clamp |

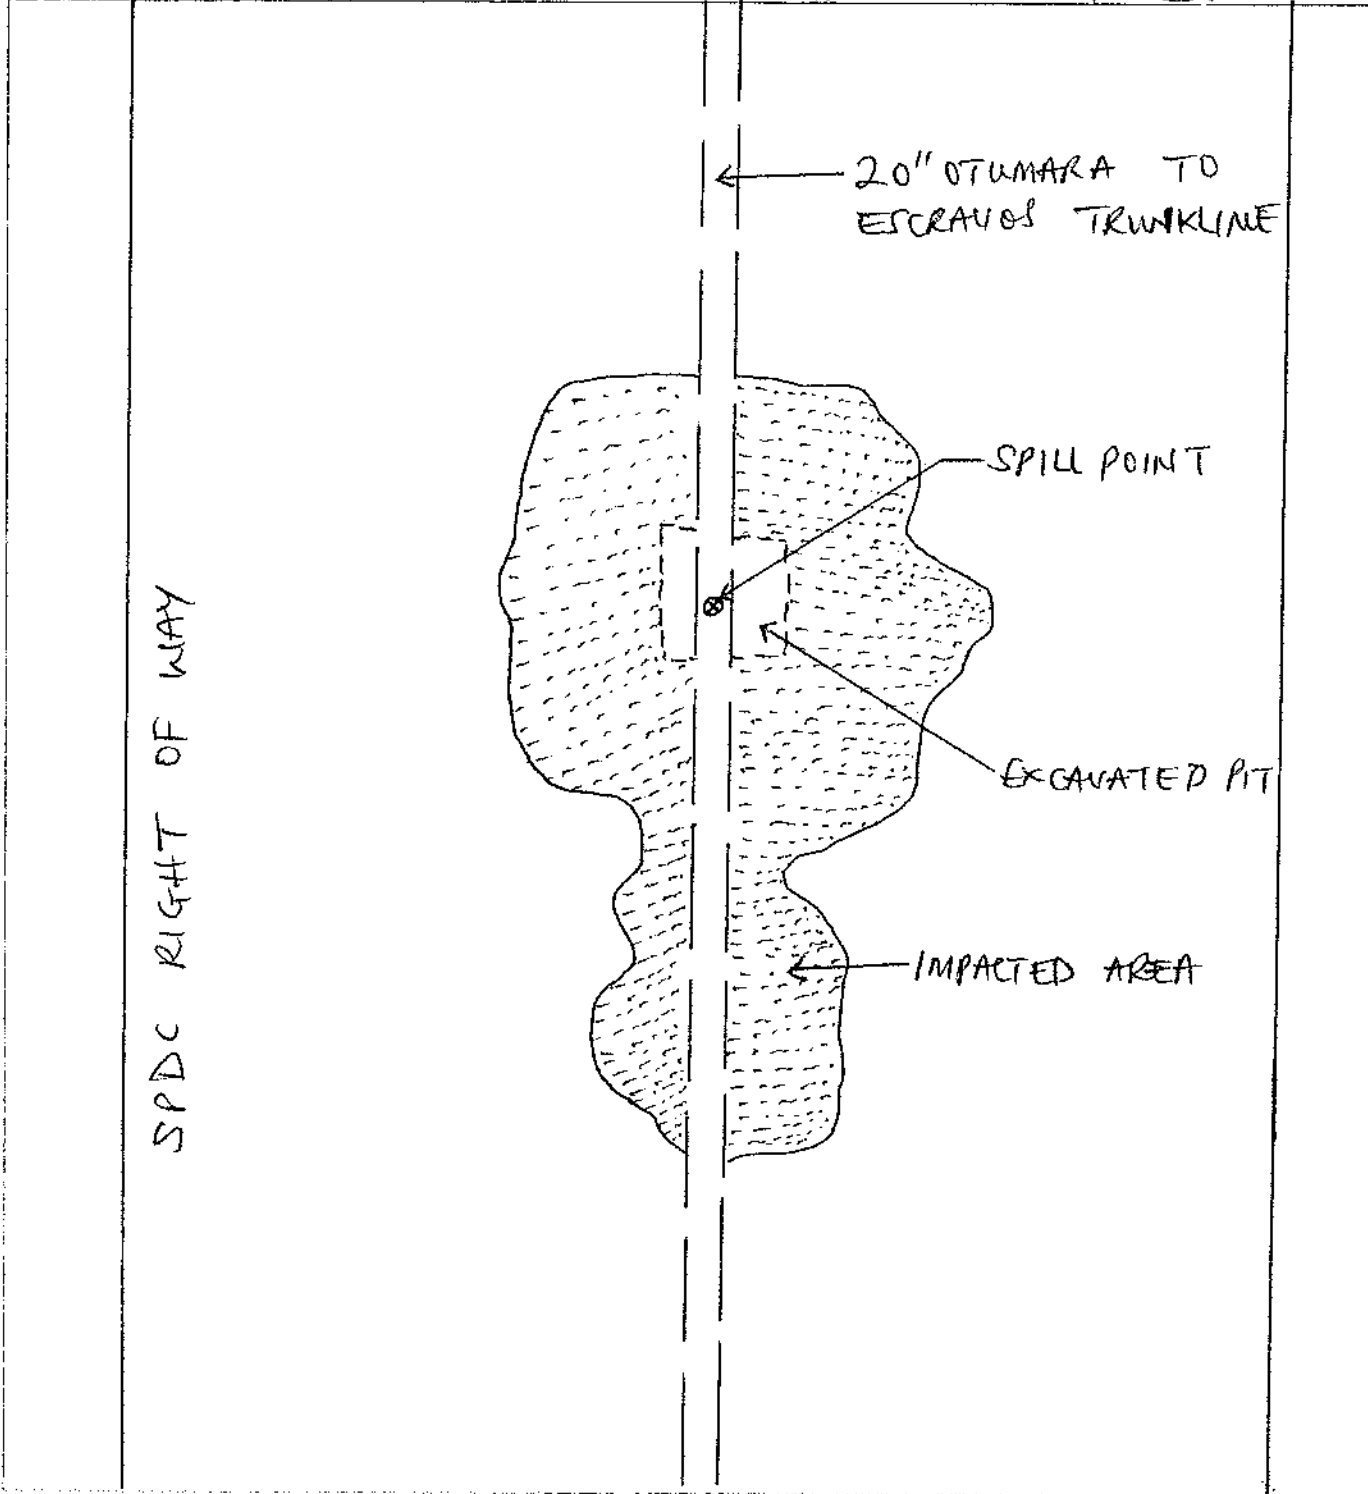
28. Appendix I: Overview sketch of the site

- Total calculated area of impact 800 m²
- Impact within SPDC R.O.W 800 m²
- Impact outside SPDC R.O.W NOT APPLICABLE

Location: 20" OTUMARA - ESCRAVOS TRUNKLINE AT ADJUDAIBO
