**THE SHELL PETROLEUM DEVELOPMENT COMPANY OF NIGERIA LIMITED.**

JOINT INVESTIGATION REPORT FOR INCIDENT NO: 1038005 (A) JIV report S/N: 0069

1. Spill incident Number: 1038005 (A) 2. Type of incident\* OIL SPILL  
 3. Name of Location 30" NEMBE CREEK PIPELINE  
 4. Name of nearest community KRAKAMA 5. State: RIVERS 6. LGA DEGEMA  
 7. Type of Production facility/Installation OIL PIPELINE 8. Asset owner/District PIPELINE/SKARIP

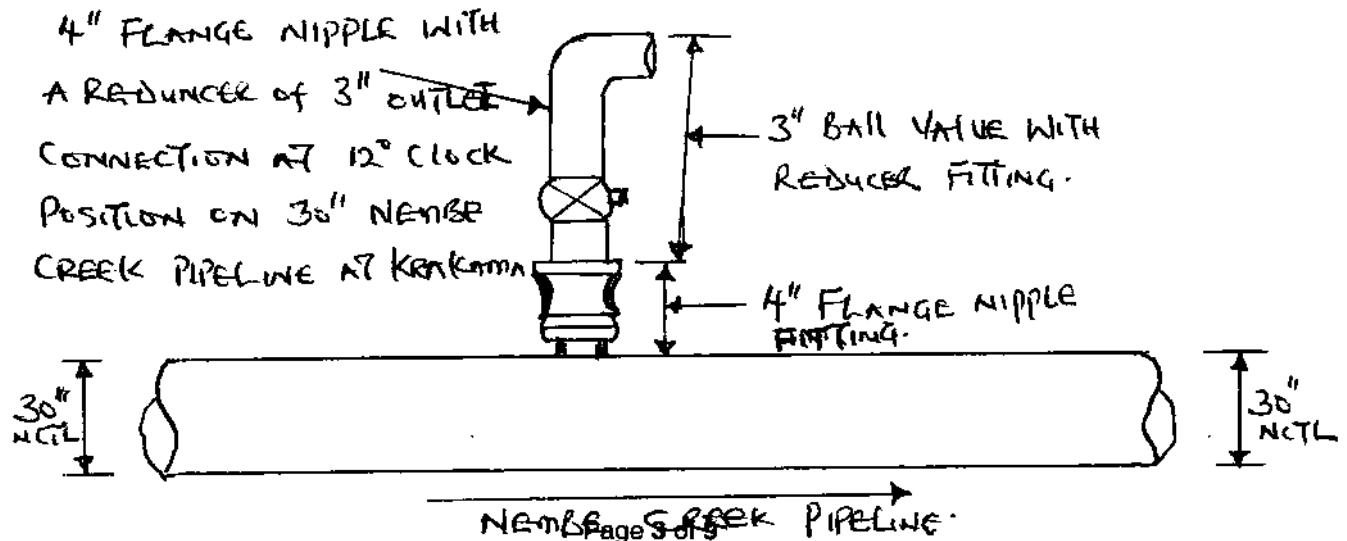
| <input checked="" type="checkbox"/> Failed Weld-on illegal hot tap valve, | <input type="checkbox"/> Failed Clamp | <input type="checkbox"/> Missing Pipeline/Flowline |
| <input checked="" type="checkbox"/> Crude oil theft (illegal bunkering) point, | | <input type="checkbox"/> Third party tampering with Clamp |

SECTIONAL VIEW OF 30" NEMBE CREEK PIPELINE AT KRAKAMA

SHOWING ILLEGALLY INSTALLED BUNKERING FITTINGS
