THE SHELL PETROLEUM DEVELOPMENT COMPANY OF NIGERIA LIMITED.

JOINT INVESTIGATION REPORT FOR INCIDENT NO: 1041257 JIV report S/N: 0254

1. Spill incident Number: 1041257 2. Type of incident* OIL SPILL AND FIRE
 3. Name of Location 12" IMO RIVER 2 - OGALA PIPELINE
UMUDOLOLO
 4. Name of nearest community OWAZA 5. State: ABIA 6. LGA UKWA WEST
 7. Type of Production facility/Installation OIL PIPELINE 8. Asset owner/District PIPELINE

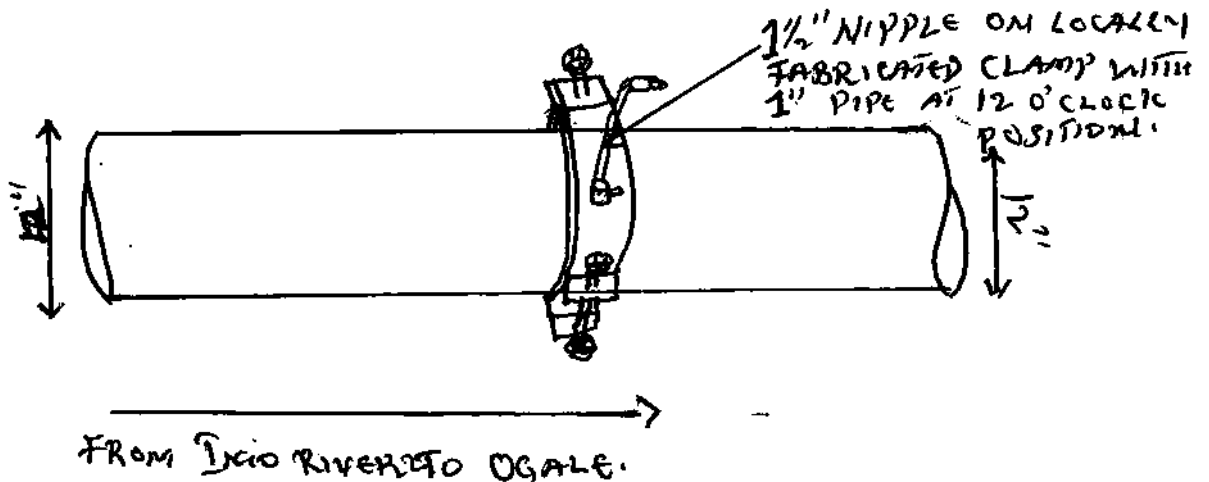
| <input checked="" type="checkbox"/> Failed Weld-on illegal hot tap valve, | <input type="checkbox"/> Failed Clamp | <input type="checkbox"/> Missing Pipeline/Flowline |
| <input checked="" type="checkbox"/> Crude oil theft (illegal bunkering) point, | | <input type="checkbox"/> Third party tampering with Clamp |

SECTION OF 12" IMO RIVER - OGALE PIPELINE AT UMUOLOLO OWAZA SHOWING POSITION OF CRUDE OIL TANK LEAK POINT

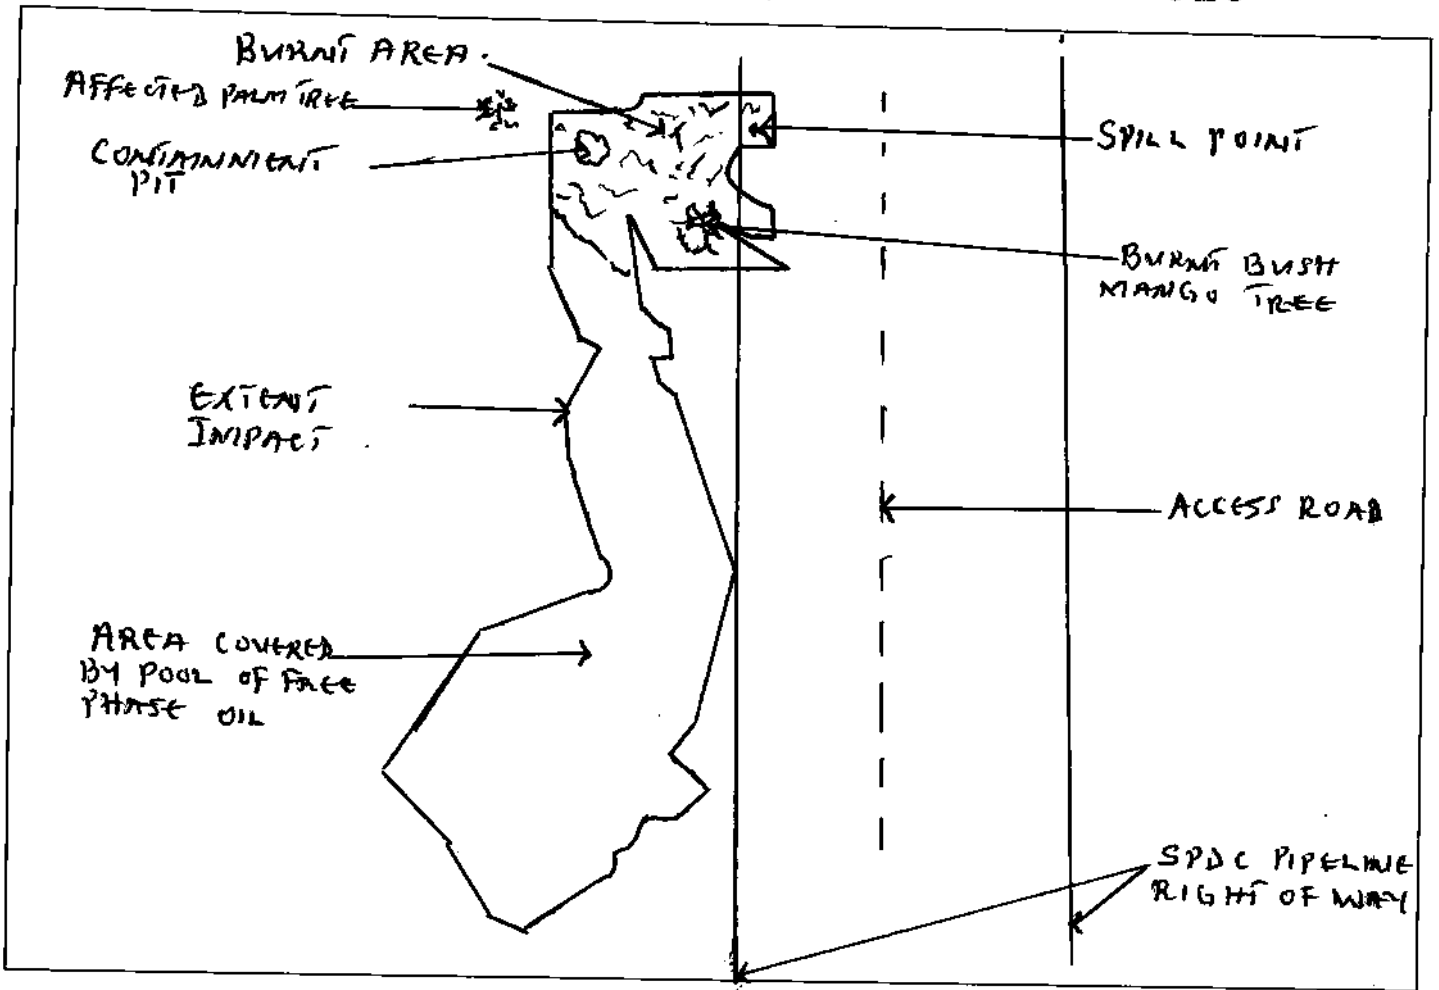
28. Appendix 1: Overview sketch of the site

Location: 12" Imo River - OGALt PIPELINE AT UMUOLOLO DWAZA
