**THE SHELL PETROLEUM DEVELOPMENT COMPANY OF NIGERIA LIMITED.**

JOINT INVESTIGATION REPORT FOR INCIDENT NO: 1043882 JIV report S/N: 0187

1. Spill incident Number: 1043882 2. Type of incident\* OIL SPILL  
 3. Name of Location KANBO WELL - 7S FLOWLINE  
 4. Name of nearest community EGTBEMDANGARABIRI/ABIDIAMA 5. State: BAYELSA 6. LGA EKEREMOR  
 7. Type of Production facility/Installation FLOWLINE 8. Asset owner/District NWS2

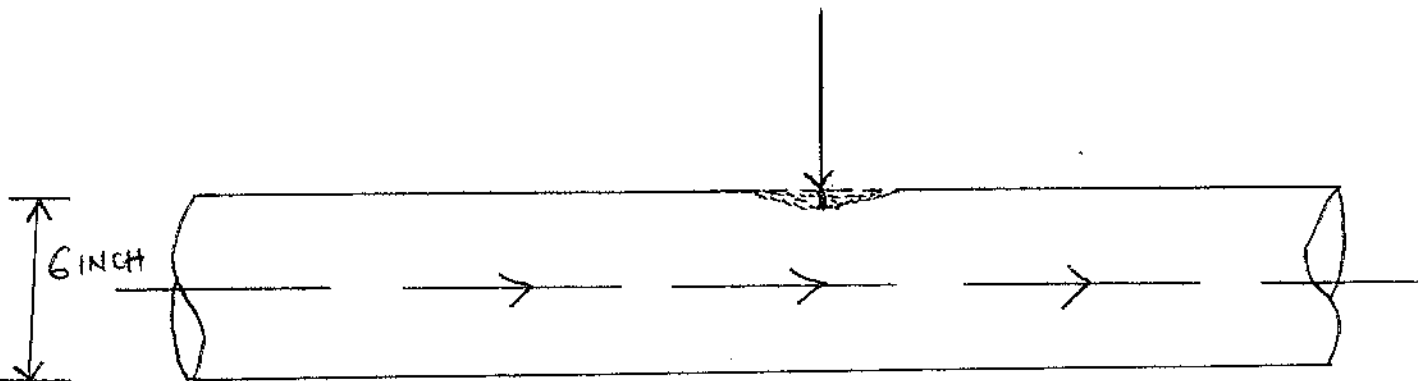
KANBO WELL-7S FLOWLINE

EXTERNAL CORROSION AT A WELDED JOINT  
[AT 12 O'CLOCK POSITION]
