**THE SHELL PETROLEUM DEVELOPMENT COMPANY OF NIGERIA LIMITED.**

JOINT INVESTIGATION REPORT FOR INCIDENT NO: 1043511 JIV report S/N: 0258

1. Spill incident Number: 1043511 2. Type of incident\* OIL SPILL  
 3. Name of Location 4" UBIE WELL 5L FLOWLINE  
 4. Name of nearest community IDU EKPEYE 5. State: RIVERS 6. LGA AMOADA WEST  
 7. Type of Production facility/Installation OIL FLOWLINE Asset owner/District LAND 2.

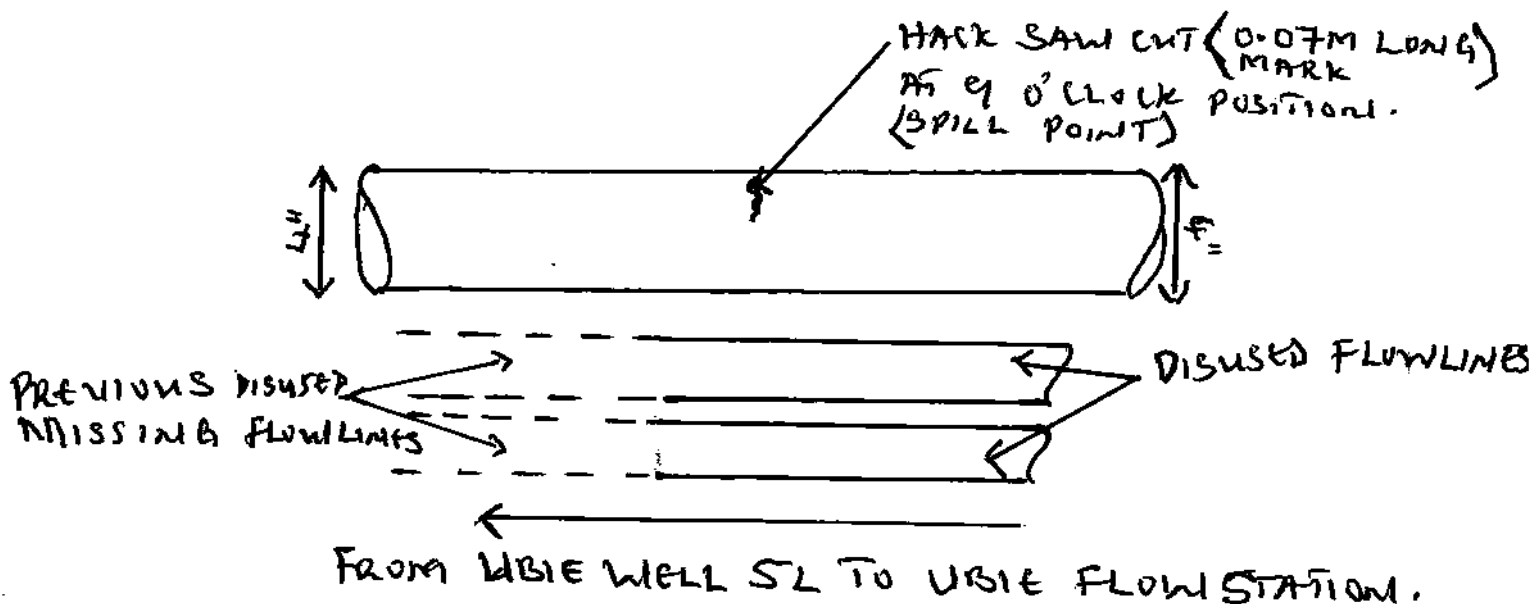
E. GRAPHIC DESCRIPTION OF LEAK POINT (while detail report of the leak point should be contained in the leak report, overview sketch of the site should be added as an appendix 1)

| <input type="checkbox"/> Drilled hole | <input checked="" type="checkbox"/> Hack saw cut | <input type="checkbox"/> Tear (_____), |

SECTION OF 4" UBIE WELL SL FLOWLINE AT IDU EKPTME  
SHOWING POSITION OF HACK SAW CUT AT 9 O'CLOCK POSITION.

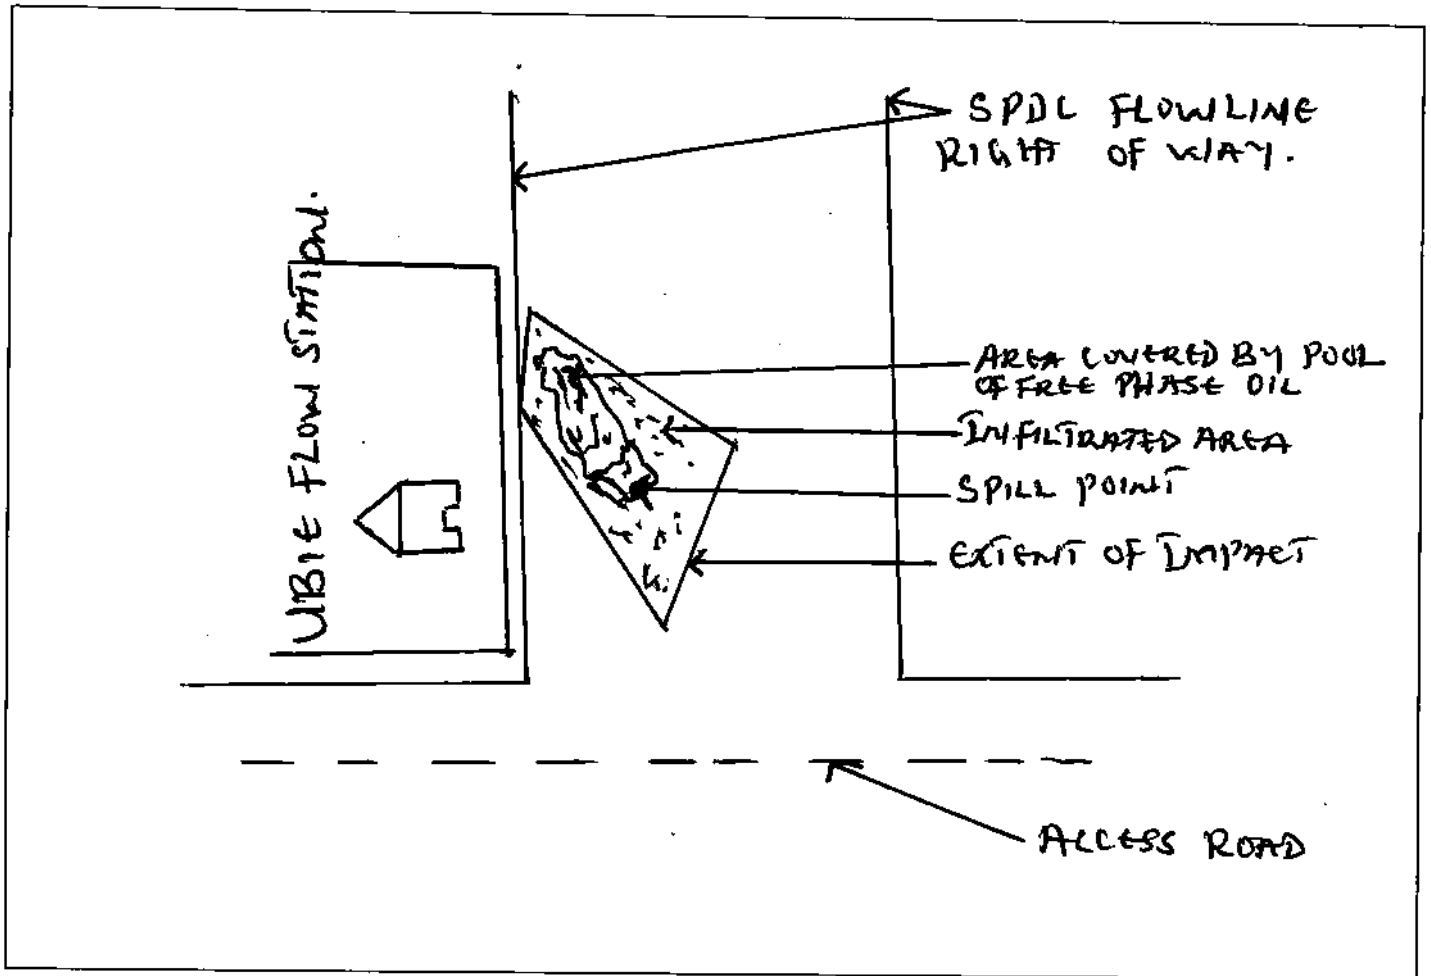
28. Appendix 1: Overview sketch of the site

Location: 4" Ubie Well SL Flowline at IDU Ekpeni
